Upgrading of quay walls at the Ravenna port, Italy: evaluation of the steel piles degradation after a long working life

# Upgrading of quay walls at the Ravenna port, Italy: evaluation of the steel piles degradation after a long working life

Paolo Ruggeri<sup>1</sup>, Vivienne Marianne Esther Fruzzetti<sup>1</sup>, Giuseppe Scarpelli<sup>1</sup>

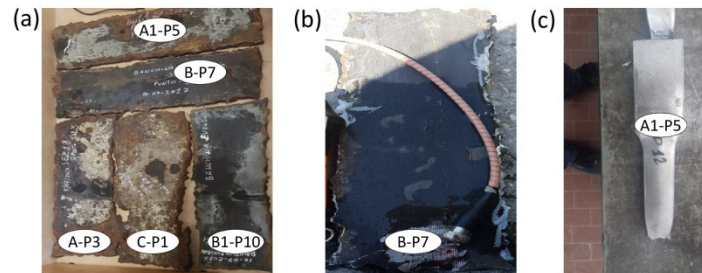
Figure 6

A picture of the outer surface of the samples taken from the flanges is shown in Figure 6a. The black epoxy coating of the surface of the plates is evident from the pictures, although not uniformly preserved. Note that the general rusty state of the surfaces is a consequence of the rapid oxidation of the metal after the oxy-arc cutting; this is confirmed by the picture of Figure 6b taken soon after the sampling in which no evidence of rust can be found. Moreover, it should be considered that the samples were taken 2.50 – 3.00 m below sea level that is very close to the permanent immersed zone and it is possible that in the low water zone the preservation of the coating was worse than on the sampled plates, especially for the oldest steel profiles.

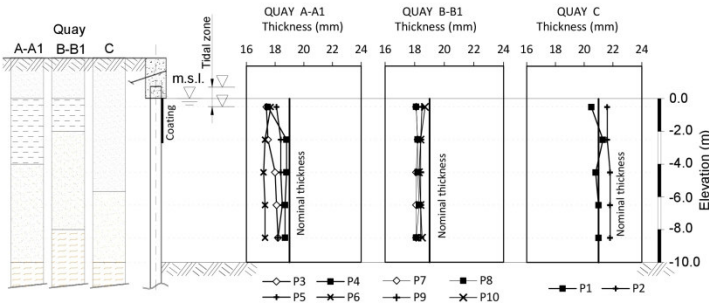
The measurements of the flange steel thickness are displayed in the graphs of Figure 7 for the three quays (A-A1, B-B1, C) together with the representative stratigraphy for each segment. Moreover, the measured thickness is compared with the nominal thickness of the king pile flange. Preliminarily, it should be noted that measurements on quays A-A1 and B-B1 indicate the reduction of the thickness with respect to the nominal values everywhere; on the contrary, the measured thickness for quay C resulted equal or slightly higher than nominal, therefore indicating an initial over-thickness of the profile.

Unfortunately, accurate measurements of initial thickness of the profiles are missing. This is a common problem of many old structures, related to the absence of any specific measurement of the size of the steel profiles in the inspection documents. To overcome this difficulty, it is possible to relate the size of the profiles to the original weight of the steel at delivering to the construction site. In fact, for every public work in Italy, the weight of any precast steel product must be checked by the Supervisor before installation and reported on the worksite book. This approach has been tested on the quay C. By examining the original official notes for the quay C, it resulted an extra-weight of the 3.4% in respect to the nominal weight of the steel profiles. For comparison, this value is much higher than the extra-weight resulting for quay A, which was equal to 0.4%. So, as a first approximation, by increasing 3.4% the nominal thickness of the king piles of the quay C (21 mm), the value of 21.7 mm is obtained. Such value fulfils the tolerance limit at delivering and can explain the actual thickness of the pile of quay C. However, this estimation is based on the unverifiable hypothesis that every plate of the steel profile is 3.4% heavier than the nominal. For these uncertainties, Quay C measurements were excluded from the corrosion rate assessment.

Apart from this aspect, it can be observed that the reduction of thickness is always very small and roughly uniform for the entire inspected depth. It means that for all the examined quays the structural safety after a long operative life is still not an issue. This result was meaningful for the designers when planning the upgrading of the quays, because the old steel structures resulted perfectly reliable.

Only in two points of the quay A-A1 it is observed a more pronounced reduction of the thickness in the low water zone with respect to those at greater depths. These findings could be related to the different present efficiency of the protection of the low water zone offered by the coating: on quay A-A1, the oldest one which was investigated (29 year of exposure), the coating began to end its protection, while on quay B-B1 (25 year old) and quay C (21 year old) the coating appears still capable of limiting the corrosion process. This observation is consistent with international standards, typically suggesting an extra life of 20 years due to coating protection only. Moreover, no significant effect related to the kind of soil in contact with the steel were observed in the present case, even if a thick anthropic deposit and some meters of marsh clay are somewhere part of the soil stratigraphy.

Figure 7. Measurements of the thickness of the steel profiles at different depth  
209x297mm (300 x 300 DPI)

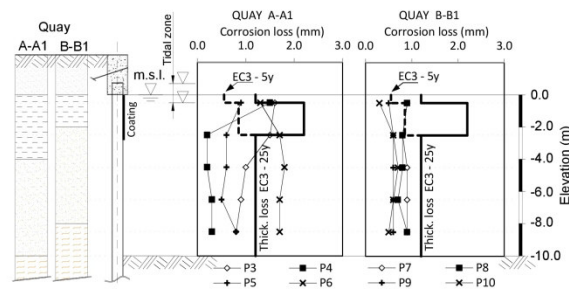
Focusing on the measurements of the quays A-A1 and B-B1, for which the nominal thickness appears representative of the original thickness, it is possible to estimate the corrosion loss. In Figure 8 the profile of the thickness loss has been displayed in comparison with the corrosion profile provided by Eurocode 3 after 25 years of exposure. On the other hand, for the low water zone 5 years of exposure is considered as the service life of the coating protection. It can be observed that, with the exception of the inspected profile P6, all the measured patterns indicate a corrosion loss smaller than expected in the permanently immersed zone. In the low water zone the effect of the coating has been substantial to limit the corrosion process as demonstrated by the quay B-B1 in which the measurements carried out exactly after 25 year of exposure agree very well with the expected 5 years figures. On the contrary, quay A-A1, after 29 years of exposure, shows the exhaustion of the coating protection and the beginning of the much aggressive corrosion in the low

Figure 8. Corrosion loss evaluated from nominal thickness of the profiles compared with corrosion profiles suggested by Eurocode 3 for 25 y (□□□) and 5 y (- -) of exposure

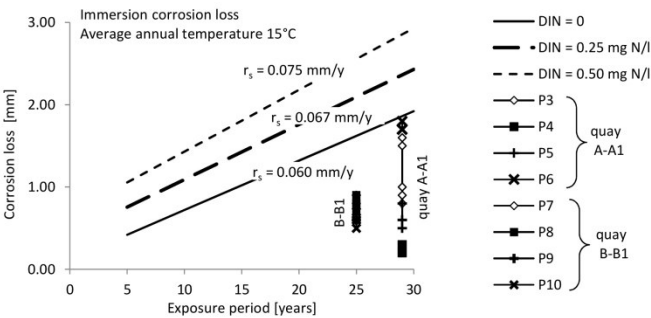
A different evaluation of the corrosion loss has been performed by following the approach suggested by Melchers. Climatological data of the Ravenna port indicate an average annual water temperature equal to 15°C. The concentration of dissolved inorganic nitrogen (DIN) is probably high: tentative values equal to 0.0, 0.25 and 0.5 mg N/l have been assumed to estimate the intercept ( $c_s$ ) and the corrosion rate ( $r_s$ ) of the linear model proposed by Melchers and Jeffrey (2014). The resulting trends of the corrosion losses with time of exposure are shown in Figure 9 for different dissolved inorganic concentrations and compared with the observed corrosion rates for the Ravenna quays A-A1 and B-B1. The measured corrosion losses are generally lower than expected and the proposed trends always overestimate the observed data. Considering that the model of Melchers and Jeffrey is based on a wide variety of data from many sources it is probable that some environmental aspect in the Ravenna port favored the preservation of the steel in the permanent immersed zone. The available data do not indicate peculiar characteristics of the site that could explain the observations: for example, the concentration of dissolved inorganic nitrogen is high, so the explanation has to be found elsewhere. The **most unusual aspect at the Ravenna harbour in comparison with ports worldwide** is the location along an artificial channel, in which both water flow and tidal oscillations are small. So, we can speculate that these aspects contribute to limit the supply of both nutrients and oxygen to the metal. In conclusion, the experimental results indicate that in the permanent immersed zone the corrosion rates well compare with the average values recommended by international standards and by recent approaches, so proving the very low progression of the corrosion process in this specific environment and that steel structures can be considered fully operative for long-time. In particular, the measured corrosion losses are largely lower of the maximum values suggested by EAU recommendation. A monitoring activity in the future should be oriented to check the evolution of the corrosion in the low water zone where the present data give evidence of the progressive exhaustion of the coating protection.

Figure 9. Measured corrosion losses compared with the linear model predictions according to Melchers and Jeffrey (2014)
