Upgrading of quay walls at the Ravenna port, Italy: evaluation of the steel piles degradation after a long working life

Paolo Ruggeri¹, Viviene Marianne Esther Fruzzetti¹, Giuseppe Scarpelli¹

ABSTRACT

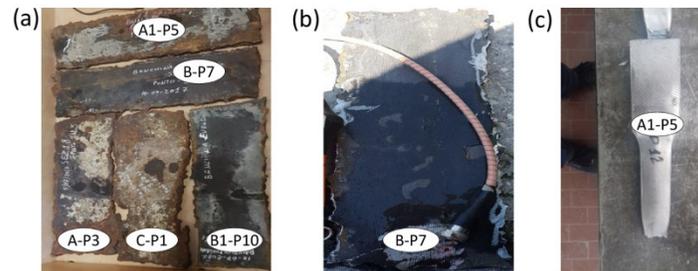
Figure 6

A picture of the outer surface of the samples taken from the flanges is shown in Figure 6a. The black epoxy coating of the surface of the plates is evident from the pictures, although not uniformly preserved. Note that the general rusty state of the surfaces is a consequence of the rapid oxidation of the metal after the oxy-arc cutting; this is confirmed by the picture of Figure 6b taken soon after the sampling in which no evidence of rust can be found. Moreover, it should be considered that the samples were taken 2.50 – 3.00 m below sea level that is very close to the permanent immersed zone and it is possible that in the low water zone the preservation of the coating was worse than on the sampled plates, especially for the oldest steel profiles.

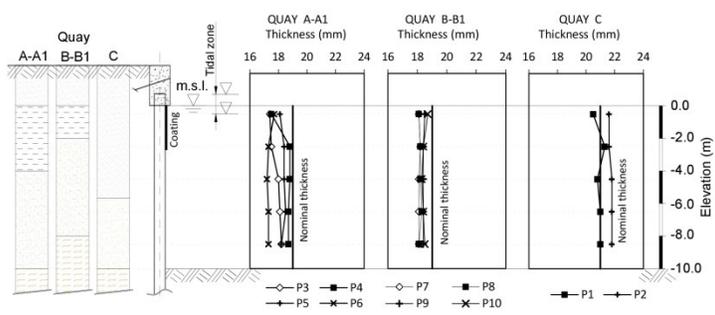
10 The measurements of the flange steel thickness are displayed in the graphs of Figure 7 for the three quays
11 (A-A1, B-B1, C) together with the representative stratigraphy for each segment. Moreover, the measured
12 thickness is compared with the nominal thickness of the king pile flange. Preliminarily, it should be noted
13 that measurements on quays A-A1 and B-B1 indicate the reduction of the thickness with respect to the
14 nominal values everywhere; on the contrary, the measured thickness for quay C resulted equal or slightly
15 higher than nominal, therefore indicating an initial over-thickness of the profile.
16

31 Apart from this aspect, it can be observed that the reduction of thickness is always very small and roughly
32 uniform for the entire inspected depth. It means that for all the examined quays the structural safety after a
33 long operative life is still not an issue. This result was meaningful for the designers when planning the
34 upgrading of the quays, because the old steel structures resulted perfectly reliable.
35

36 Only in two points of the quay A-A1 it is observed a more pronounced reduction of the thickness in the low
37 water zone with respect to those at greater depths. These findings could be related to the different present
38 efficiency of the protection of the low water zone offered by the coating: on quay A-A1, the oldest one
39 which was investigated (29 year of exposure), the coating began to end its protection, while on quay B-B1
40 (25 year old) and quay C (21 year old) the coating appears still capable of limiting the corrosion process.
41 This observation is consistent with international standards, typically suggesting an extra life of 20 years due
42 to coating protection only. Moreover, no significant effect related to the kind of soil in contact with the steel
43 were observed in the present case, even if a thick anthropic deposit and some meters of marsh clay are
44 somewhere part of the soil stratigraphy.

Figure 7. Measurements of the thickness of the steel profiles at different depth
209x297mm (300 x 300 DPI)

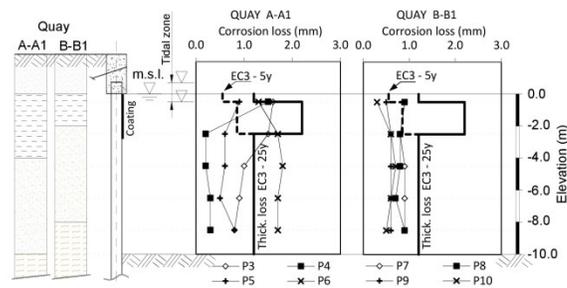
50 Focusing on the measurements of the quays A-A1 and B-B1, for which the nominal thickness appears
51 representative of the original thickness, it is possible to estimate the corrosion loss. In Figure 8 the profile of
52 the thickness loss has been displayed in comparison with the corrosion profile provided by Eurocode 3 after
53 25 years of exposure. On the other hand, for the low water zone 5 years of exposure is considered as the
54 service life of the coating protection. It can be observed that, with the exception of the inspected profile P6,
55 all the measured patterns indicate a corrosion loss smaller than expected in the permanently immersed zone.
56 In the low water zone the effect of the coating has been substantial to limit the corrosion process as
57 demonstrated by the quay B-B1 in which the measurements carried out exactly after 25 year of exposure
58 agree very well with the expected 5 years figures. On the contrary, quay A-A1, after 29 years of exposure,

59 shows the exhaustion of the coating protection and the beginning of the much aggressive corrosion in the low
60

Figure 8. Corrosion loss evaluated from nominal thickness of the profiles compared with corrosion profiles suggested by Eurocode 3 for 25 y (□□□) and 5 y (- -) of exposure

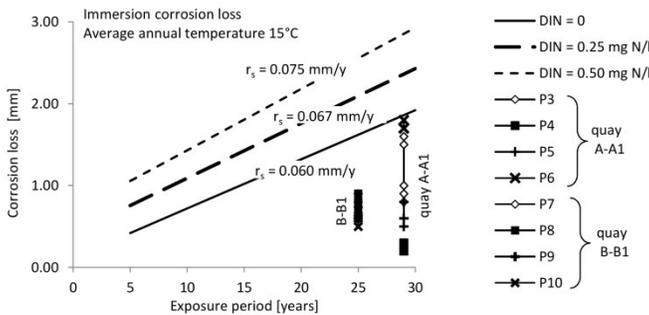
7
8 A different evaluation of the corrosion loss has been performed by following the approach suggested by
9 Melchers. Climatological data of the Ravenna port indicate an average annual water temperature equal to
10 15°C. The concentration of dissolved inorganic nitrogen (DIN) is probably high: tentative values equal to
11 0.0, 0.25 and 0.5 mg N/l have been assumed to estimate the intercept (c_s) and the corrosion rate (r_s) of the
12 linear model proposed by Melchers and Jeffrey (2014). The resulting trends of the corrosion losses with time
13 of exposure are shown in Figure 9 for different dissolved inorganic concentrations and compared with the
14 observed corrosion rates for the Ravenna quays A-A1 and B-B1. The measured corrosion losses are
15 generally lower than expected and the proposed trends always overestimate the observed data. Considering
16 that the model of Melchers and Jeffrey is based on a wide variety of data from many sources it is probable

17 that some environmental aspect in the Ravenna port favored the preservation of the steel in the permanent
18 immersed zone. The available data do not indicate peculiar characteristics of the site that could explain the
19 observations: for example, the concentration of dissolved inorganic nitrogen is high, so the explanation has
20 to be found elsewhere. The **most unusual aspect at the Ravenna harbour in comparison with ports worldwide**
21 is the location along an artificial channel, in which both water flow and tidal oscillations are small. So, we
22 can speculate that these aspects contribute to limit the supply of both nutrients and oxygen to the metal.
23

Figure 9. Measured corrosion losses compared with the linear model predictions according to Melchers and Jeffrey (2014)
