Numerical model upgrading of a historical masonry building damaged during the 2016 Italian earthquakes: the case study of the Podestà palace in Montelupone (Italy)

NUMERICAL MODEL UPGRADING OF A HISTORICAL MASONRY BUILDING DAMAGED DURING THE 2016 ITALIAN EARTHQUAKES: THE CASE STUDY OF THE PODESTÀ PALACE IN MONTELUPONE (ITALY)

Keyword: Structural Health Monitoring; Cultural Heritage; Masonry towers; Damage.

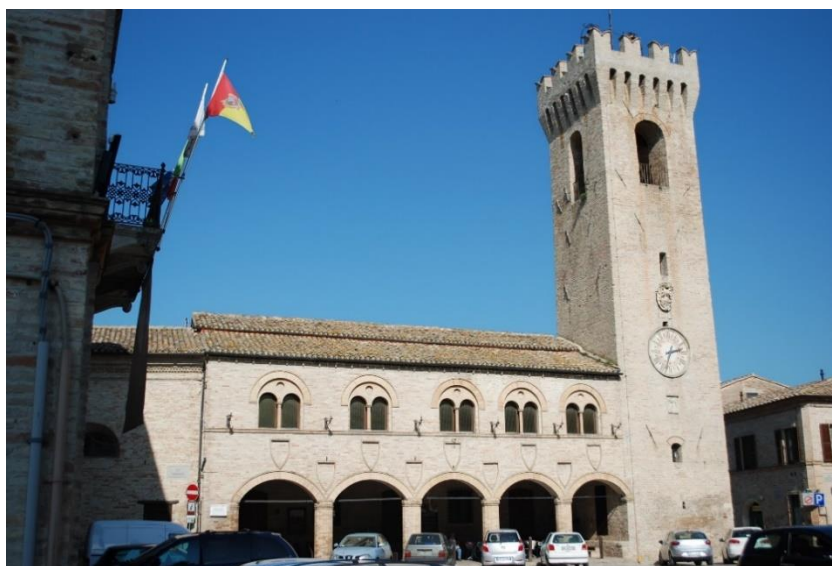
Figure 1. Picture of the palace during the AVS in 2016 November 25th.

The Podestà Palace (**Figure 1**) is the most important building in the historic centre of Montelupone. A proper dating is not simple, considering that the first document from the Historical Municipal Archives, excluding some parchments, date back to the 15th century. Therefore, there are no reliable documents attesting to the date or the period of construction which, however, dates back to the end of the 13th century and the beginning of the 14th century. The building would be made by Lombard masters, for the markedly horizontal development, which it shares with the palace of the nearby Montecassiano town.

Alongside the Podestà Palace stands the Civic Tower (**Figures 1 and 2d**). As for the palace, it is difficult to estimate the construction period, but it can be dated to the end of the 12th century or the beginning of the 13th century.

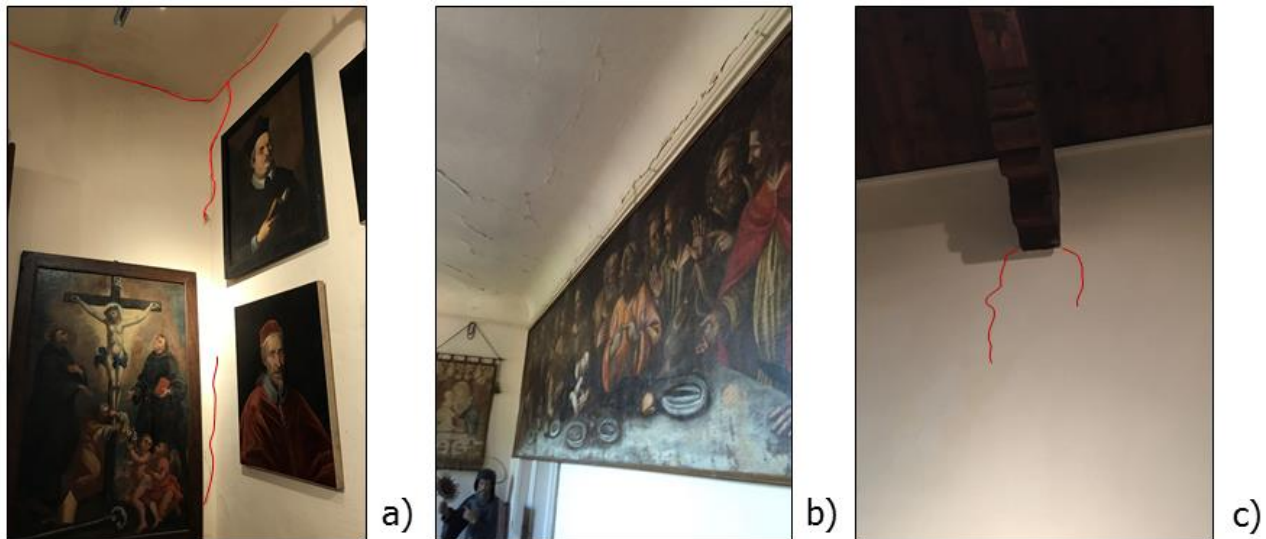
Figure 4. Some damages in the *camorcanna* and in the connection between transversal walls (a), only in the *camorcanna* (b) and in the connection between wooden beams and walls of the facades (c).

After the first seismic event of August 24th, the Podestà Palace was closed because several cracks appeared in the non-structural elements, **especially in the *camorcanna* (i.e., light vaults made up of plaster and reed laths hanging from wooden centrings)** [31] in some parts of the wooden roof of the palace (**Figure 4**). The subsequent seismic event of October 30th produce a lot of damages in structural elements, as it is possible to observe comparing the **Figure 5a**, acquired between August 25th and October 30th, and **Figure 5b**, taken during the AVS of 2016 November 25th.

Sliding between wooden roof beams and housing in the main walls have also appeared after the main shock (**Figure 4c**). Further enlargements of the previous damages in stuccos and in *camorcanna* were observed. Actually, the Podestà Palace is closed and some retrofitting interventions should be addressed in order to reopen the building.
