Comparative fragility methods for seismic assessment of masonry buildings located in Muccia (Italy)

# Comparative fragility methods for seismic assessment of masonry buildings located in Muccia (Italy)

Nicola Chieffo<sup>1</sup>, Francesco Clementi<sup>2</sup>, Antonio Formisano<sup>3</sup>, Stefano Lenci<sup>4</sup>

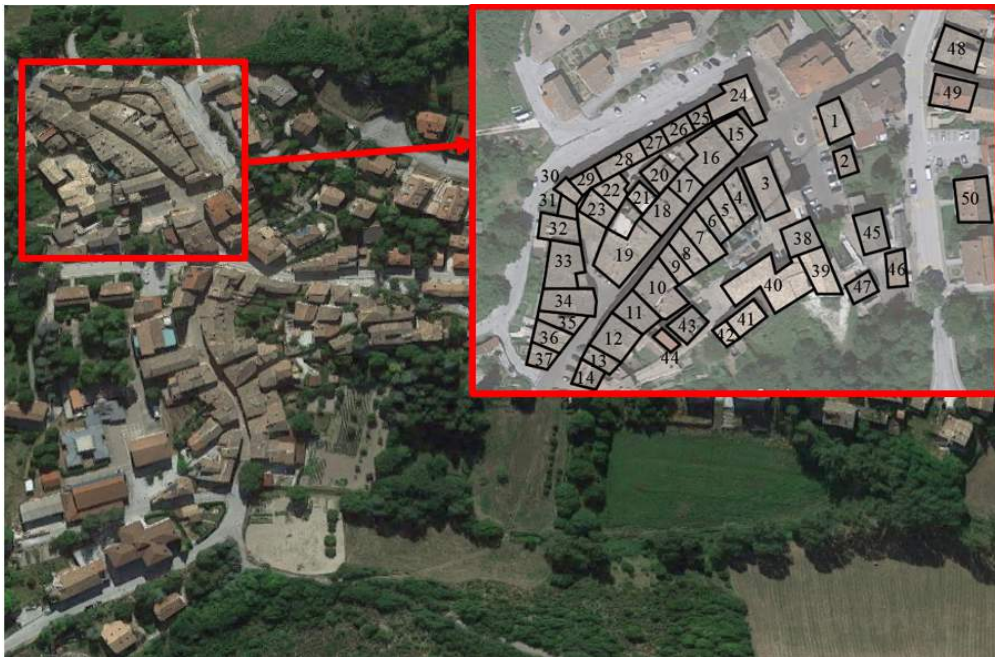
Figure 6. The sub-urban sector identification.

The sub-urban sector analysed (Fig.6) is to be considered homogeneous from a typological and structural point of view. It consists of 50 masonry buildings dating back to the 19<sup>th</sup> century.

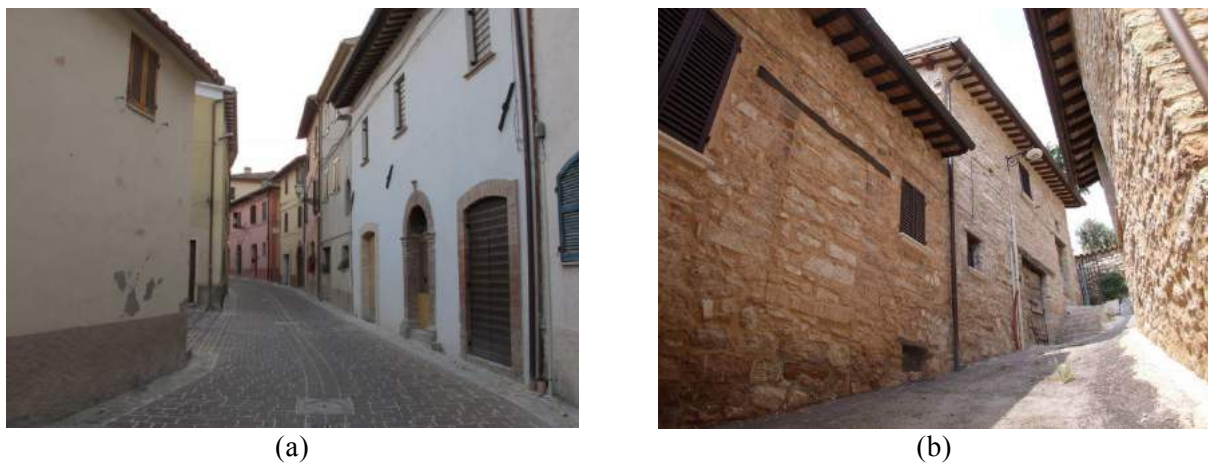
Figure 8. Building conformation: a) vertical configuration; b) structural heterogeneities.

Roofing structures are often composed of double pitch r.c. beams with clay tile covering or wooden elements. In many cases the presence in the walls of an incongruous and brittle binder, which lost over time its characteristics, compromises the static nature of the buildings themselves and, sometimes, of the whole aggregate. The presence of these vulnerability factors increases the possibility of collapse and instability of the historical built-up when subjected to an impacting seismic action (Fig. 8).

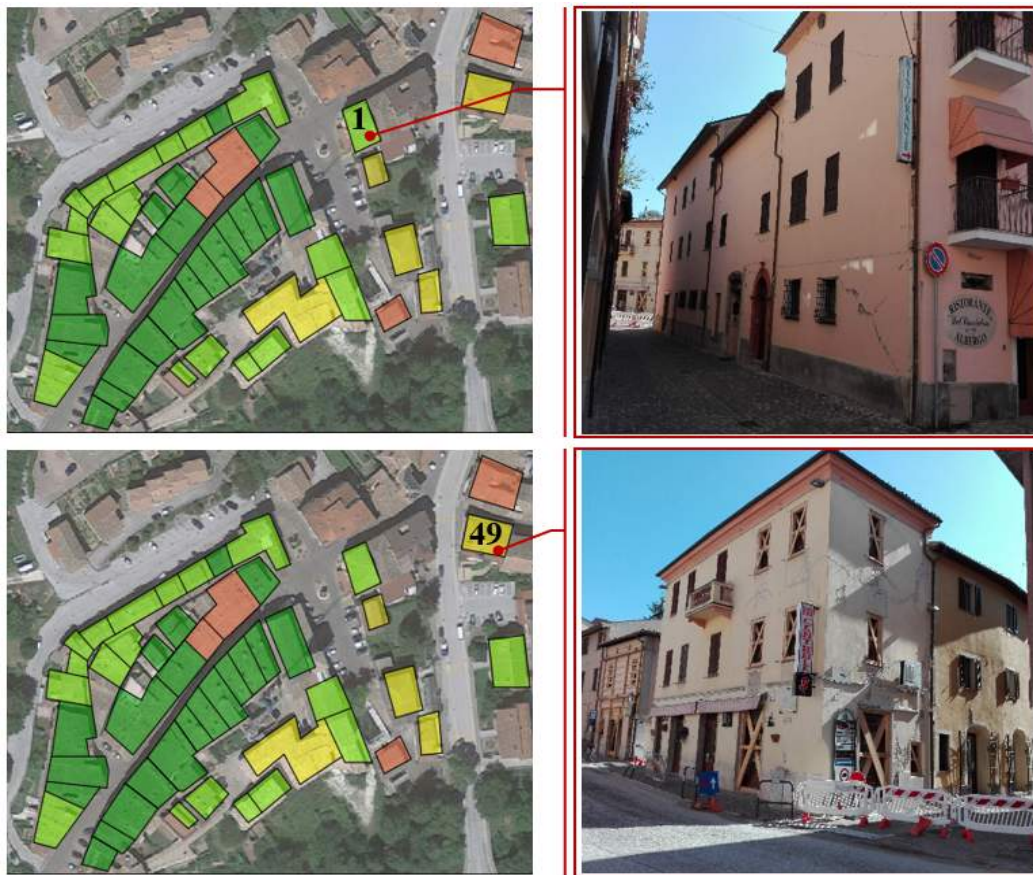
Figure 13: Correlation between examined damage scenario and site-inspection.

Moreover, considering the event occurred on October 30<sup>th</sup>, the correlation between the empirical damage scenario and site-inspection recognition have been showed in Fig.13.
