Comparative fragility methods for seismic assessment of masonry buildings located in Muccia (Italy) / Chieffo, N.; Clementi, F.; Formisano, A.; Lenci, S.. - In: JOURNAL OF BUILDING ENGINEERING. - ISSN 2352-7102. - STAMPA. - 25:(2019), p. 100813. [10.1016/j.jobe.2019.100813]

# Comparative fragility methods for seismic assessment of masonry buildings located in Muccia (Italy)

The current paper focuses on a sector of the historic centre of Muccia, in the district of Macerata (Italy), affected by the seismic sequence that involved Central Italy in 2016. *The main goal is the comparison in terms of fragility curves among two vulnerability assessment methodologies, empirical and mechanical ones.* The study area has been structurally and typologically identified according to the Building Typology Matrix (BTM). The physical vulnerability analysis of the urban-sector was performed through the application of a specific form for masonry building aggregates. Consecutively, an isolated masonry building, damaged after the seismic sequences, has been selected as a case study. On the assessed building, empirical fragility curves are presented according to the Guagenti & Petrini's correlation law

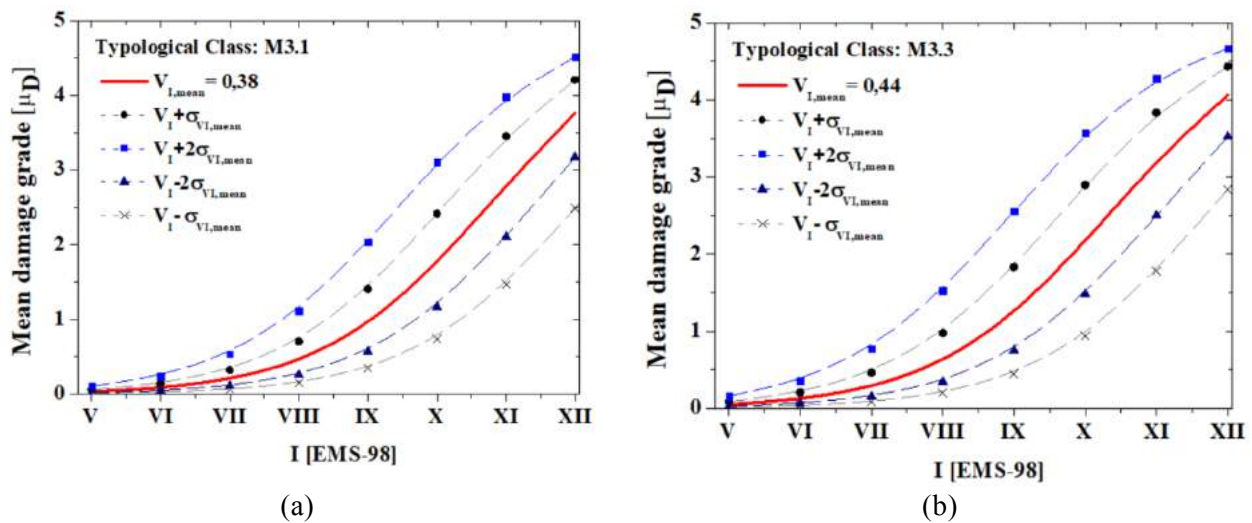
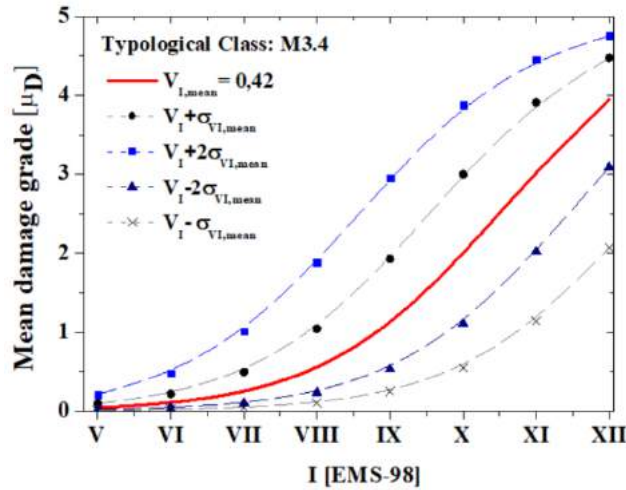
(c)  
Figure 10: Mean typological vulnerability curves for the sample of buildings examined.

As can be seen, the vulnerability curves depend on three variables: the vulnerability index ( $V_I$ ), the hazard, expressed in terms of macroseismic intensity ( $I$ ), and a ductility factor  $Q$ , ranging from 1 to 4, which describes the ductility of typological classes of buildings and has been assumed as equal to 2,3 as proposed by [9]. The method refers to the vulnerability model implicitly included in the EMS-98 and accounts for the uncertainty in the attribution of the different building typologies to the EMS-98 vulnerability classes and for the variability in the building-to building vulnerability within the same typology. Therefore, the mean vulnerability curves shown in Figure 10 have been plotted in order to estimate the collapse probability of analysed buildings for different scenarios ( $V_I - \sigma_{V_I, Mean}$ ;  $V_I + \sigma_{V_I, Mean}$ ;  $V_I + 2\sigma_{V_I, Mean}$ ;  $V_I + 2\sigma_{V_I, Mean}$ ) [28, 29].

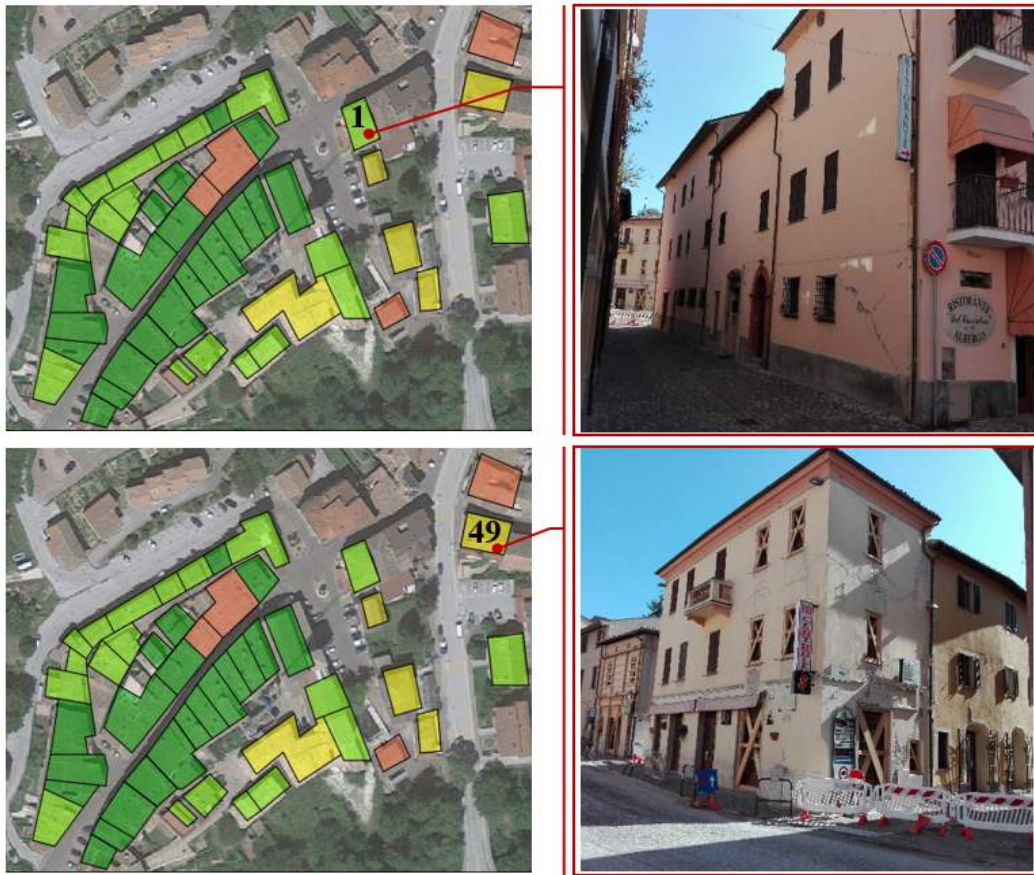
918 Figure 13: Correlation between examined damage scenario and site-inspection.  
919  
920

886  
887  
888 Moreover, considering the event occurred on October 30<sup>th</sup>, the correlation between the empirical  
889 damage scenario and site-inspection recognition have been showed in Fig.13.  
890  
891
