Experimental study of the mechanical behaviour of a new extruded earth block masonry

Experimental study of the mechanical behaviour of a new extruded earth block masonry / Stazi, Francesca; Serpilli, Michele; Chiappini, Gianluca; Pergolini, Marianna; Fratolocchi, Evelina; Lenci, Stefano. - In: CONSTRUCTION AND BUILDING MATERIALS. - ISSN 0950-0618. - ELETTRONICO. - 244:(2020). [10.1016/j.conbuildmat.2020.118368]

Keywords: earth masonry; digital image correlation; shear behaviour; diagonal compression; failure mechanism; compressive behaviour; full-field strain.

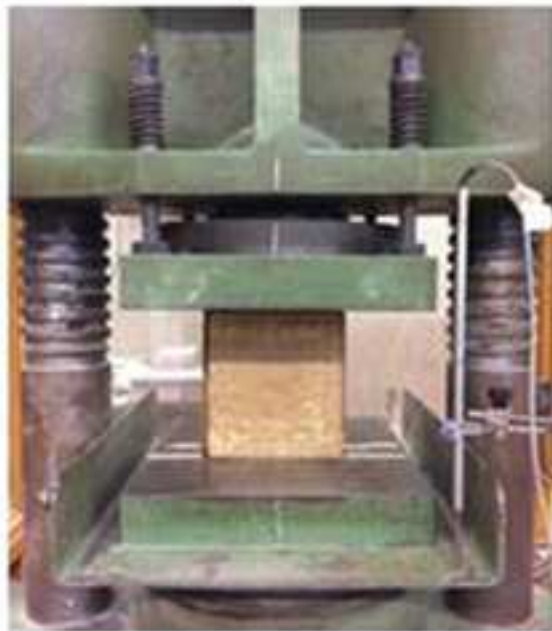
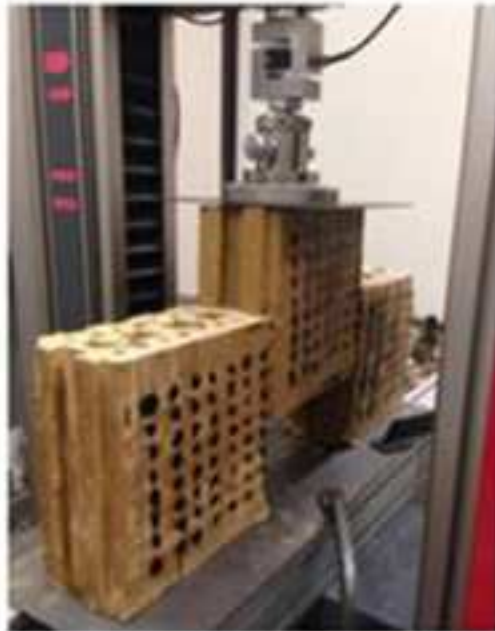
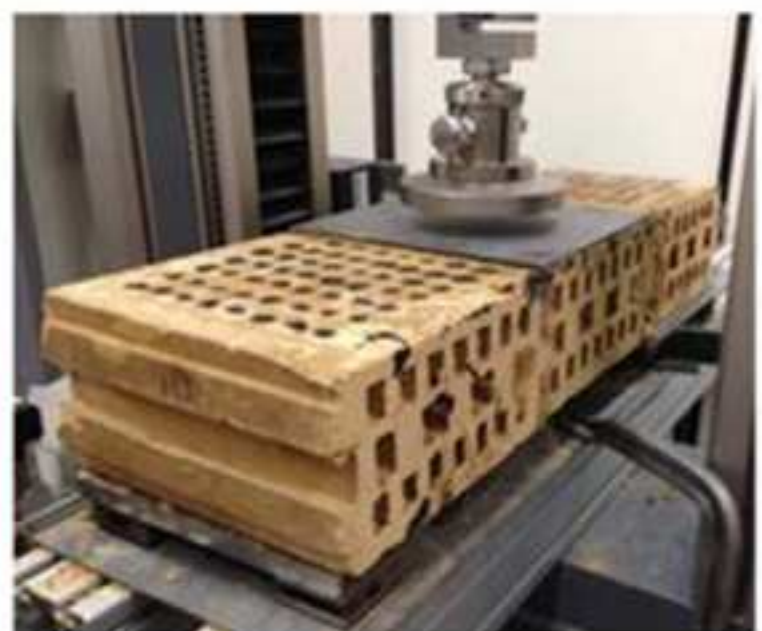
Figure 4  
[Click here to download high resolution image](#)

Fig. 4. DIC set up.

### PRELIMINARY TESTS SET-UP

6  
7 The displacement and deformation of the surface of the wallettes were measured using the 3D-DIC  
8 technique. The region of interest (ROI) on each side of the wallettes has been spray-painted with  
9 black and white texture. Preliminary tests were carried out to define the most suitable dimensions  
10 and intensity of the pattern, following [24]. The experimental set-up is presented in Fig. 4. The  
11 features of the two cameras (model Pixelink® B371F – see insert A in Fig. 4) and the calibration  
12 data are shown in Table 4.  
13  
14  
15  
16  
17

18 A third camera (insert A in Fig. 4) was used to check, with DIC-2D, the displacement and the  
19 deformation of the backside. During the tests, the manometer was coupled with an additional high-  
20 resolution camera that acquired the frames needed to register the pressure trend against time. Then,  
21 compression and tensile strengths values were obtained, according to the relative test standards.  
22  
23  
24

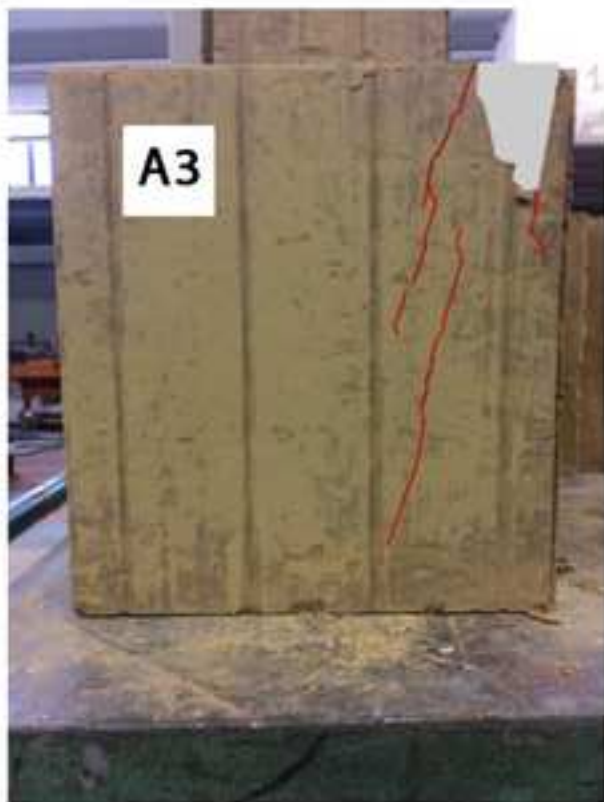
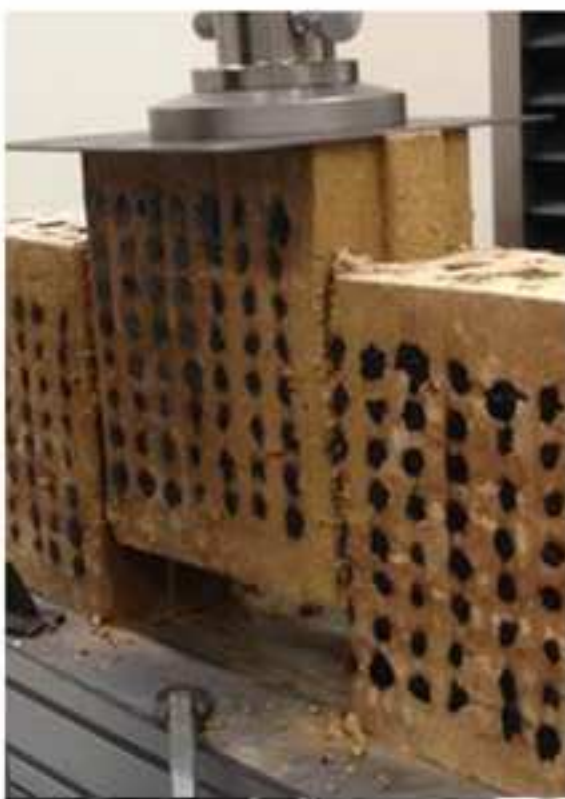
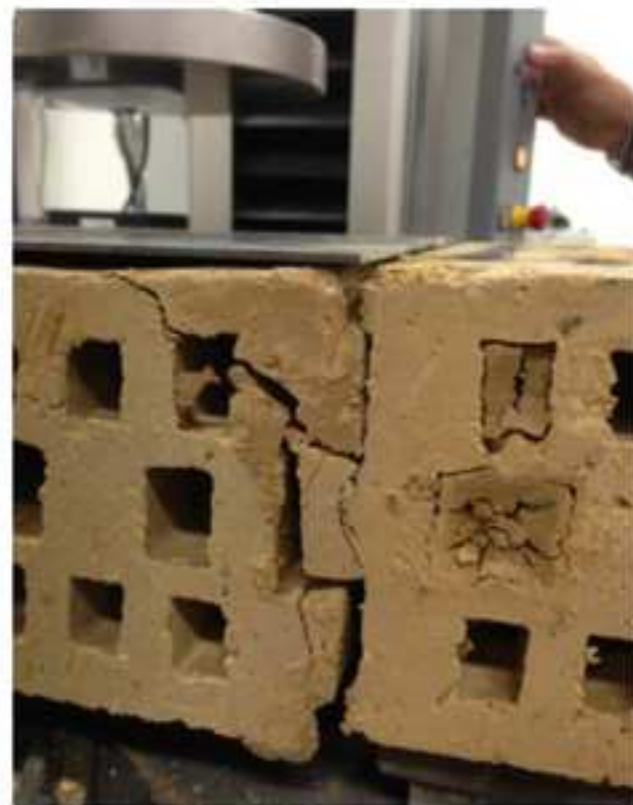
Figure 7  
[Click here to download high resolution image](#)

Fig. 7. Failure modes of (a) the earth block, (b) of the triplet (configuration A) and (c) of the triplet (configuration B).

The failure mode was the same for all the specimens tested, with cracks originating before the peak load (Fig. 7a). Cracks were located on the front and backsides of the blocks, close to the point of application of the load.

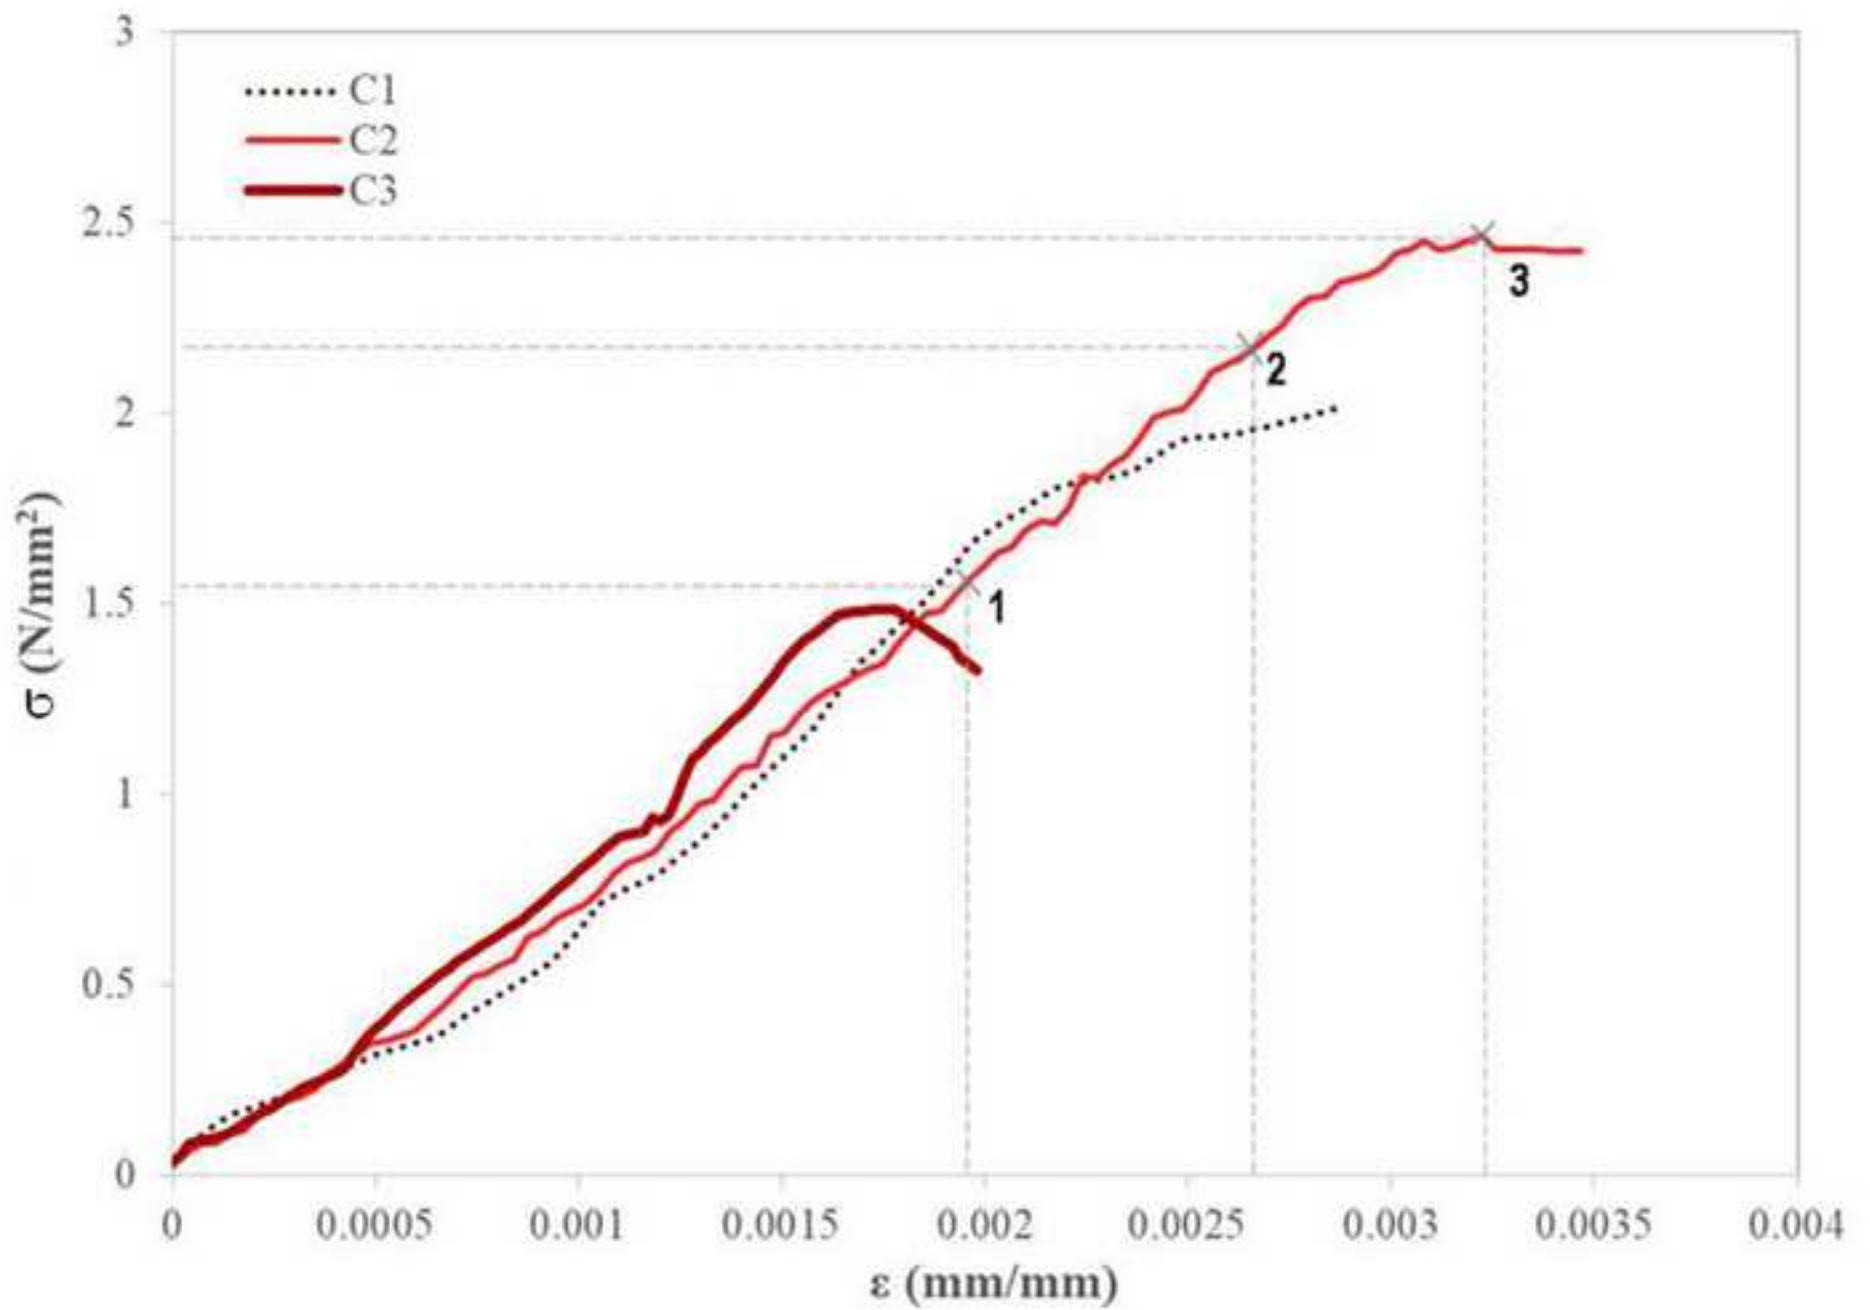
Figure 8  
[Click here to download high resolution image](#)

16 The stress – strain  $\sigma - \varepsilon$  diagrams for the 3 wallettes are shown in Fig. 8, where the strain values  
17 were obtained through DIC and post-processed in MATLAB. The specimens exhibited an  
18 approximately linear behaviour up to the maximum load with a brittle failure.  
19  
20  
21  
22

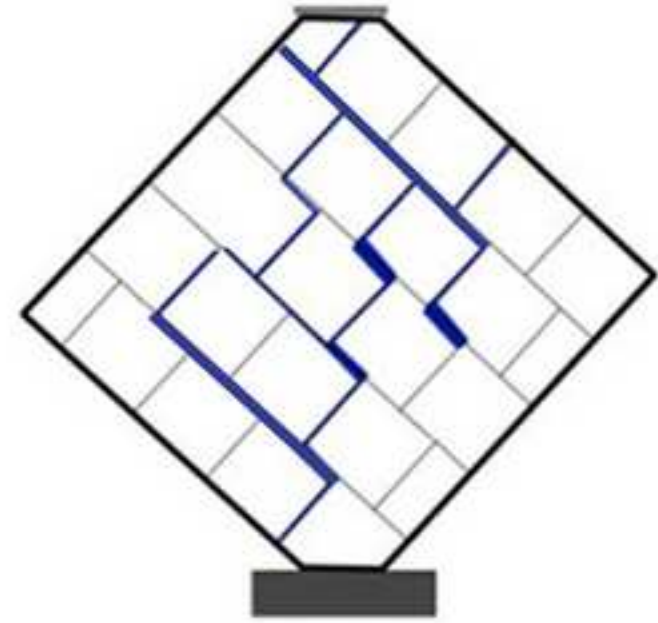
42 The cracks map under a diagonal compression load derived from a visual inspection is presented in  
43 Fig. 13 and is compared with the Von Mises strain map obtained by DIC. All the specimens  
44 exhibited a brittle behavior. Fragile-type cracks originated very close to the normal loading line and  
45 propagated through the joints, without damaging the blocks. At the end of the tests, all the wallettes  
46 were completely disrupted. The DIC successfully reproduced the visual inspection, giving  
47 adjunctive information on the strain field.  
48  
49  
50  
51  
52  
53  
54  
55  
56

Fig. 13. Crack mapping on walette diagonal compression load: (a) Von Mises strain field of the ultimate state and (b) hand-drawn map based on visual inspection.

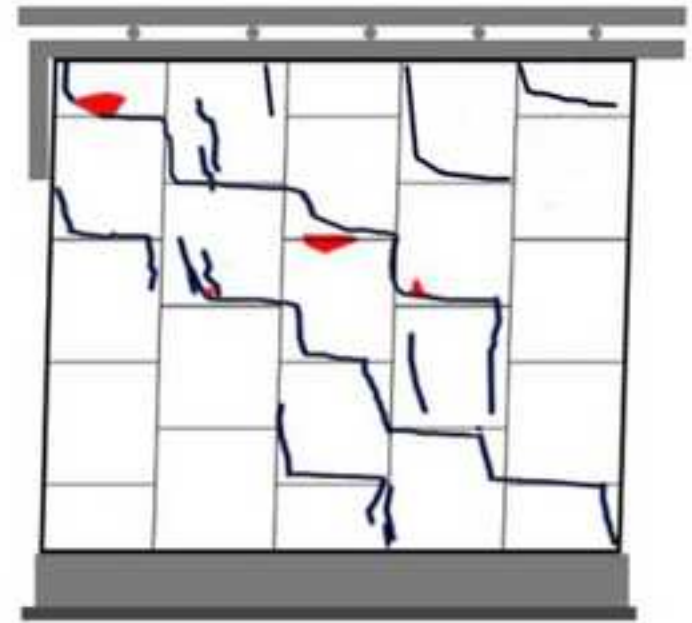
32  
33  
34 The hand-drawn cracks map of the specimens under shear and constant compression load is  
35 compared with the Von Mises strain map in Fig. 16. As expected, the failure mechanism highlights  
36 diagonal staggered fractures following the vertical and horizontal lines of the joints.  
37  
38  
39  
40

8 Fig. 16. Crack mapping on walette under shear and pre-compression load: (a) Von Mises strain  
9 field of the ultimate state and (b) hand-drawn map based on visual inspection.  
10  
11

5 The DIC on shear tests with pre-compression highlighted the formation of cracks along the diagonal  
6 compressive strut following the staggered lines of the bed joints (see Fig. 16). The shear tests was  
7 also evaluated through DIC in [17], [33] and [43]. The former study found quasi-diagonal cracks in  
8 rammed earth walls, while the latter two observed more sharply diagonal cracks for traditional fired  
9 clay and concrete masonry, respectively (Fig. 19c).  
10  
11  
12  
13
