Experimental study of the mechanical behaviour of a new extruded earth block masonry

Experimental study of the mechanical behaviour of a new extruded earth block masonry / Stazi, Francesca; Serpilli, Michele; Chiappini, Gianluca; Pergolini, Marianna; Fratalocchi, Evelina; Lenci, Stefano. - In: CONSTRUCTION AND BUILDING MATERIALS. - ISSN 0950-0618. - ELETTRONICO. - 244:(2020). [10.1016/j.conbuildmat.2020.118368]

Keywords: earth masonry; digital image correlation; shear behaviour; diagonal compression; failure mechanism; compressive behaviour; full-field strain.

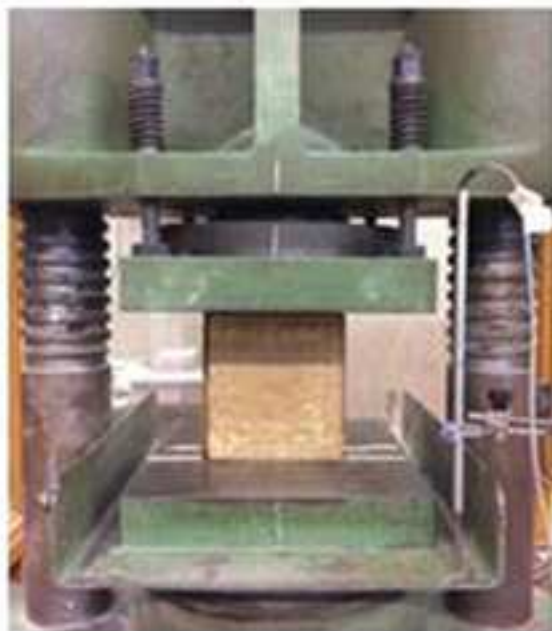
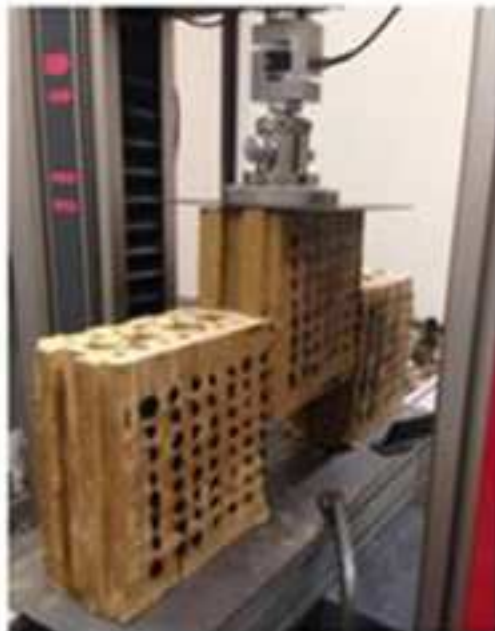
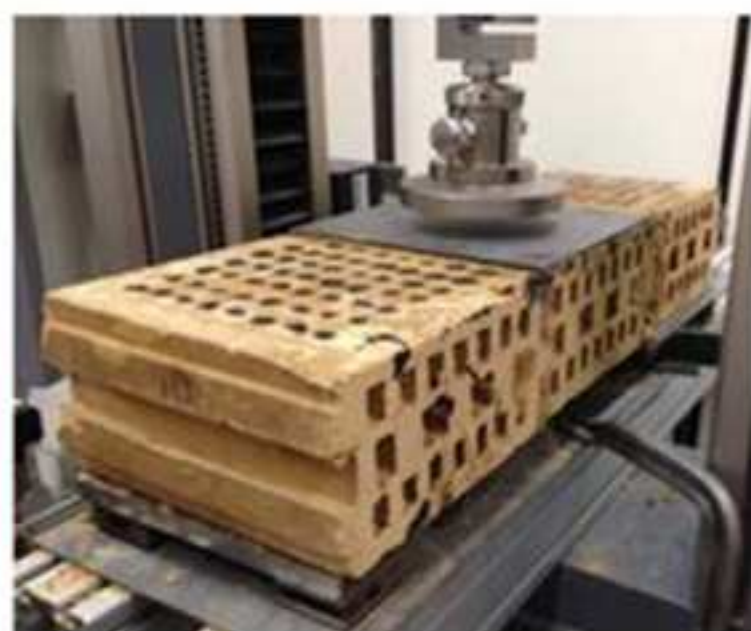
Figure 3
[Click here to download high resolution image](#)

The initial shear strength parallel to the dovetail joints (Fig. 3b) was determined on 3 specimens according to UNI EN 1052-3:2007 standard (Procedure B). The test set up involved the use of two 20-mm thick plates at the top and at the bottom of the specimen. Compressive load was applied on the top plate using of Zwick Roell Z050 testing machine (maximum load of 1000 kN) in force control at a rate of 2645 N/min until failure.

PRELIMINARY TESTS SET-UP

The initial shear strength parallel to the dovetail joints (Fig. 3b) was determined on 3 specimens according to UNI EN 1052-3:2007 standard (Procedure B). The test set up involved the use of two 20-mm thick plates at the top and at the bottom of the specimen. Compressive load was applied on the top plate using of Zwick Roell Z050 testing machine (maximum load of 1000 kN) in force control at a rate of 2645 N/min until failure.

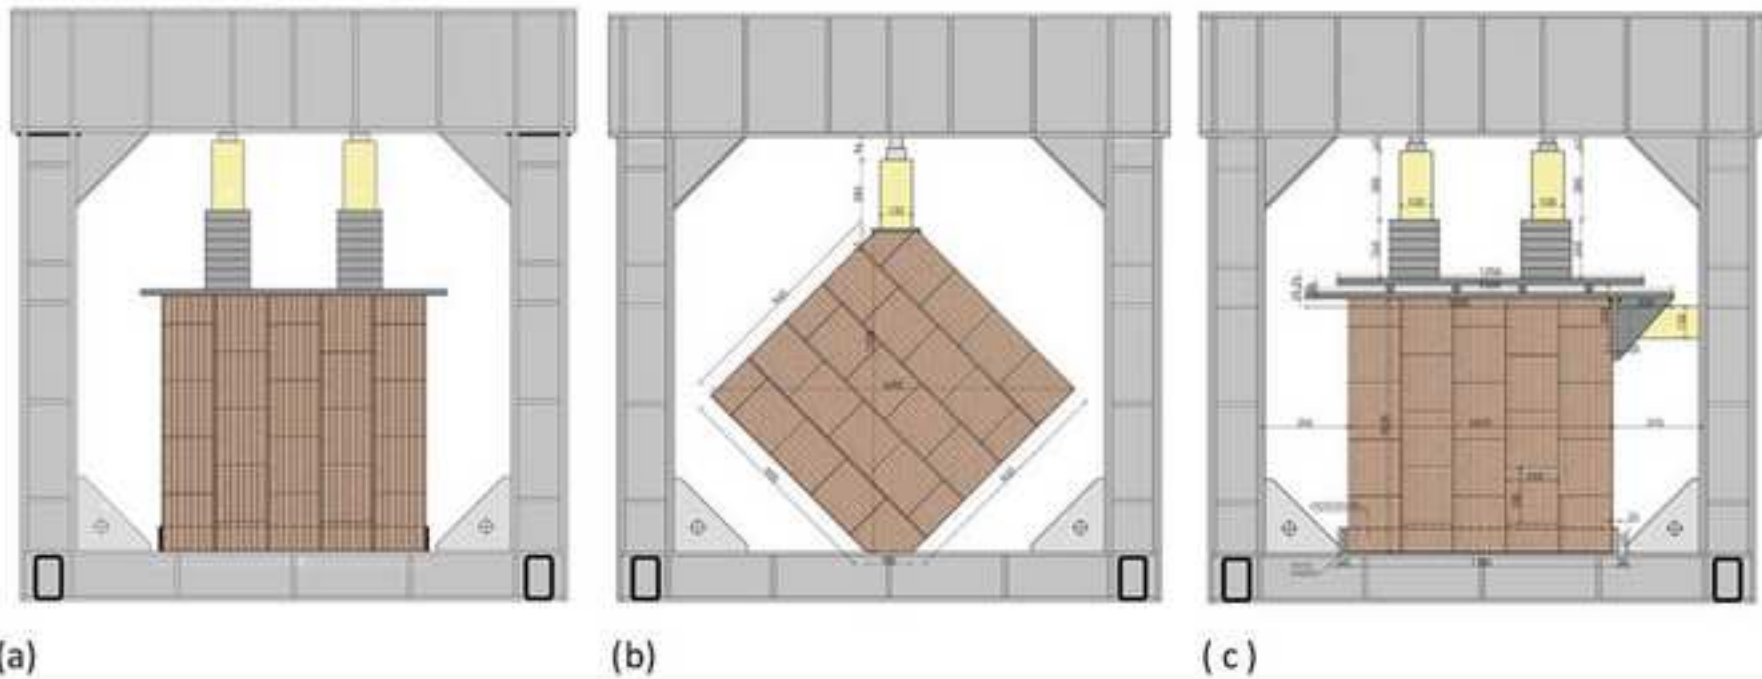
Figure 6
[Click here to download high resolution image](#)

MAIN PHASE: TESTS SET-UP

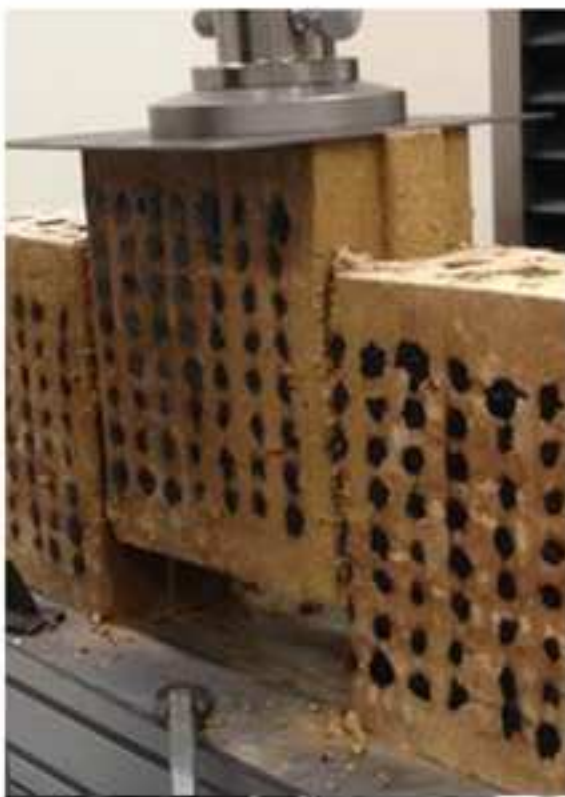
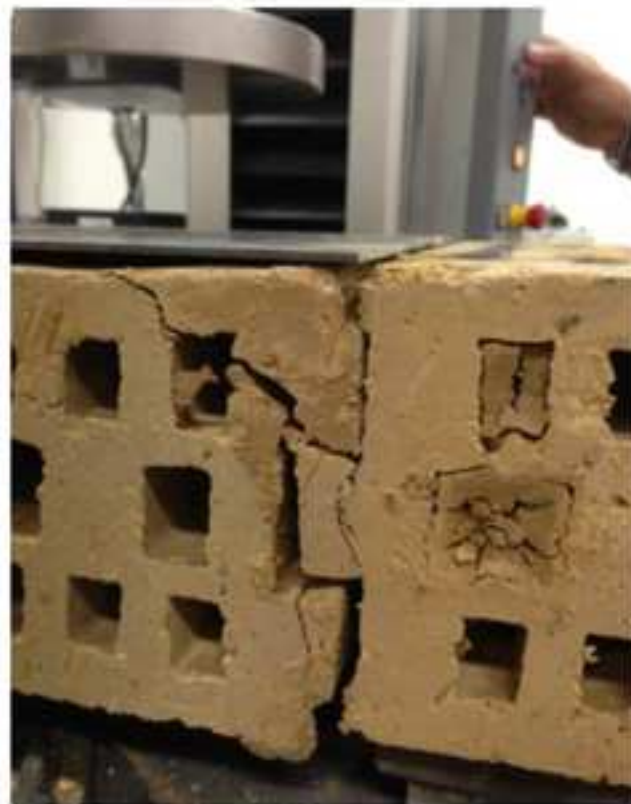
Figure 7
[Click here to download high resolution image](#)

The failure mode was the same for all the specimens tested, with cracks originating before the peak load (Fig. 7a). Cracks were located on the front and backsides of the blocks, close to the point of application of the load.

Fig. 7. Failure modes of (a) the earth block, (b) of the triplet (configuration A) and (c) of the triplet (configuration B).

The failure mode was the same for all the specimens tested, with cracks originating before the peak load (Fig. 7a). Cracks were located on the front and backsides of the blocks, close to the point of application of the load.

Fig. 7. Failure modes of (a) the earth block, (b) of the triplet (configuration A) and (c) of the triplet (configuration B).

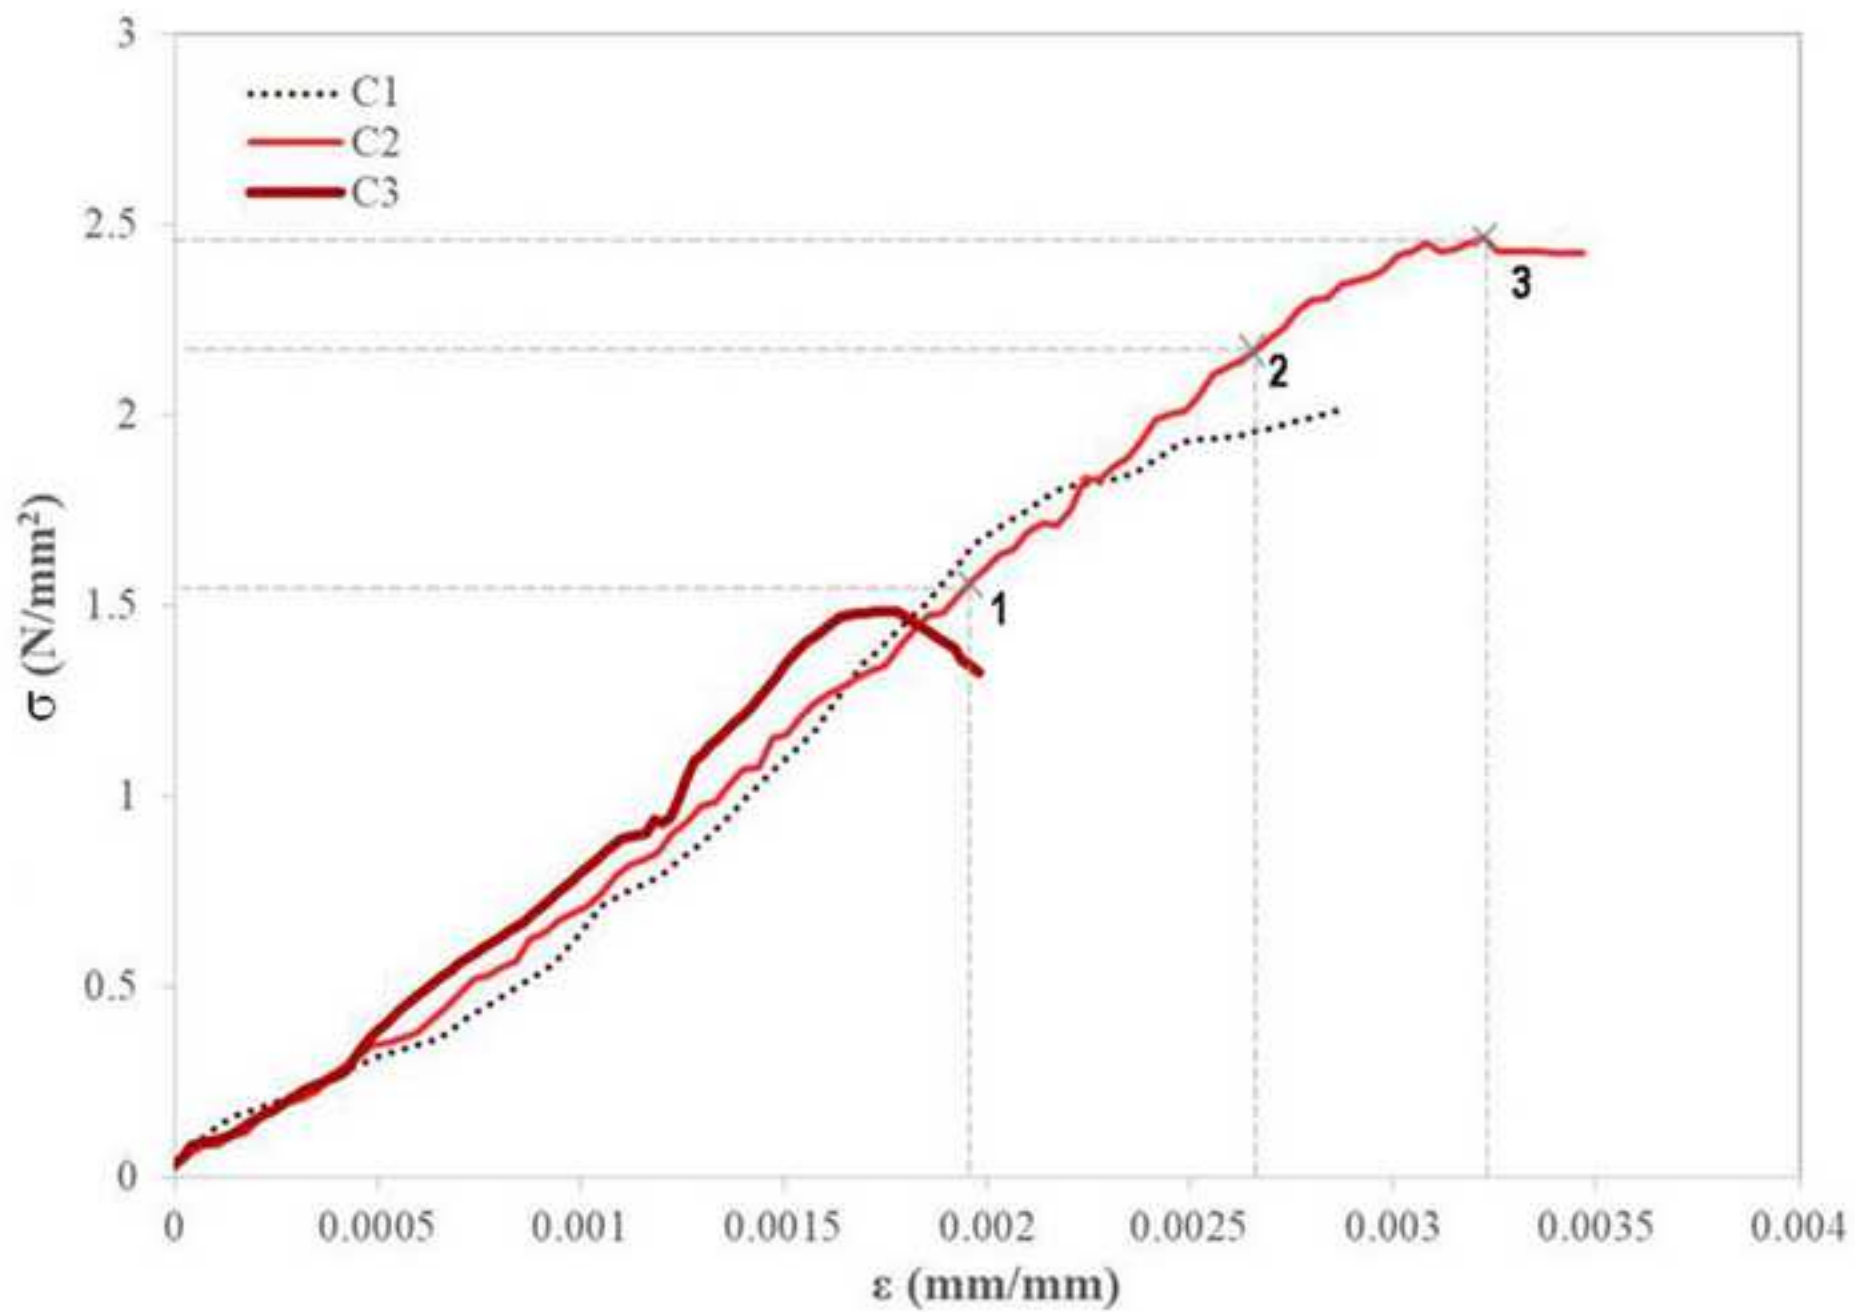
Figure 8
[Click here to download high resolution image](#)

The stress – strain $\sigma - \varepsilon$ diagrams for the 3 wallettes are shown in Fig. 8, where the strain values were obtained through DIC and post-processed in MATLAB. The specimens exhibited an approximately linear behaviour up to the maximum load with a brittle failure.

The stress – strain $\sigma - \varepsilon$ diagrams for the 3 wallettes are shown in Fig. 8, where the strain values were obtained through DIC and post-processed in MATLAB. The specimens exhibited an approximately linear behaviour up to the maximum load with a brittle failure.

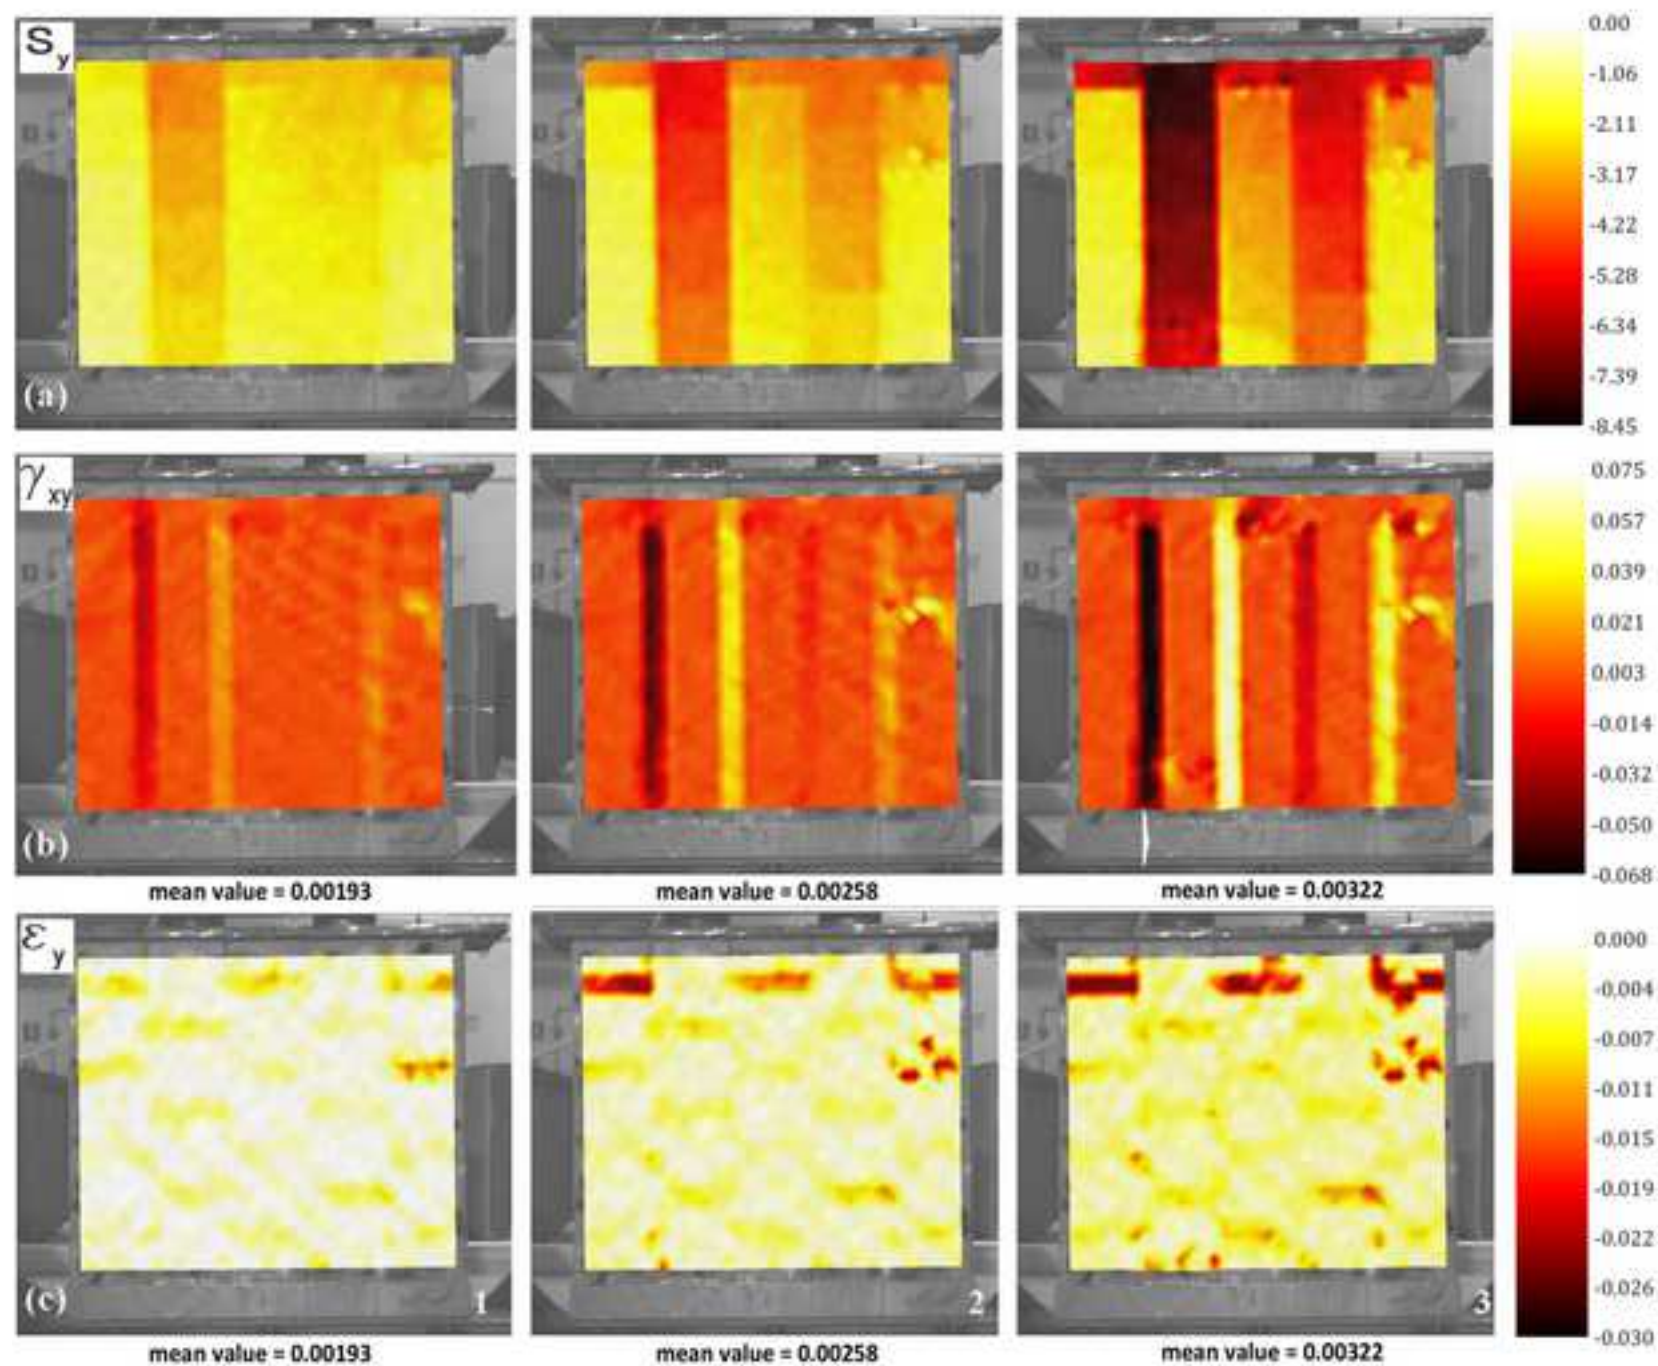
Figure 9
[Click here to download high resolution image](#)

From the evolution of s_y it could be noted that the wall behaves as a series of independent slender adjacent columns (Fig. 9a). Indeed, the alignment of the vertical joints avoids the uniform downward distribution of the load. This behavior leads to a modest out-of-plane instability phenomenon (confirmed by the 3D-DIC), which is mitigated by the presence of the dovetail joints. The “column effect” is also visible by the evolution of the γ_{xy} that registered high relative sliding between the vertical members (Fig. 9b). As expected, the ε_y is uniformly distributed on the ROI surface with some evident areas of strain concentration (Fig. 9c).

From the evolution of s_y it could be noted that the wall behaves as a series of independent slender adjacent columns (Fig. 9a). Indeed, the alignment of the vertical joints avoids the uniform downward distribution of the load. This behavior leads to a modest out-of-plane instability phenomenon (confirmed by the 3D-DIC), which is mitigated by the presence of the dovetail joints. The “column effect” is also visible by the evolution of the γ_{xy} that registered high relative sliding between the vertical members (Fig. 9b). As expected, the ε_y is uniformly distributed on the ROI surface with some evident areas of strain concentration (Fig. 9c).

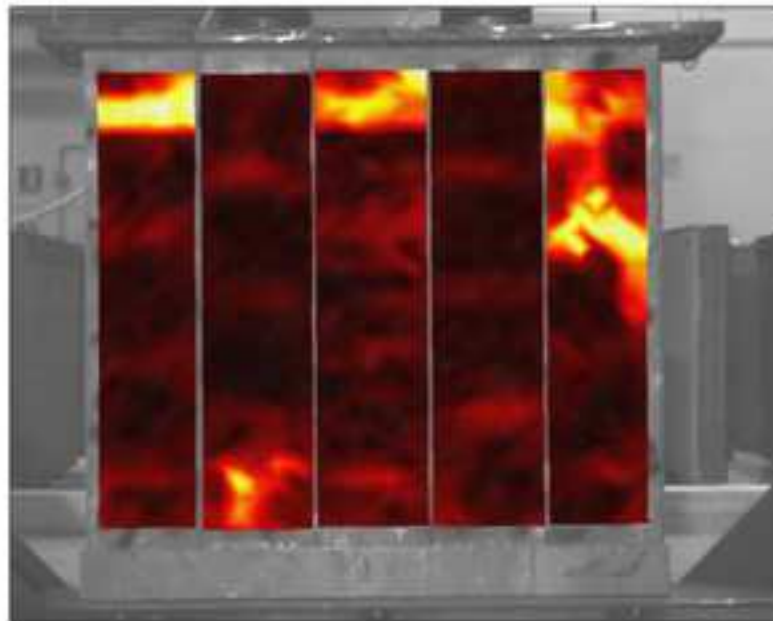
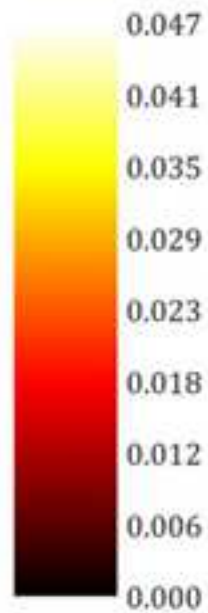
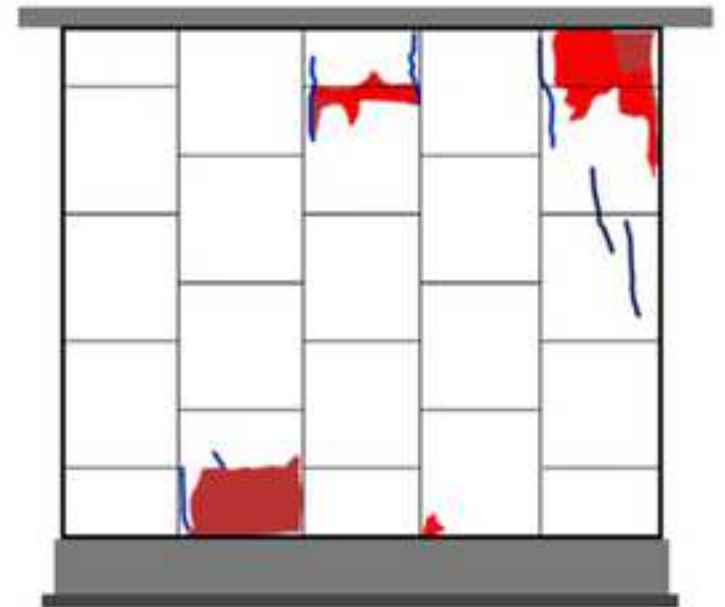
Figure 10

The cracks map under uniaxial compression load obtained through a visual survey is compared with the Von Mises strain map obtained by DIC, in Fig. 10. The cracks propagated from the upper region of the specimens along the masonry surface, with clay expulsions in proximity of the applied force.

The DIC results confirm those obtained by visual inspection and highlight more in detail the weak points. Some vertical cracks, not referable to typical tensile block failures, are located in the proximity of the wall top edge due to an expulsion mechanism.

Fig. 10. Crack mapping on wallette under compression load: (a) Von Mises strain field of the ultimate state and (b) hand-drawn map based on visual inspection.

The DIC applied on compression tests (see Fig. 10 and Fig. 19a) revealed the absence of tensile block failure characterized by vertical cracks through the blocks that typically occurs under compression in traditional brick masonries (e.g. [41]) and earthen block masonries with horizontal courses (e.g. [13]). This behaviour is due to the lack in the present wall of a deformable mortar layer, which causes horizontal tensions within the blocks. Moreover, the crack pattern in the present work reveals also a different failure behaviour respect to the one observed in rammed earth wallettes (see e.g. [14]), characterized by the formation of cone shaped cracks at the upper and lower regions.

The cracks map under uniaxial compression load obtained through a visual survey is compared with the Von Mises strain map obtained by DIC, in Fig. 10. The cracks propagated from the upper region of the specimens along the masonry surface, with clay expulsions in proximity of the applied force.

The DIC results confirm those obtained by visual inspection and highlight more in detail the weak points. Some vertical cracks, not referable to typical tensile block failures, are located in the proximity of the wall top edge due to an expulsion mechanism.

Fig. 10. Crack mapping on wallette under compression load: (a) Von Mises strain field of the ultimate state and (b) hand-drawn map based on visual inspection.

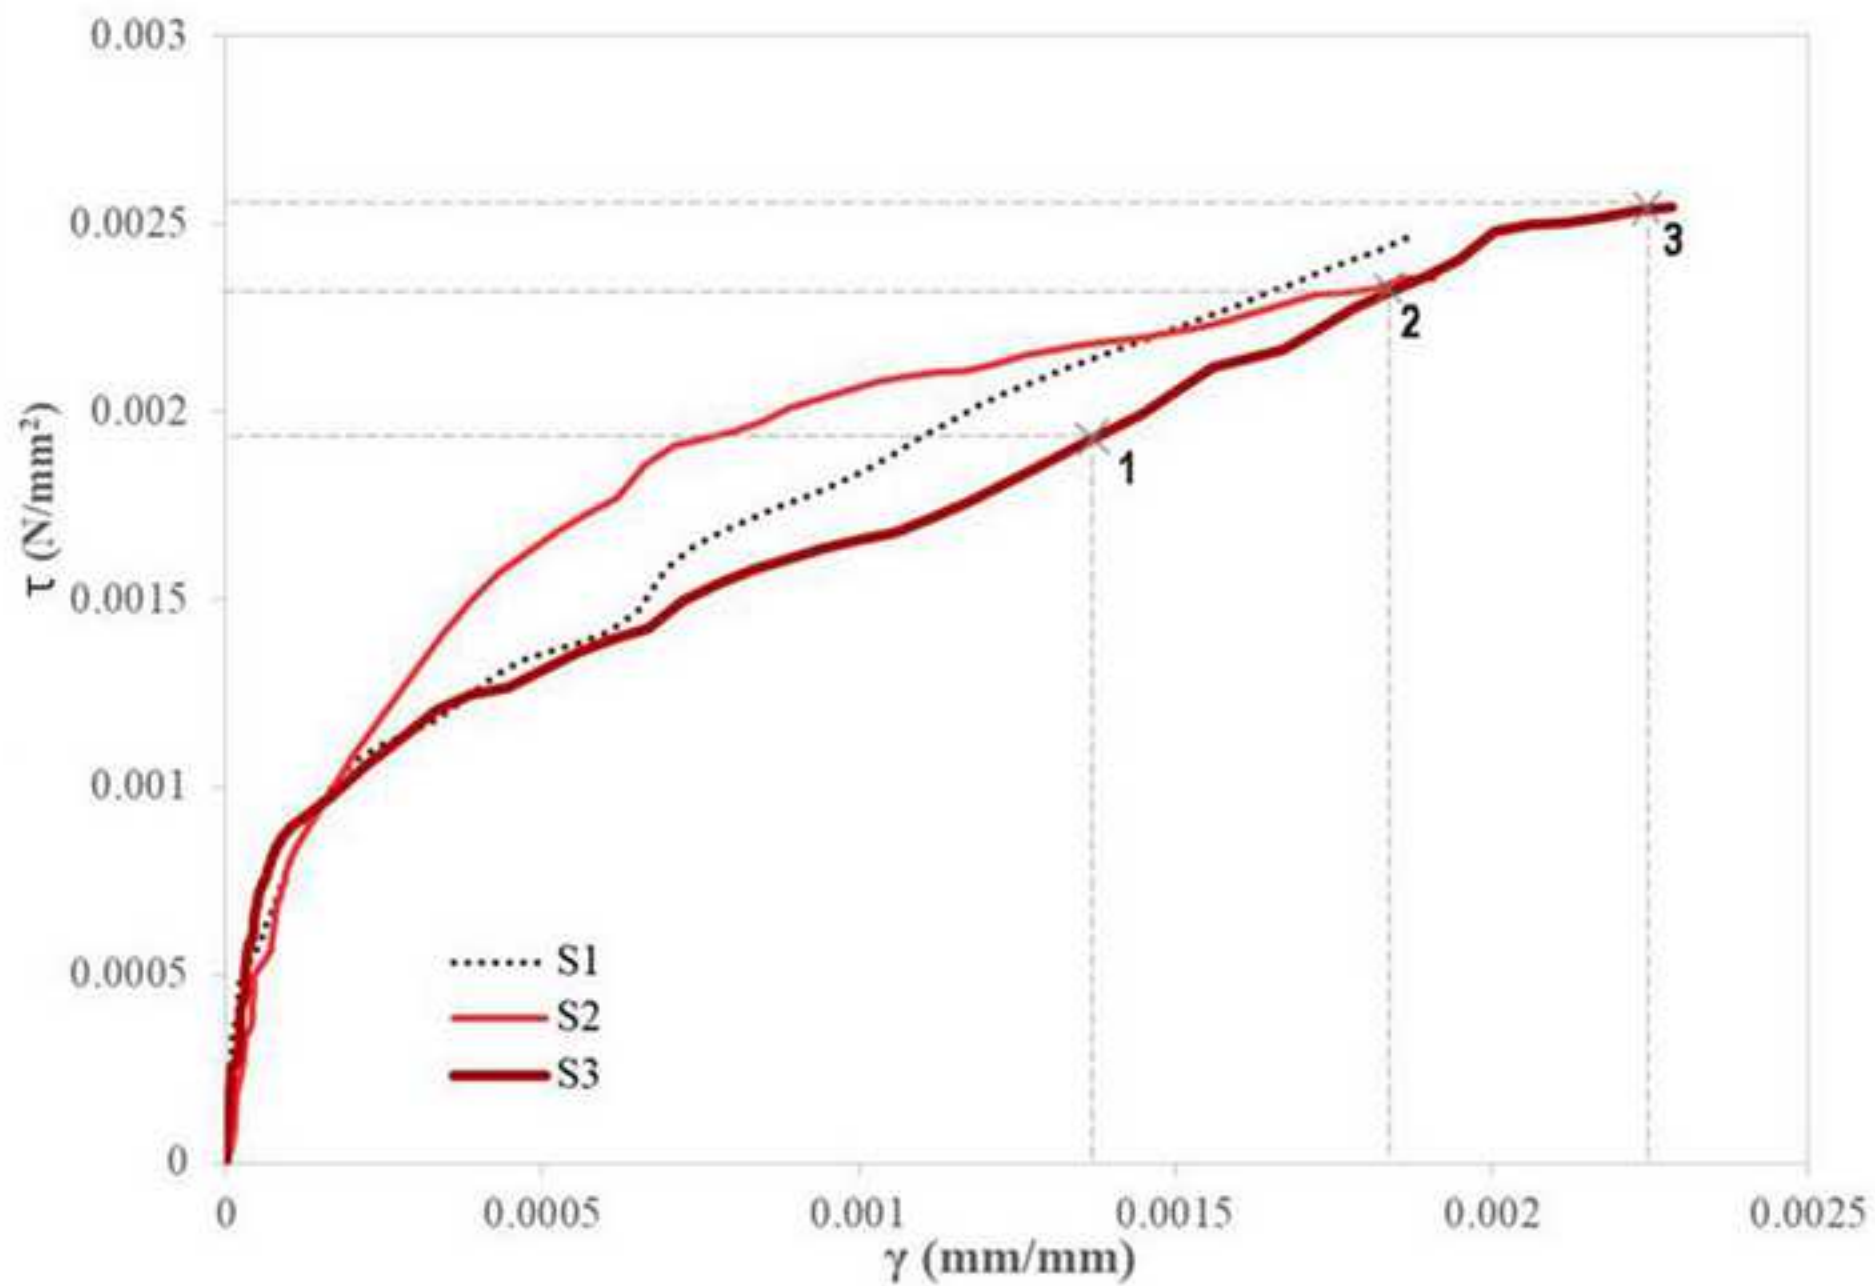
Figure 11
[Click here to download high resolution image](#)

The shear stress–strain $\tau - \gamma$ curves for the 3 wallettes are presented in Fig. 11. It can be noted a distinctive yield point when elasticity of the specimen is exceeded and first cracks appeared. The tensile strength τ_m , shear modulus G and shear strain γ of the wallettes are reported in Table 8. The diagonal compression test registered a very low average strength value τ_m (0.002 N/mm^2). This value is due to the specific construction technique which relies only on the friction between the horizontal and the vertical dovetail joints since the thin mortar layer is characterized by low resistance.

The shear stress–strain $\tau - \gamma$ curves for the 3 wallettes are presented in Fig. 11. It can be noted a distinctive yield point when elasticity of the specimen is exceeded and first cracks appeared. The tensile strength τ_m , shear modulus G and shear strain γ of the wallettes are reported in Table 8. The diagonal compression test registered a very low average strength value τ_m (0.002 N/mm^2). This value is due to the specific construction technique which relies only on the friction between the horizontal and the vertical dovetail joints since the thin mortar layer is characterized by low resistance.

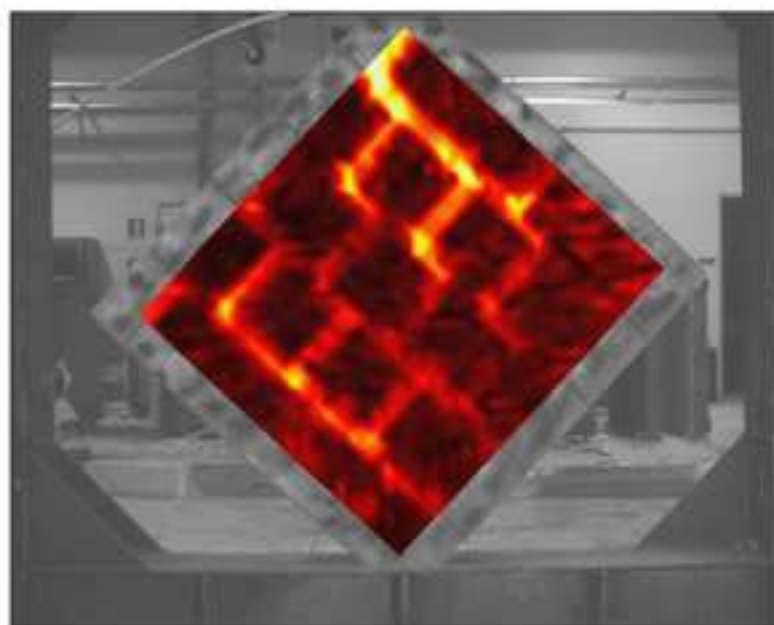
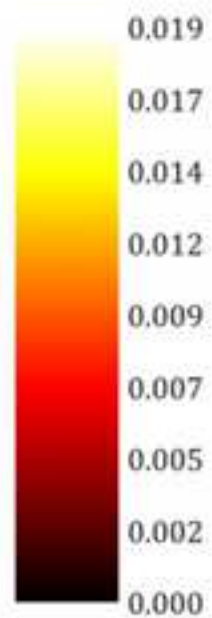
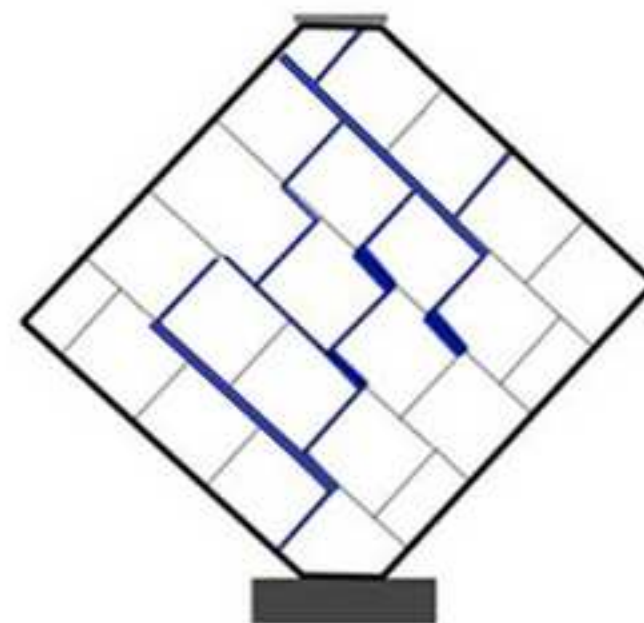
Figure 13

The cracks map under a diagonal compression load derived from a visual inspection is presented in Fig. 13 and is compared with the Von Mises strain map obtained by DIC. All the specimens exhibited a brittle behavior. Fragile-type cracks originated very close to the normal loading line and propagated through the joints, without damaging the blocks. At the end of the tests, all the wallettes were completely disrupted. The DIC successfully reproduced the visual inspection, giving adjunctive information on the strain field.

Fig. 13. Crack mapping on wallette diagonal compression load: (a) Von Mises strain field of the ultimate state and (b) hand-drawn map based on visual inspection.

The cracks map under a diagonal compression load derived from a visual inspection is presented in Fig. 13 and is compared with the Von Mises strain map obtained by DIC. All the specimens exhibited a brittle behavior. Fragile-type cracks originated very close to the normal loading line and propagated through the joints, without damaging the blocks. At the end of the tests, all the wallettes were completely disrupted. The DIC successfully reproduced the visual inspection, giving adjunctive information on the strain field.

Fig. 13. Crack mapping on wallette diagonal compression load: (a) Von Mises strain field of the ultimate state and (b) hand-drawn map based on visual inspection.

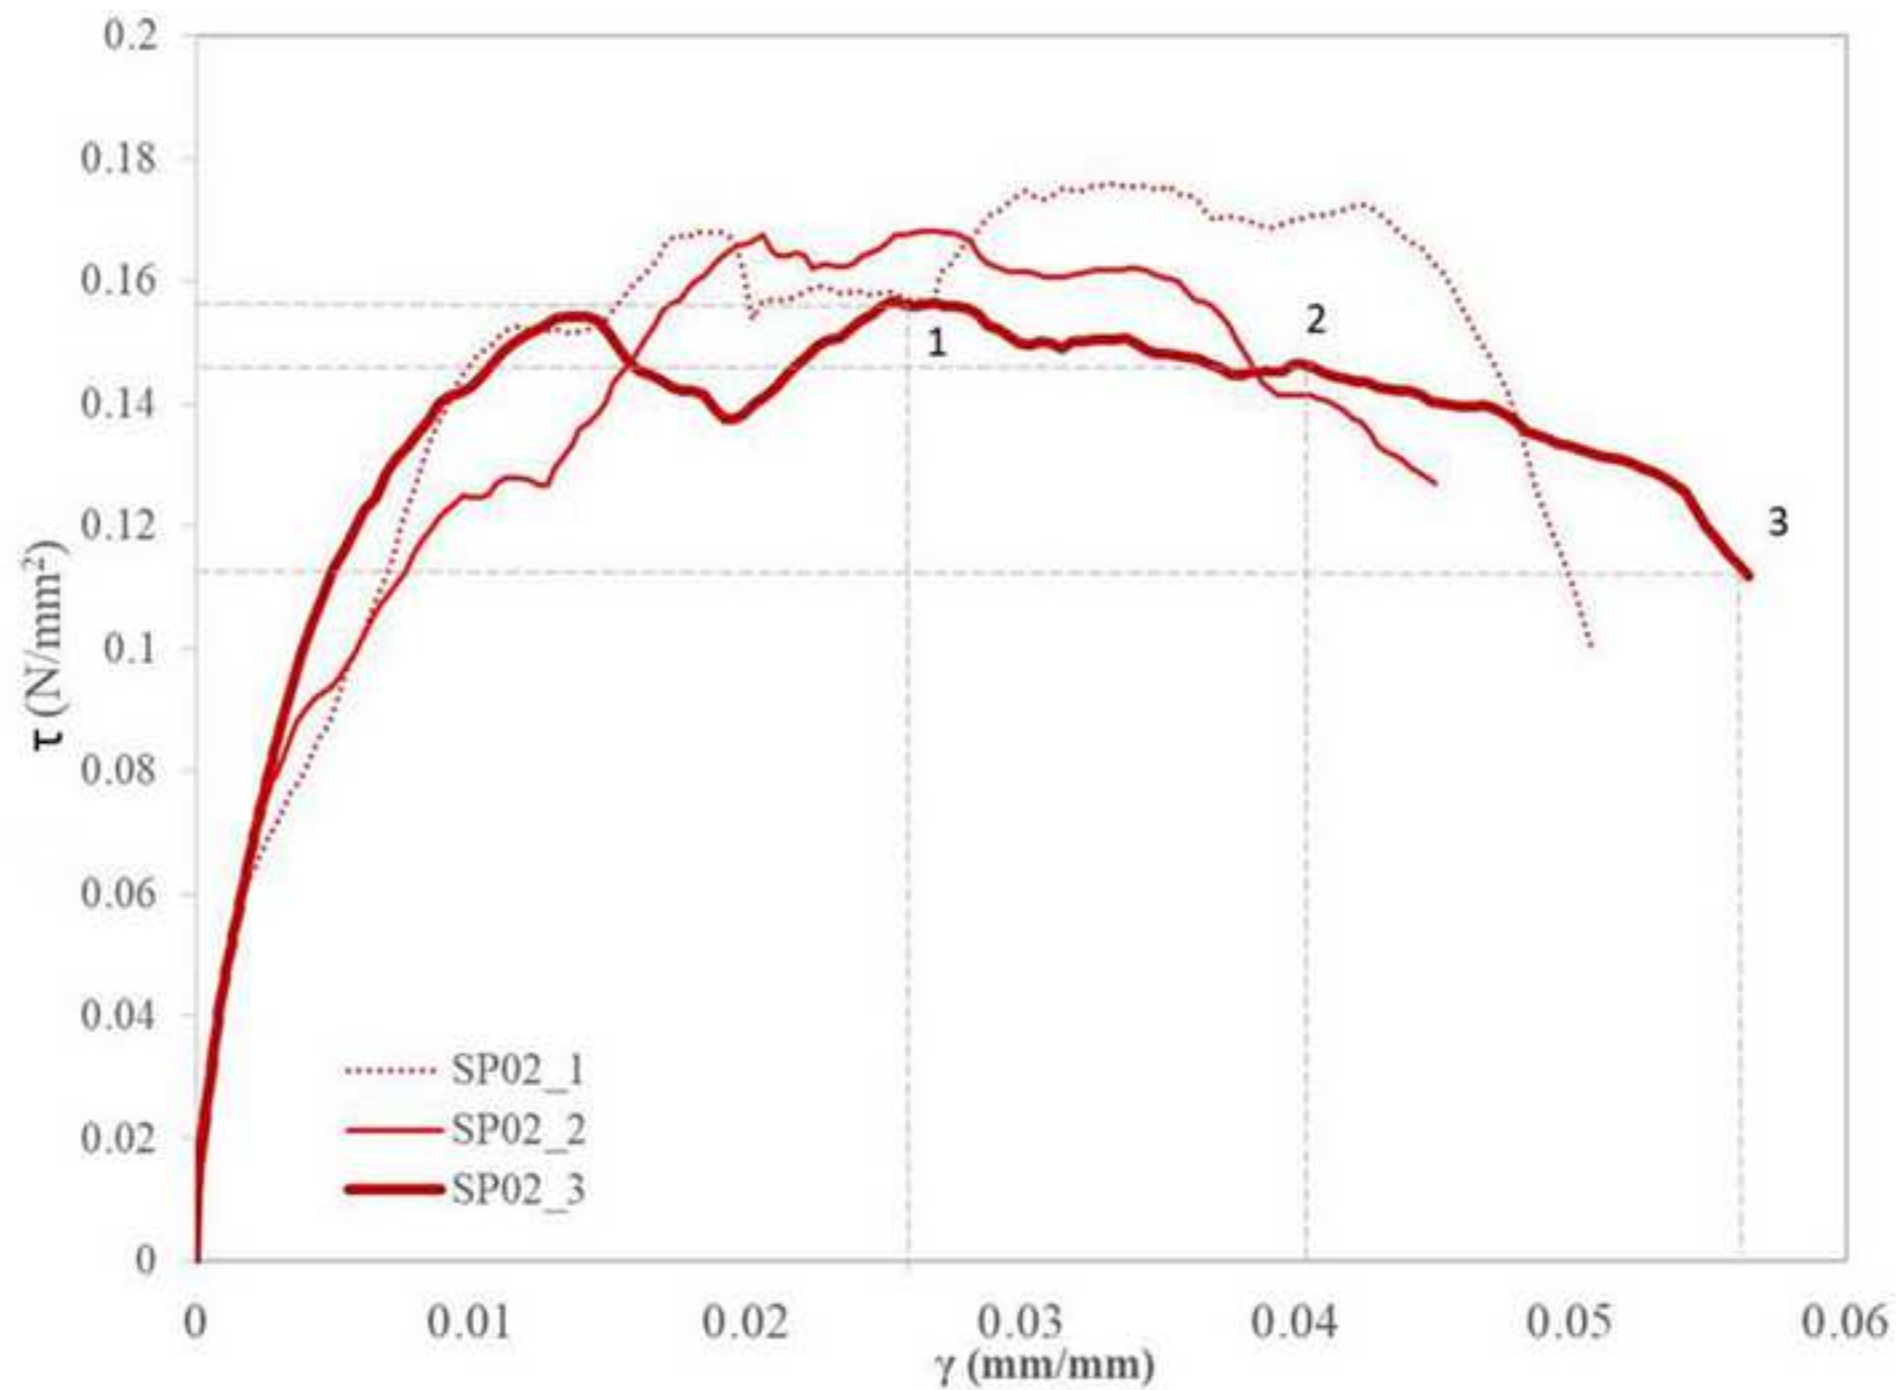
Figure 14
[Click here to download high resolution image](#)

The results of the shear stress–strain τ - γ diagrams for the 3 specimens subject to a pre-compression load of 0.2 N/mm^2 are presented in Fig. 14. In the first part, the curves showed a linear trend until the first crack appeared. Then, a plastic region occurred with formation of other diagonal cracks. The trend showed a ductile behaviour, typical of shear tests with pre-compression. The tensile strength τ_m , shear modulus G and shear strain γ of the wallettes are collected in Table 9. As expected, the test showed a slight increase (about 2.4%) in terms of tensile strength with respect to the diagonal tensile findings without pre-compression.

The results of the shear stress–strain τ - γ diagrams for the 3 specimens subject to a pre-compression load of 0.2 N/mm^2 are presented in Fig. 14. In the first part, the curves showed a linear trend until the first crack appeared. Then, a plastic region occurred with formation of other diagonal cracks. The trend showed a ductile behaviour, typical of shear tests with pre-compression. The tensile strength τ_m , shear modulus G and shear strain γ of the wallettes are collected in Table 9. As expected, the test showed a slight increase (about 2.4%) in terms of tensile strength with respect to the diagonal tensile findings without pre-compression.

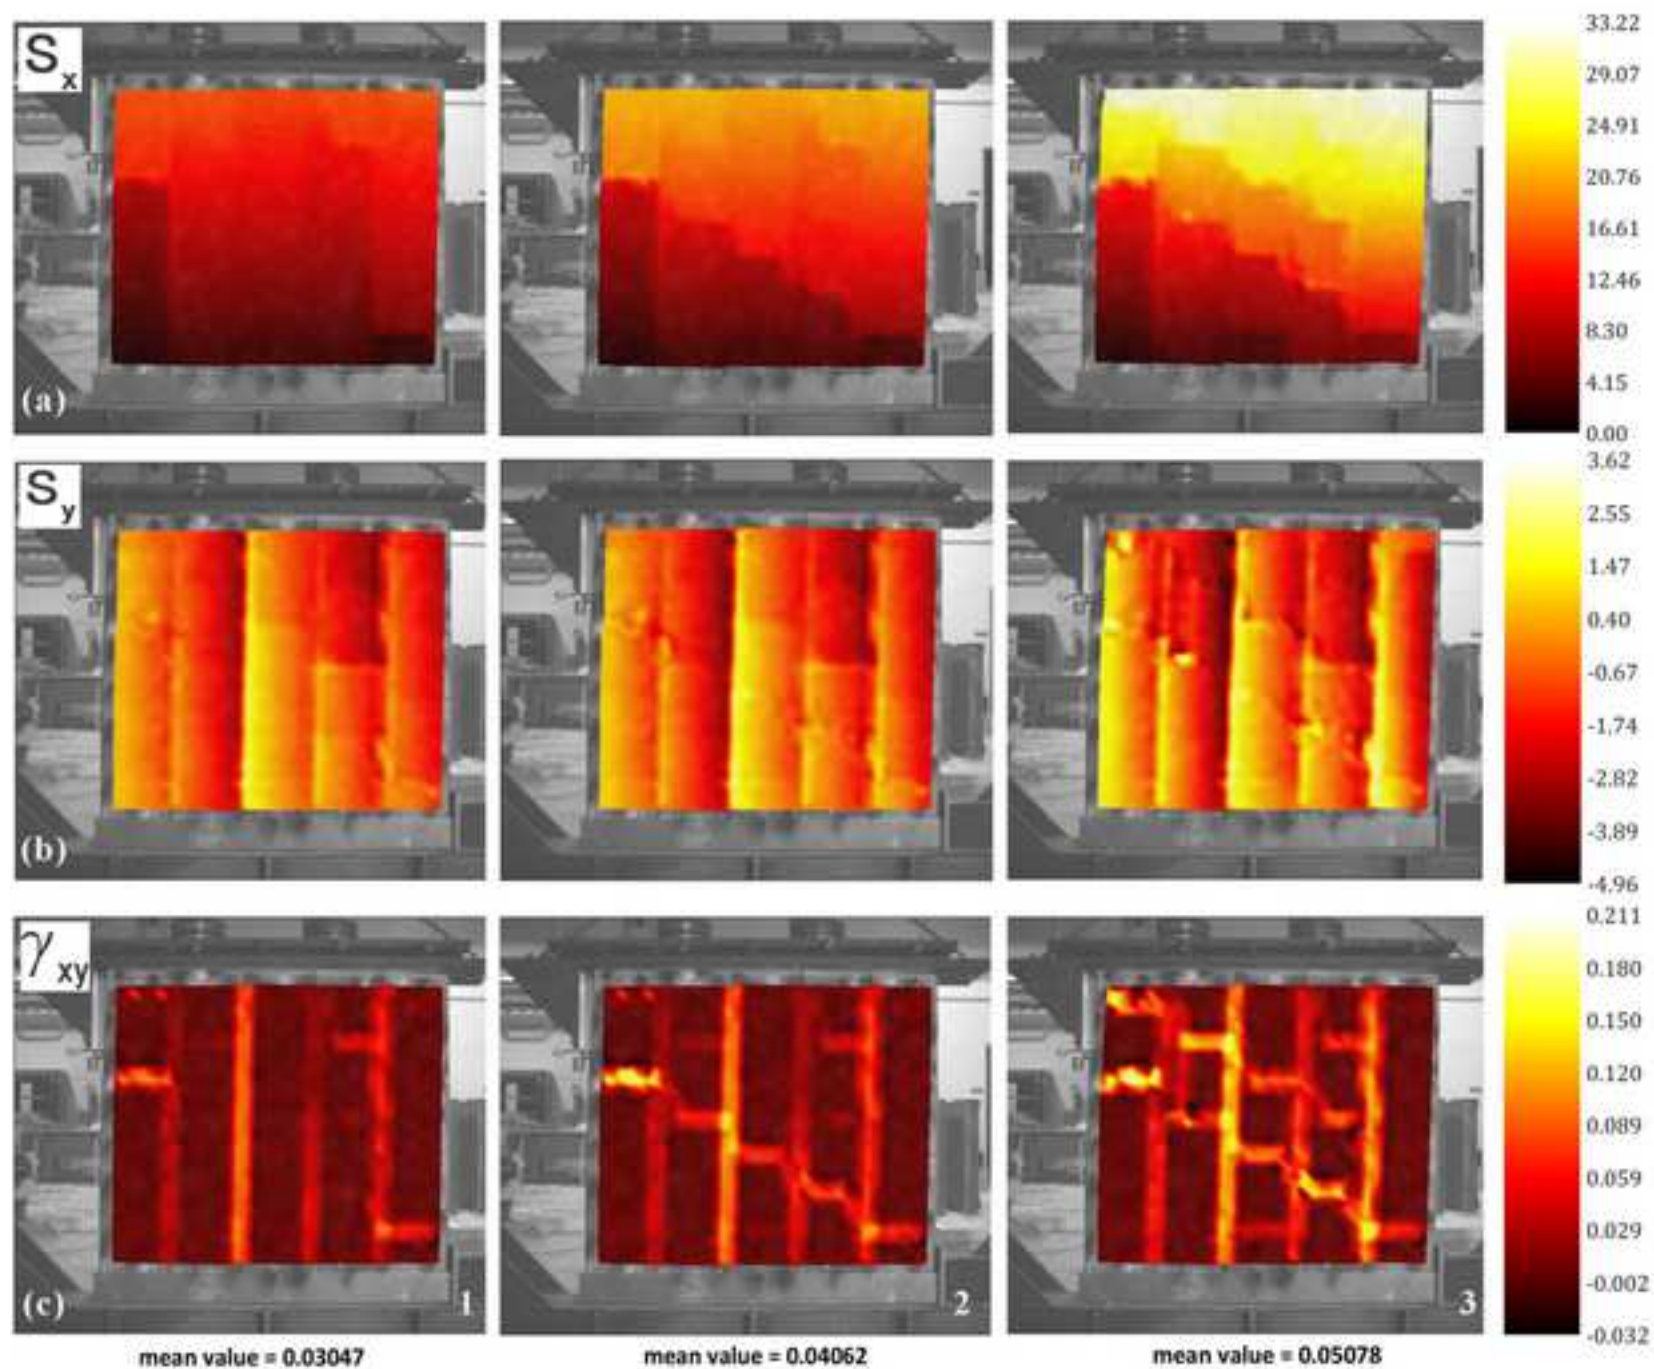
Figure 15
[Click here to download high resolution image](#)

The evolution in time of s_x , s_y and γ_{xy} for the wallettes under shear combined with pre-compression are shown in Fig. 16. As expected, the displacement s_x presented an approximately linear trend along the vertical axis (Fig. 15a). The displacement s_y showed a relevant sliding along the vertical joints. This phenomenon has already been pointed out in the full strain maps of the compression test (Fig. 15b). In the strain γ_{xy} maps, two inclined crack lines originating from the point of application of the shear force were visible (Fig. 15c).

The evolution in time of s_x , s_y and γ_{xy} for the wallettes under shear combined with pre-compression are shown in Fig. 16. As expected, the displacement s_x presented an approximately linear trend along the vertical axis (Fig. 15a). The displacement s_y showed a relevant sliding along the vertical joints. This phenomenon has already been pointed out in the full strain maps of the compression test (Fig. 15b). In the strain γ_{xy} maps, two inclined crack lines originating from the point of application of the shear force were visible (Fig. 15c).

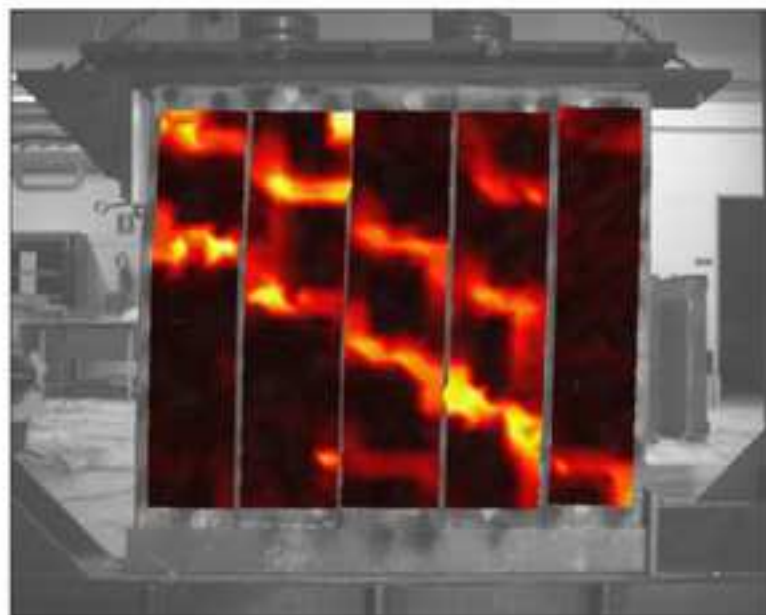
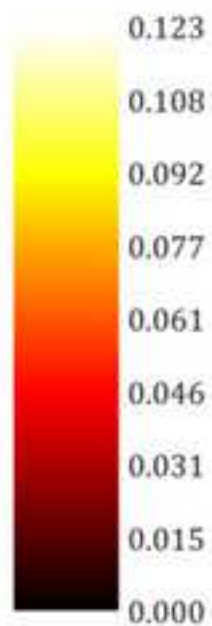
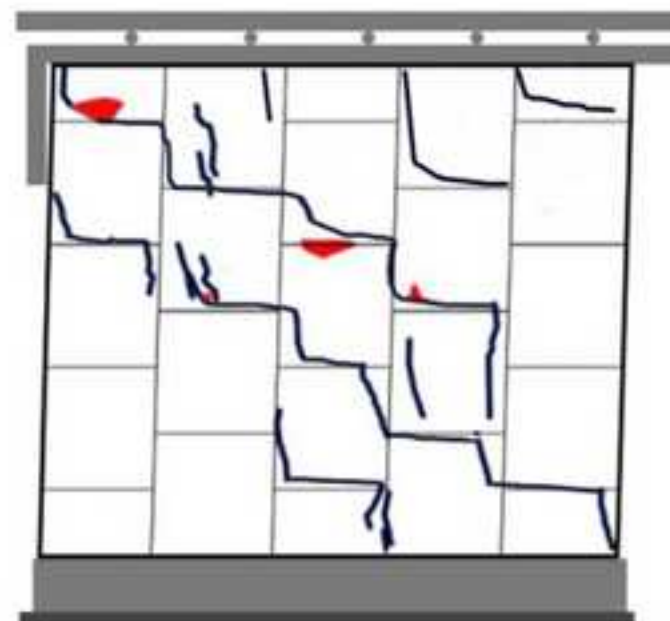
Figure 16

The hand-drawn cracks map of the specimens under shear and constant compression load is compared with the Von Mises strain map in Fig. 16. As expected, the failure mechanism highlights diagonal staggered fractures following the vertical and horizontal lines of the joints.

Fig. 16. Crack mapping on wallette under shear and pre-compression load: (a) Von Mises strain field of the ultimate state and (b) hand-drawn map based on visual inspection.

The DIC on shear tests with pre-compression highlighted the formation of cracks along the diagonal compressive strut following the staggered lines of the bed joints (see Fig. 16). The shear tests was also evaluated through DIC in [17], [33] and [43]. The former study found quasi-diagonal cracks in rammed earth walls, while the latter two observed more sharply diagonal cracks for traditional fired clay and concrete masonry, respectively (Fig. 19c).

The hand-drawn cracks map of the specimens under shear and constant compression load is compared with the Von Mises strain map in Fig. 16. As expected, the failure mechanism highlights diagonal staggered fractures following the vertical and horizontal lines of the joints.

Fig. 16. Crack mapping on wallette under shear and pre-compression load: (a) Von Mises strain field of the ultimate state and (b) hand-drawn map based on visual inspection.
