Experimental study of the mechanical behaviour of a new extruded earth block masonry

Experimental study of the mechanical behaviour of a new extruded earth block masonry / Stazi, Francesca; Serpilli, Michele; Chiappini, Gianluca; Pergolini, Marianna; Fratalocchi, Evelina; Lenci, Stefano. - In: CONSTRUCTION AND BUILDING MATERIALS. - ISSN 0950-0618. - ELETTRONICO. - 244:(2020). [10.1016/j.conbuildmat.2020.118368]

Keywords: earth masonry; digital image correlation; shear behaviour; diagonal compression; failure mechanism; compressive behaviour; full-field strain.

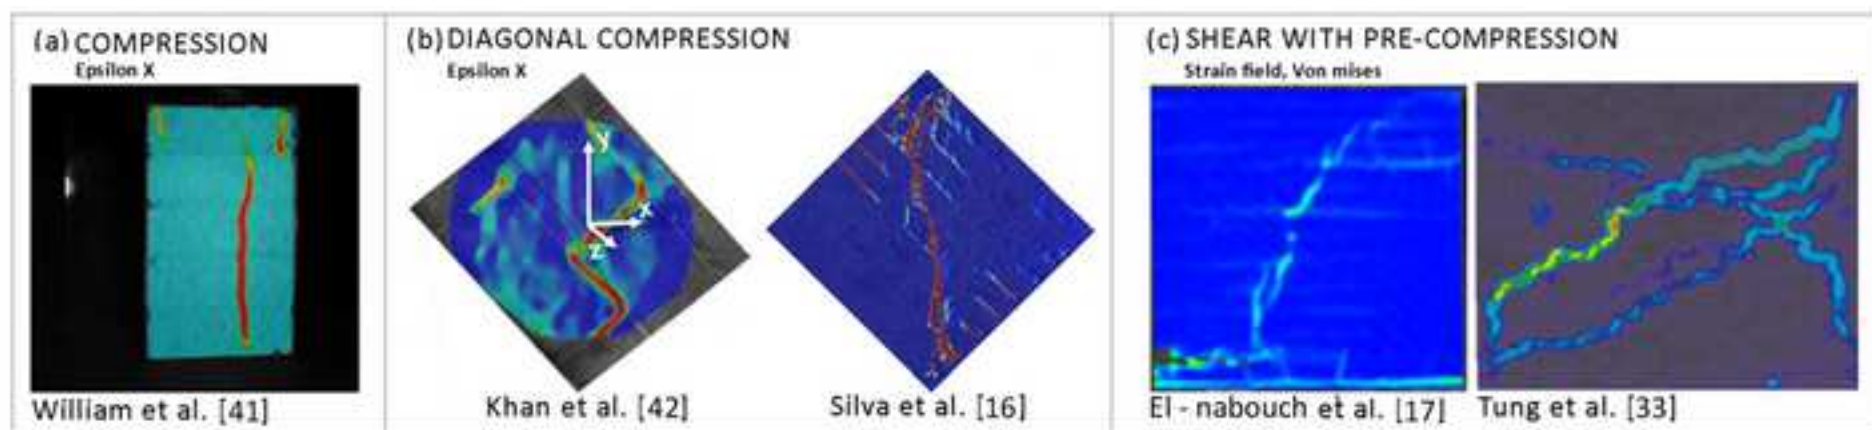
Figure 19
[Click here to download high resolution image](#)

The DIC applied on compression tests (see Fig. 10 and Fig. 19a) revealed the absence of tensile block failure characterized by vertical cracks through the blocks that typically occurs under compression in traditional brick masonries (e.g. [41]) and earthen block masonries with horizontal courses (e.g. [13]). This behaviour is due to the lack in the present wall of a deformable mortar layer, which causes horizontal tensions within the blocks. Moreover, the crack pattern in the present work reveals also a different failure behaviour respect to the one observed in rammed earth wallettes (see e.g. [14]), characterized by the formation of cone shaped cracks at the upper and lower regions.

The DIC on shear tests with pre-compression highlighted the formation of cracks along the diagonal compressive strut following the staggered lines of the bed joints (see Fig. 16). The shear tests was also evaluated through DIC in [17], [33] and [43]. The former study found quasi-diagonal cracks in rammed earth walls, while the latter two observed more sharply diagonal cracks for traditional fired clay and concrete masonry, respectively (Fig. 19c).

The DIC applied on compression tests (see Fig. 10 and Fig. 19a) revealed the absence of tensile block failure characterized by vertical cracks through the blocks that typically occurs under compression in traditional brick masonries (e.g. [41]) and earthen block masonries with horizontal courses (e.g. [13]). This behaviour is due to the lack in the present wall of a deformable mortar layer, which causes horizontal tensions within the blocks. Moreover, the crack pattern in the present work reveals also a different failure behaviour respect to the one observed in rammed earth wallettes (see e.g. [14]), characterized by the formation of cone shaped cracks at the upper and lower regions.

The DIC on shear tests with pre-compression highlighted the formation of cracks along the diagonal compressive strut following the staggered lines of the bed joints (see Fig. 16). The shear tests was also evaluated through DIC in [17], [33] and [43]. The former study found quasi-diagonal cracks in rammed earth walls, while the latter two observed more sharply diagonal cracks for traditional fired clay and concrete masonry, respectively (Fig. 19c).
