RC beam models damaged and strengthened with GFRP strips under bending loading and free vibration

RC beam models damaged and strengthened with GFRP strips under bending loading and free vibration / Capozucca, R., Magagnini, E.. - In: COMPOSITE STRUCTURES. - ISSN 0263-8223. - STAMPA. - 253:(2020). [10.1016/j.compstruct.2020.112730]

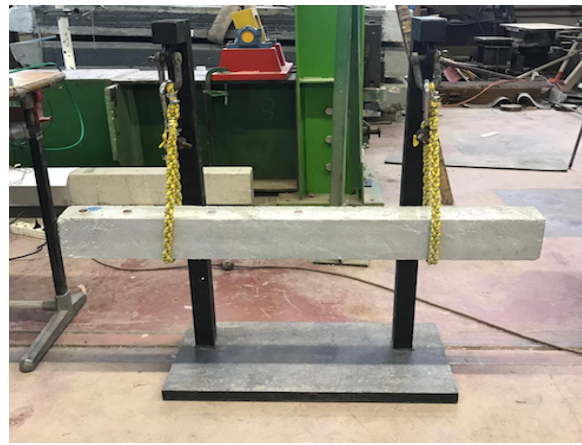
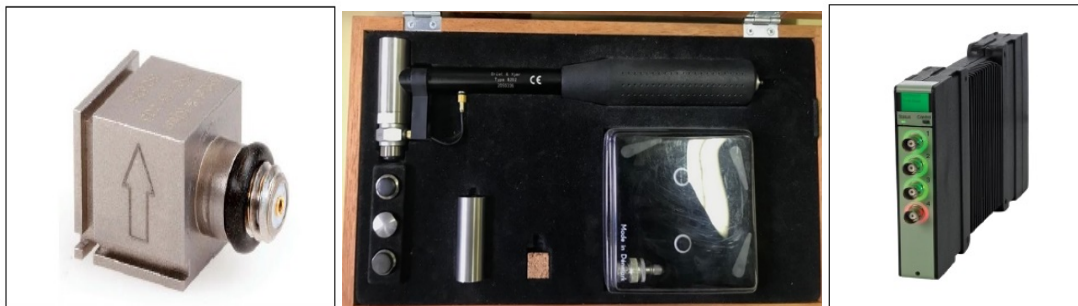
[2] 1. Beam 2. Accelerometer 3. Impact hammer 4. Analyzer FFT

Figure 2 – (a) RC beam hung to elastic springs and (b) set up for vibration tests.

The experimental response of the three beam models A, B and C was analyzed both undamaged and damaged by notching on the concrete cover in different sections using dynamic tests considering free-free ends condition obtained by a suspension system (Fig. 2(a)). Successively, after the strengthening with external bonded (EB) GFRP strips was subjected to cyclic static bending tests and at each step of loading analysed again under free vibration tests.

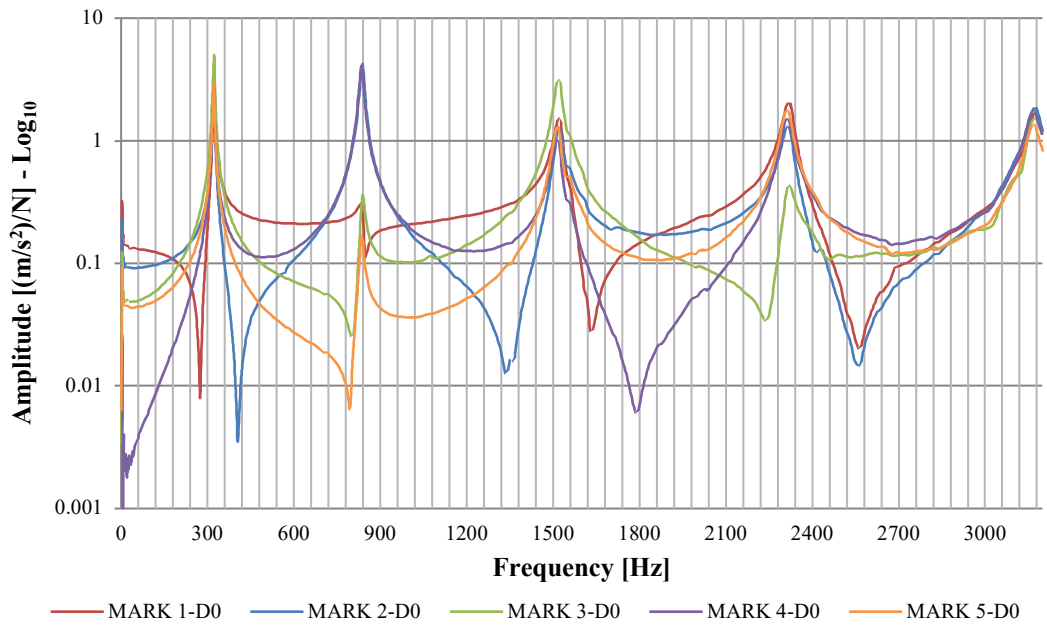
Figure 3 – Envelope of FRF by vibration tests on RC beam model (D0).

By considering only the first four values of the eigenvalue λ_r^f and substituting the parameters of the experimental prototype shown in Table 1, the first four theoretical natural frequencies were calculated for the undamaged beam (Tab. 2). These frequencies were compared with the experimental frequencies recorded in the initial undamaged condition, D0. Table 2 contains a comparison between the frequency values theoretically evaluated considering a Euler–Bernoulli uniform beam for the first four ($r=1, \dots, 4$) modes, and the experimental frequency values obtained before artificial damage. The differences between the theoretical and experimental values are due to the theoretical stiffness value, EI , and density assumed for the theoretical analysis which are different respect to actual values, influenced by presence of reinforcement in concrete, variation of Young's modulus of concrete after 28 days from casting and experimental free-free end condition with elastic springs. In addition, a numerical modelling using Finite Element (FE) method has been carried out with the purpose to check the reliability of the experimental apparatus. The FE modelling has been performed with 3D ANSYS code. The beams' suspension system has been modelled by spring elements with a constant k equal to 0.01 N/m simulating the same free beam conditions in vibration. Modal analysis has been carried out to derive the first four natural frequencies of the beams and the natural frequency values obtained are contained in Tables 2. It is possible to notice that the theoretical results obtained with FE modelling are comparable with the ones given by experimentation. We can conclude that the suitability of experimental apparatus is confirmed.

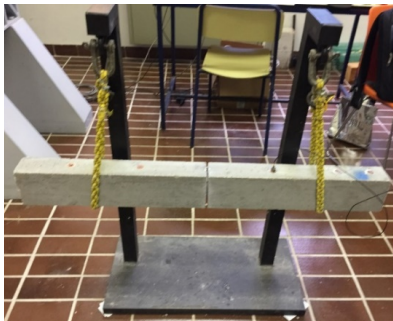
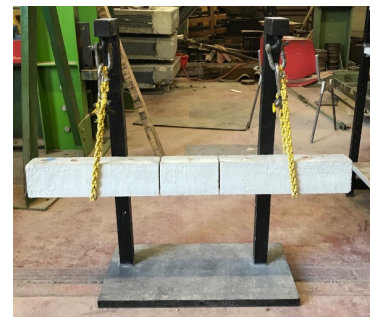
Damage type A

Damage – type B

Damage – type C

Figure 4 – (a) Damages in RC beam models: type A, B and C; (b) details of damage with different width of notch.

The analysis of experimental vibration on damaged RC beams was lead taking into account three specimens having the same dimensions and mechanical characteristics as the undamaged RC beam. Damage has been obtained removing cover concrete at different position along the beam's length considering three types: model with damage due to one notch in the middle section of beam - type A; model with damage due to one notch on concrete cover in a lateral section at 200mm to the middle of beam – type B; and model with damage due to two notches symmetrically located on the beam two symmetric sections at 100mm from the midspan – type C (Fig. 4(a)). Further, the three RC beam models, with damage type A, B, and C, are studied with different degree of damages due width of notch (Fig. 4(a)). Experimental RC beam A was damaged by notches all over the middle section with three damage step D1-D2 and D3 at midspan section: for D1 the width of notch was equal 5mm; for the damage D2 the width of notch was equal to 10mm and for damage D3 the width of notch was equal to 15mm (Fig. 4(b)).

The experimental vibration tests of damaged beam models were carried out considering set-up of free-free ends (Fig. 4(a)) with the same impact technique described above. Natural frequency values measured at each width of notch as damage degree D1, D2, D3, are shown in the Table 3 for model

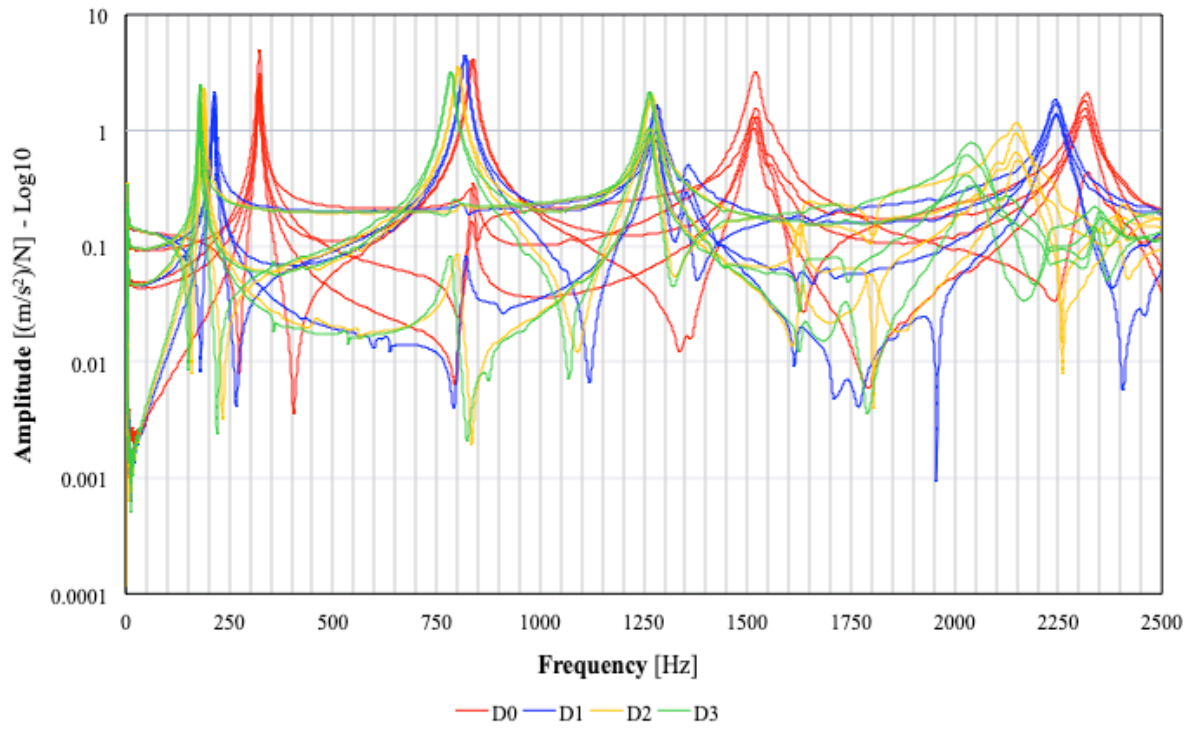
Figure 5 – Envelope diagrams of FRFs for damaged beam model type A at each damage degree D0, D1, ...,D3 by notches.

The experimental FRF envelopes at the different damage degree with measures of vibration recorded by the accelerometer in a number of selected mark points, M_i with $i = 1, \dots, 4$, for beam type A are contained in Figure 5. It is possible to observe the shift of the diagrams at various steps D_i with reduction of the frequency values due to increasing of width's notch.

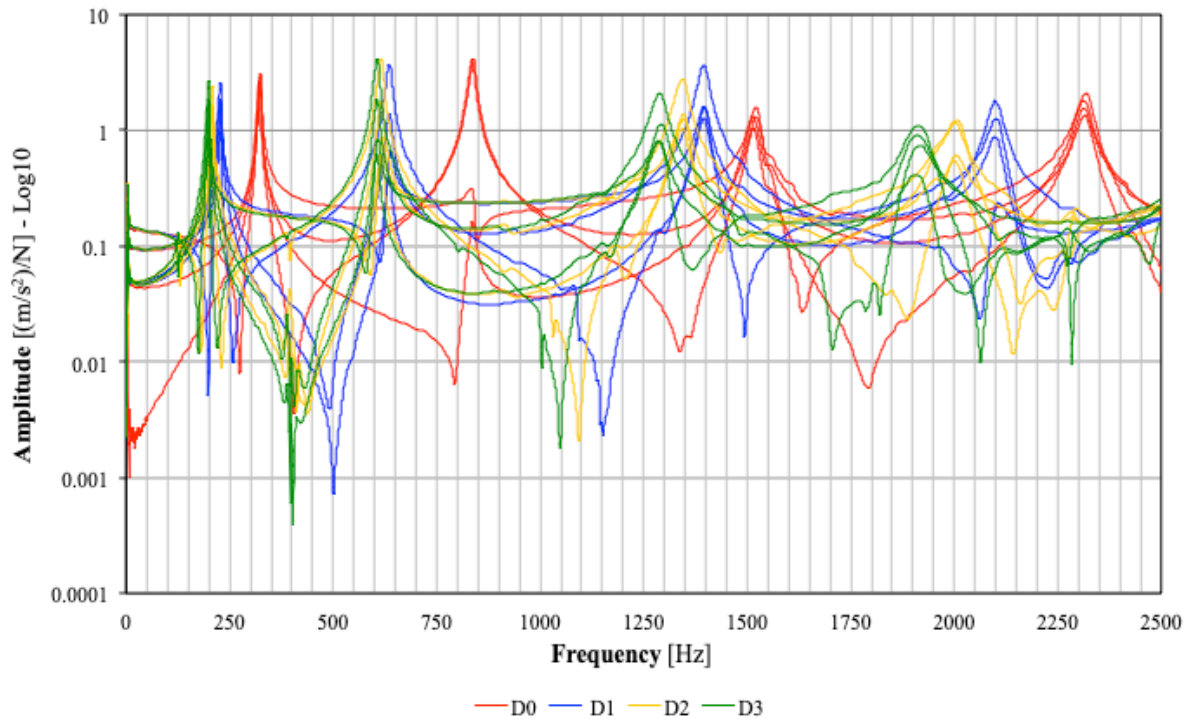
Figure 9 – Envelope diagrams of FRFs for damaged beam model type B at each damage degree D0, D1,...,D3 by notches.

Second experimental RC beam model was damaged again removing concrete cover - damage type B - all over a section located along the axis of the notches at 200mm from the midspan section of beam with three damages or notch steps D1, D2 and D3 (Fig. 4(b)). In Figure 8 details of damage by notch in RC beam are shown. Free vibration tests were performed for each damage degree and the envelope diagrams of the FRFs extracted by the measurement apparatus described above, are compared for each step of damage from degree D0 to D3 are shown in Figure 9.

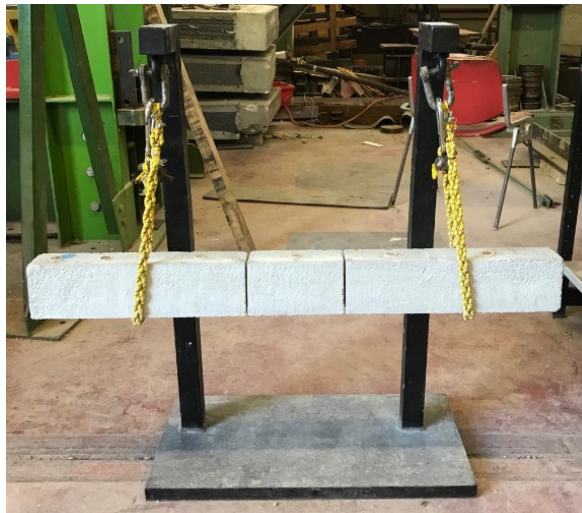
Figure 12 – Set up for vibration tests of beam type C with symmetric damage by notches.

Natural frequency values were measured at each step of damage (Fig. 12) and the dynamic responses were obtained using, once again, the same methodology described above with impact by hammer and an accelerometer at four measurement points connected to an acquisition system working in a range of frequencies between 0 and 2500 Hz. The average experimental frequency values recorded at damage degrees D_i with $i = 0, \dots, 3$ are indicated in Table 5 with the variation of frequency in percent in relation to the different damage degree. The experimental FRF envelope diagrams recorded during vibration tests for damage degrees D_i are shown in Figure 13. It is possible to observe a progressive reduction of the frequency values due to increasing of width's notch. Referring to the frequency variations values contained in Table 5, it can be noted that the variation is consistent also for a low level of damage as D1, with a value equal to approximately 43% for the first mode $r=1$ and, approximately 27% for the second mode $r=2$. The peak value is recorded at final damage degree D3, with a value equal to approximately 47% for the first mode $r=1$ and, approximately 32% for the second mode $r=2$. The notches were subsequently filled with thixotropic mortar according to the configuration outlined as R1 and then the beam was strengthened with EB GFRP strip placed at the intrados for a length equal to 900mm and width equal about 50mm (configuration R2), as shown in Figure 14.

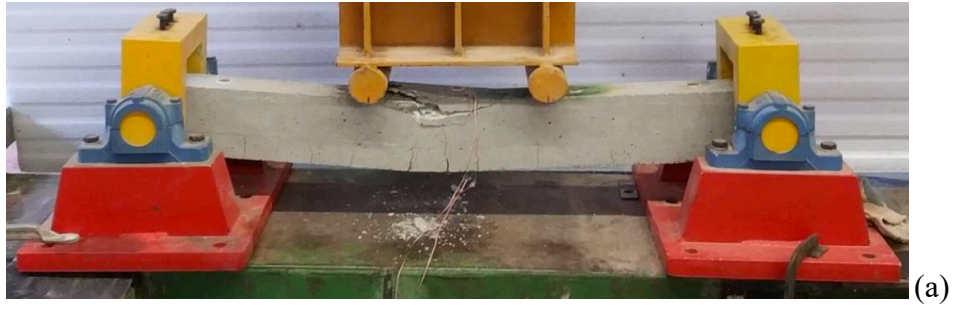
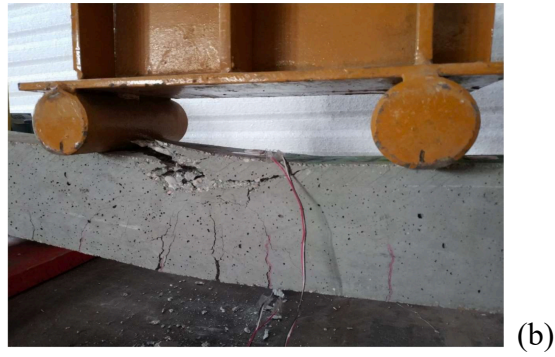
Figure 17 – (a) View of beam B0 at failure; (b) detail of cracking with detachment of compressive concrete.

The collapse of beam B0 happened at load value equal to $P=15.77\text{kN}$ reaching the maximum experimental measured value of compressed concrete strain equal to $\varepsilon_c \cong 2.77 \cdot 10^{-3}$; the failure was due to crash of compressive edge of concrete and extensive cracking of the concrete in the tensile surface (Fig. 17(a) and (b)). The envelope of experimental diagram moment, M , versus curvature, χ , is contained in Figure 31.

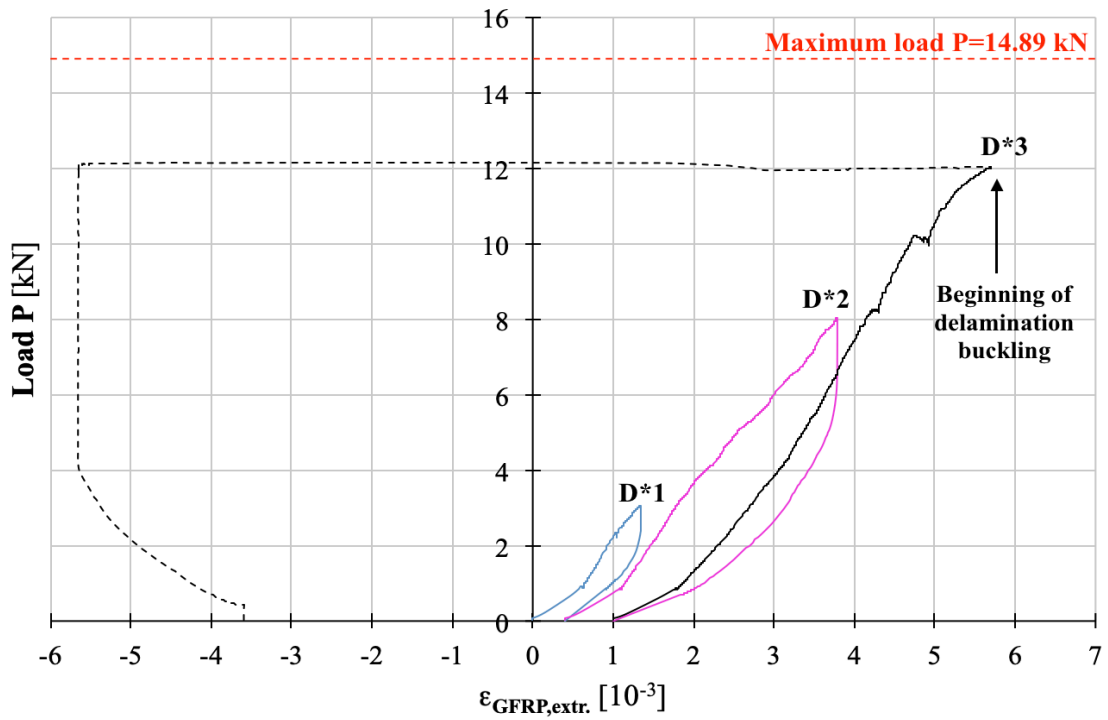
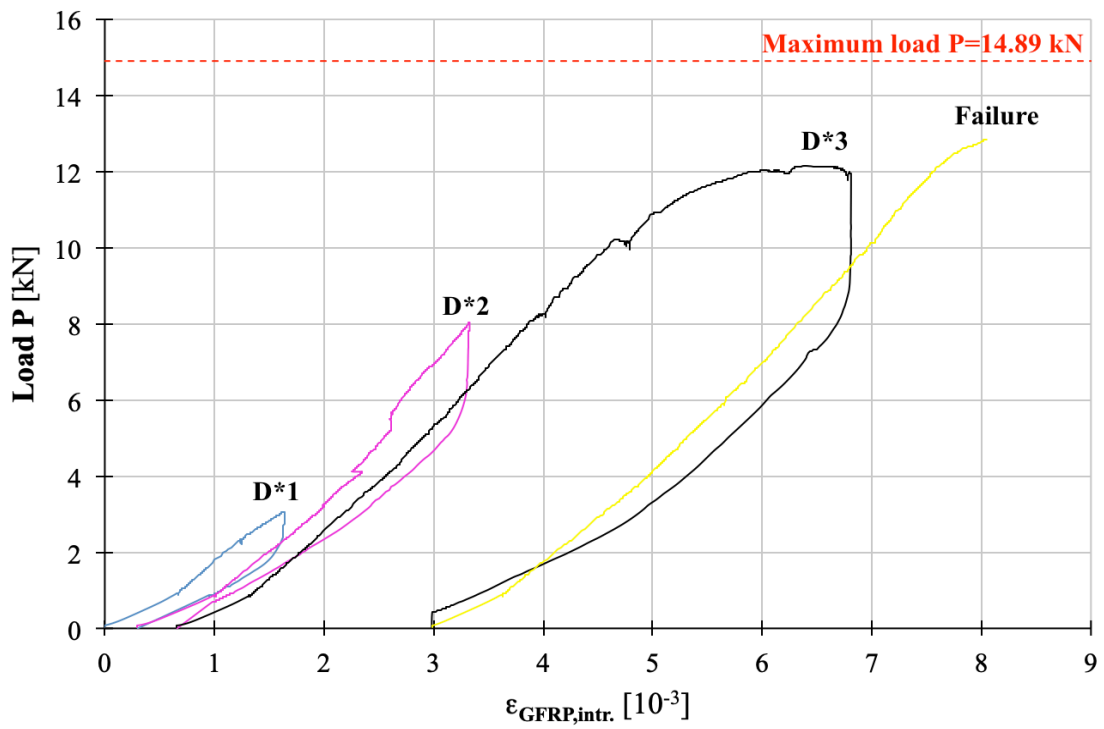
Figure 19 – (a) Exp. diagram load, P , vs strain of GFRP strip, $\epsilon_{\text{GFRP,extr.}}$, at the extradoss of beam with damage type A; (b) exp. diagram load, P , vs strain of GFRP strip, $\epsilon_{\text{GFRP,intr.}}$, at the intradoss of beam.

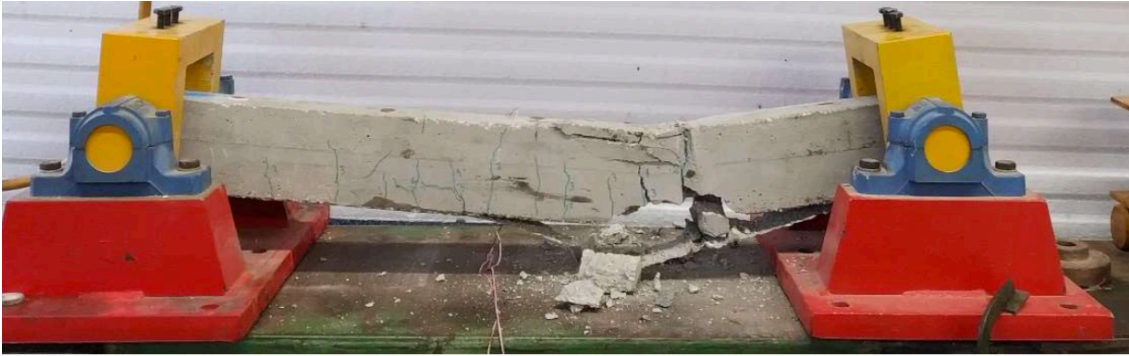
Figure 20 – View of failure of strengthened beam type B with detail of GFRP rupture.

The failure of beams type B occurred at load value equal to $P \approx 18.35 \text{ kN}$ caused by the crushing of the compressive edge of concrete and the GFRP rupture, with high concentration of damage at the filled notch (Fig. 20). In Figure 21, the strain values measured on compressive concrete, ϵ_c , on the GFRP strip, ϵ_{GFRP} , are shown for the all damage degrees. It is noted that the maximum value of strain recorded on the GFRP strengthening reached high value of deformation equal to about $8 \cdot 10^{-3}$. In Figure 31 the envelope of experimental diagram moment, M , versus curvature, χ , relative to the cross-sectional area, is shown with reference to the values measured on the compressed edge of midspan section and on GFRP strip.

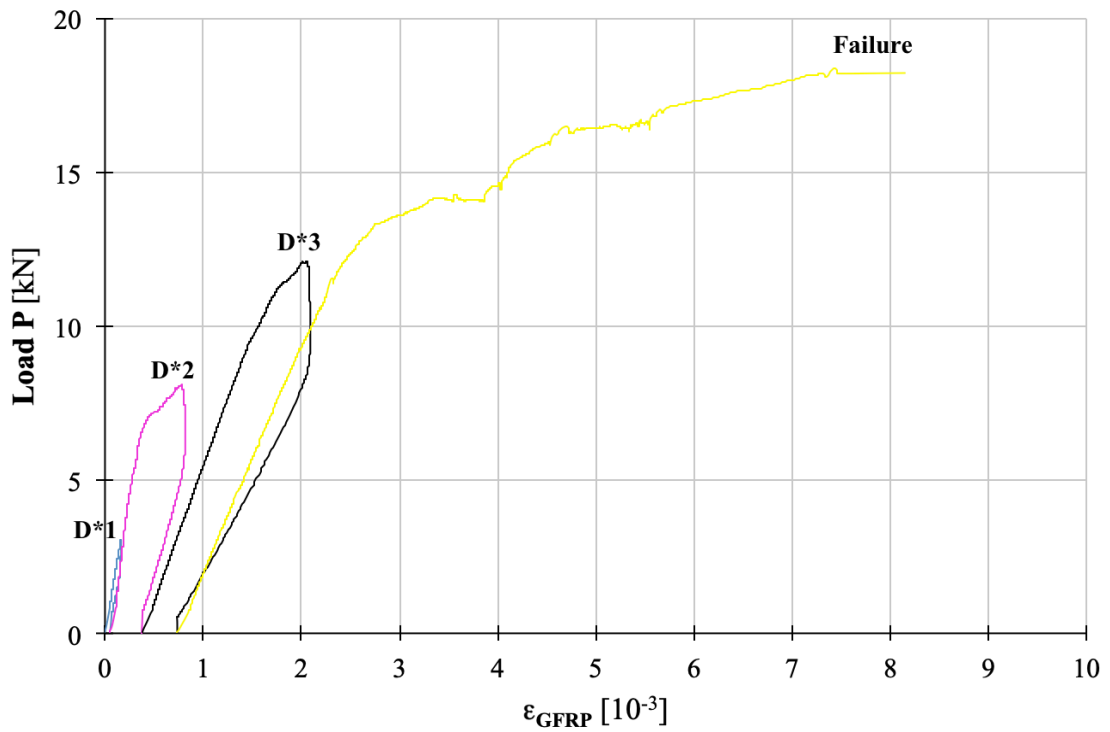
Figure 21 – (a) Exp. diagram load, P , vs strain of concrete, ϵ_c , at the edge of compressive concrete – beam with damage type B; (b) exp. diagram load, P , vs strain at the edge of tensile GFRP strip, ϵ_{GFRP} .

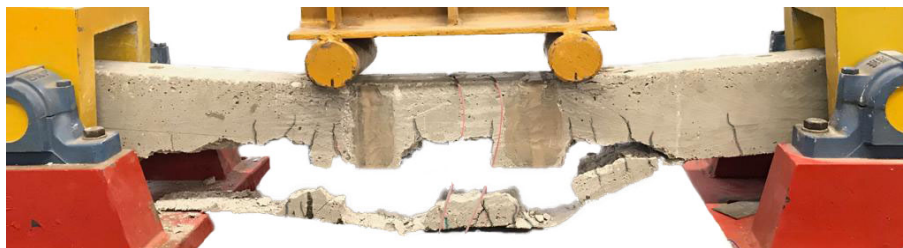
Figure 22 - Cracking damage development due to bending test at different damage degrees for strengthened beam with damage type C.

For what concern beam type C, the collapse was reached at load value equal to $P \approx 20.35 \text{ kN}$ due to expulsion of the concrete cover at the intrados with the detachment of the GFRP strip. The typical cracking states at damage D^*1 , D^*2 and D^*3 together with failure state for beam type C are shown in Figure 22. Experimental diagrams load, P , versus strain at the edge of compressed concrete, ϵ_c , and strain at the tensile GFRP strip, ϵ_{GFRP} , are shown in Figure 23. Finally, the envelope of experimental diagram moment, M , versus curvature, χ , obtained for the cross section at the beams' mid length is shown in Figure 31.

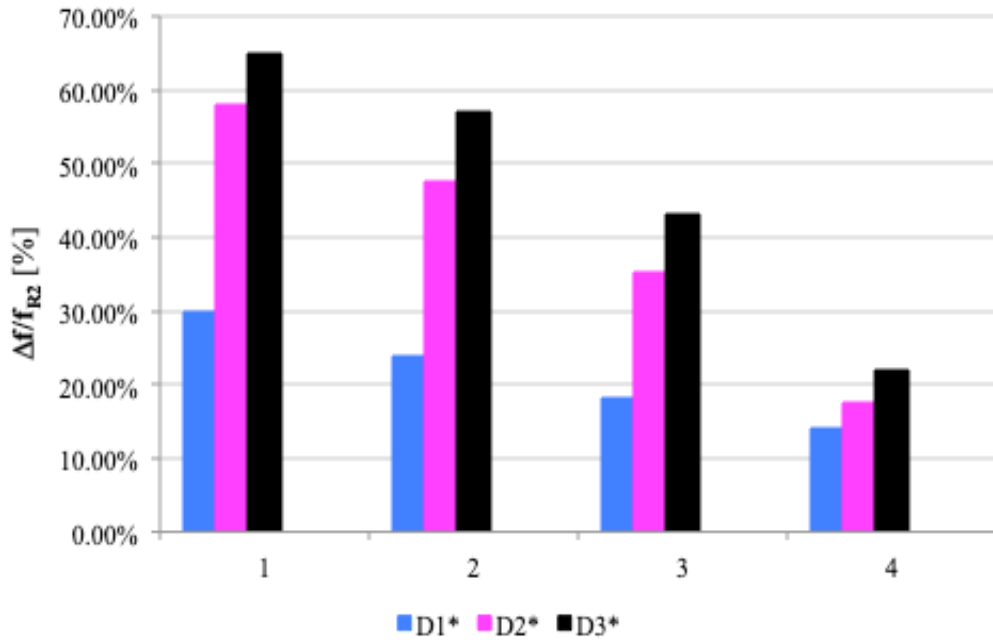
Figure 24 - Variation of exp. frequency values (%) at damage degree step by bending test for modes $r = 1, \dots, 4$ in relation to D0 condition (beam B0).

experimental frequency values as damage proceeds, for the four vibration modes $r=1, \dots, 4$, relative to condition D0 for beam type B0.

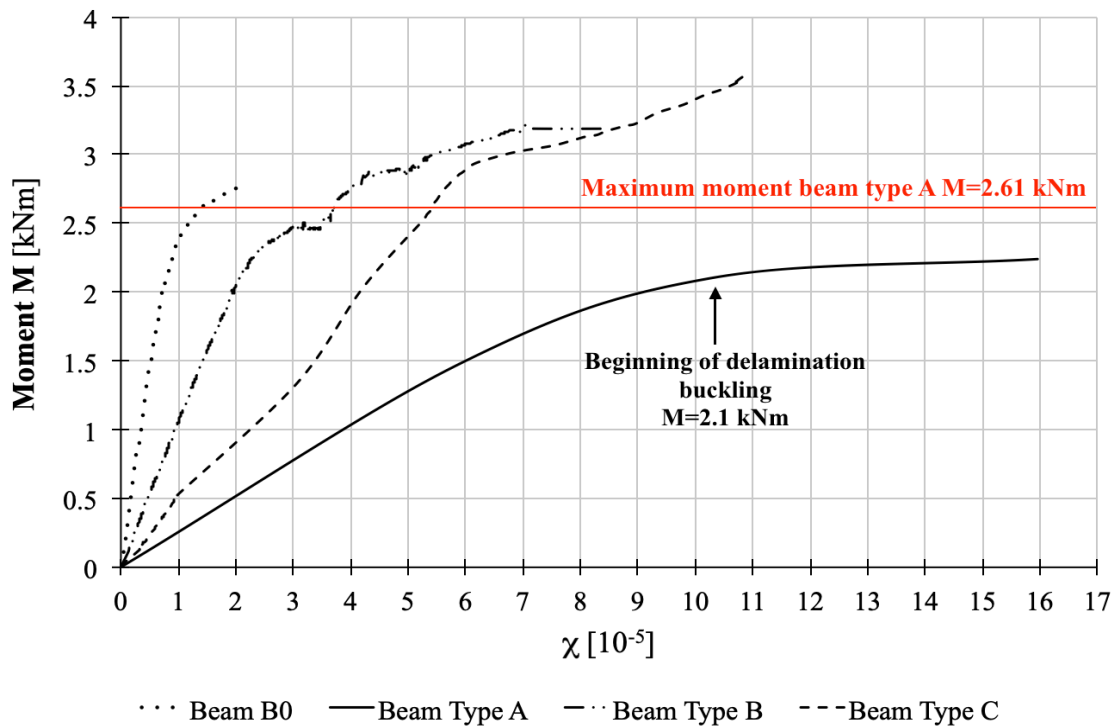
Figure 31 - Comparison between theoretical and experimental M vs. χ diagrams.

The results obtained by experimental tests, allow observing that the strengthening of RC beams with EB GFRP strips on the tensile side is an efficient way to increase the strength of damaged beams. In particular, the GFRP strengthening conferred to the RC beams, above all, a greater capacity to increase strain under tension until the failure by compression of concrete, which is the conventional ultimate condition for RC beams under bending. Instead, in a system such as RC beam strengthened with GFRP strips on the tensile side and on the compressive side, the low Young's modulus of GFRP composite material and the formation of local cracking mechanisms can cause the debonding and subsequent local buckling of the FRP layer that can result in a premature failure of the strengthened RC beam. From the analysis of the behaviour of the GFRP strip under compression it is possible to state that the presence of the strengthening on the compressive side allows having an extradosal reinforcement, which still works but is conditioned by the delamination buckling. After the beginning of the debonding of the GFRP strip, there is an increase equal to about 25% of the moment that the beam can withstand before failure (Fig. 31).

What is mainly observed in all cases investigated is that the strengthening conferred to the RC beams, above all, a good level of ductility under bending, with values of ductility ratio deduced by the ratio of ultimate curvature value, χ_u , on yield curvature, χ_y , greater than $\chi_u / \chi_y > 1.5$, for all cases investigated (Fig. 31).
