Polytechnic University of Marche
Ph.D. School in Engineering Sciences
Curriculum in Civil, Environmental, Building Engineering and Architecture

A proposal of damage identification and quantification for unreinforced and reinforced masonry structures

Ph.D. Dissertation of:

Ersilia Giordano

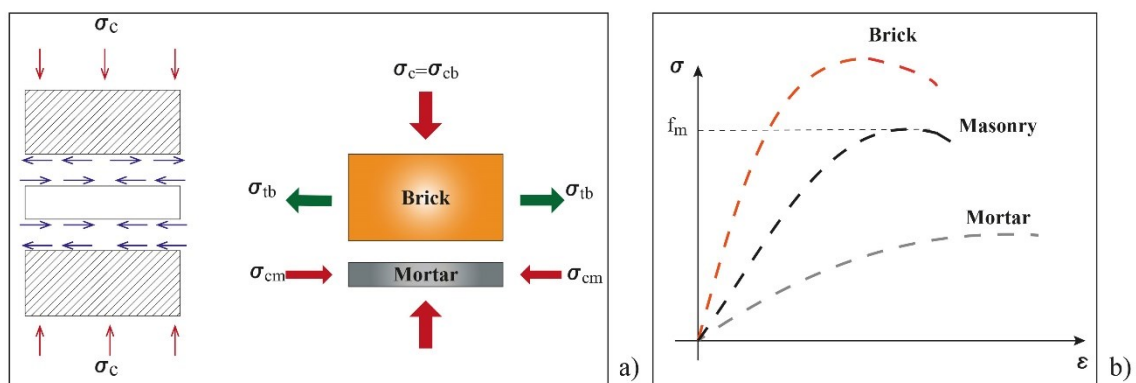
Figure 2.2 a) Inner tensions of the masonry; b) σ - ϵ diagram for brick, mortar, and masonry

In a masonry wall, two elements are distinguishable: the units and the mortar. The units can be made of stone (granite, travertine, lime, etc), adobe, concrete blocks, or solid clay blocks, whereas the mortar is a mixture of water, sand, binder, and sometimes additives. If tested individually the bricks show a brittle behaviour with high resistance, meanwhile, the mortar has a ductile response but low resistance. The combination of these elements produces walls that are less resistant to bricks but more ductile able to support stress greater than only the mortar. This phenomenon is since the mortar has higher deformability than the blocks. If this were not confined, it would show greater deformations due to its lower elastic modulus and the different Poisson's ratio. However, when it is inside a wall its deformations are prevented by the friction between mortar and blocks that produces tensions on the mortar-block interfaces that restore the congruence of the deformations Figure 2.2.a. These tensions are of horizontal compression on the mortar; therefore, they increase its resistance having a confining function, and of horizontal tensile on the blocks, which decrease its compressive strength Figure 2.2.b. From this, it follows that the tension on the blocks is a function of the ratio of the elastic modulus, the Poisson's ratio, and the ratio between the thickness of the mortar and the thickness of the blocks. In fact, the largest thickness of the mortar translates into higher traction on the blocks. [23]

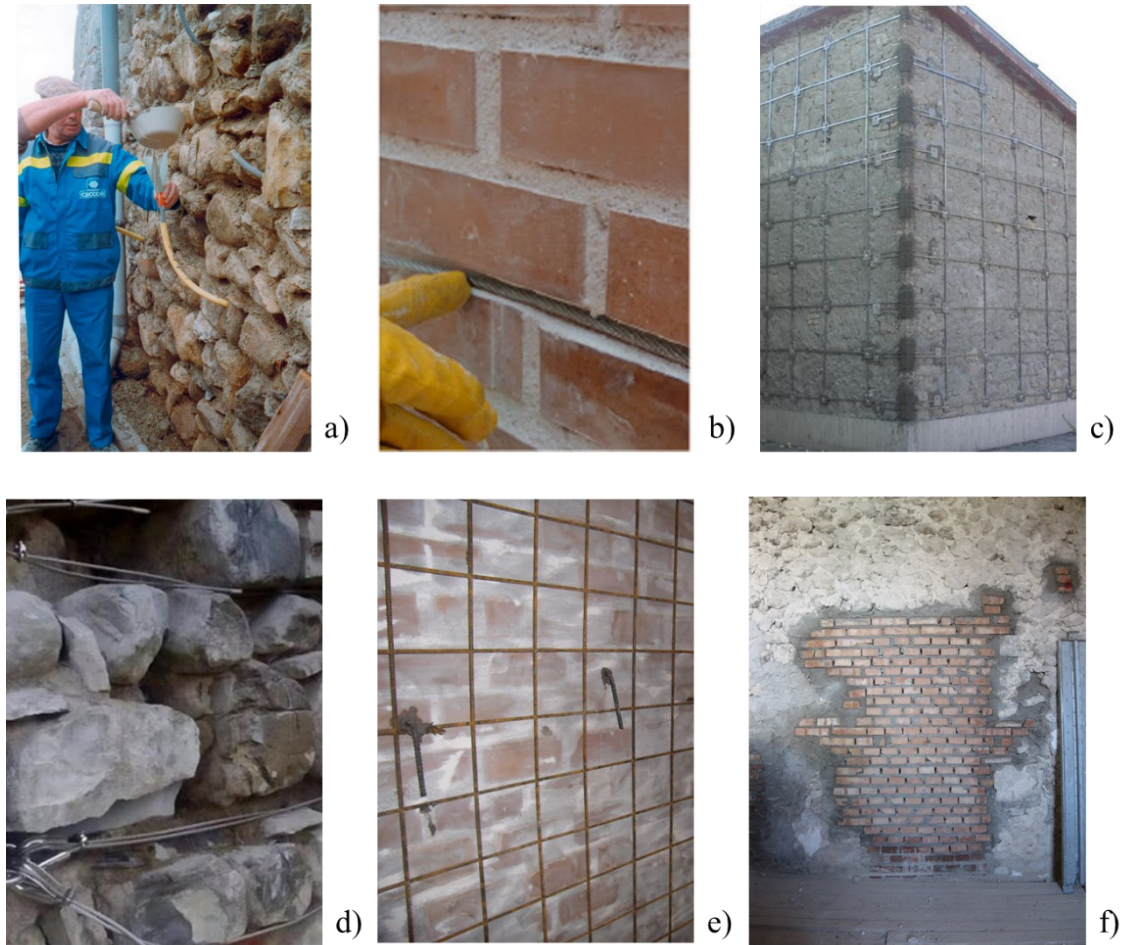
Figure 2.8 *Some interventions to increase the masonry strength: a) Injection of binder mixtures; b) Re-pointing of the joints; c) Tie rods opposing to both deformation and disconnection of wall panels ; d) Insertion of stainless steel cords in the mortar joints ; e) Reinforced concrete; f) “cuci-scuci”.*

- Tie rods opposing to both deformation and disconnection of wall panels [31] Figure 2.8.c;
- Insertion of stainless steel cords in the mortar joints [32] Figure 2.8.d;
- Reinforced concrete Figure 2.8.e;
- Coating with textile or limited in composite elements;
- Demolition and reconstruction of a portion of the wall “Scuci e cuci” Figure 2.8.f;
- Steel perforation;
- **Intervention to improve connections;**
 - Metallic chains;
 - Tie-rods;
 - Beams connects to the wall;
 - Top curbs;
 - External wrapping;
- **Intervention to reduce the flexibility of the floor:**
 - The floors have a fundamental role in the box behaviour of masonry structures. Their stiffness must be improved both in the plane that is out of the plane

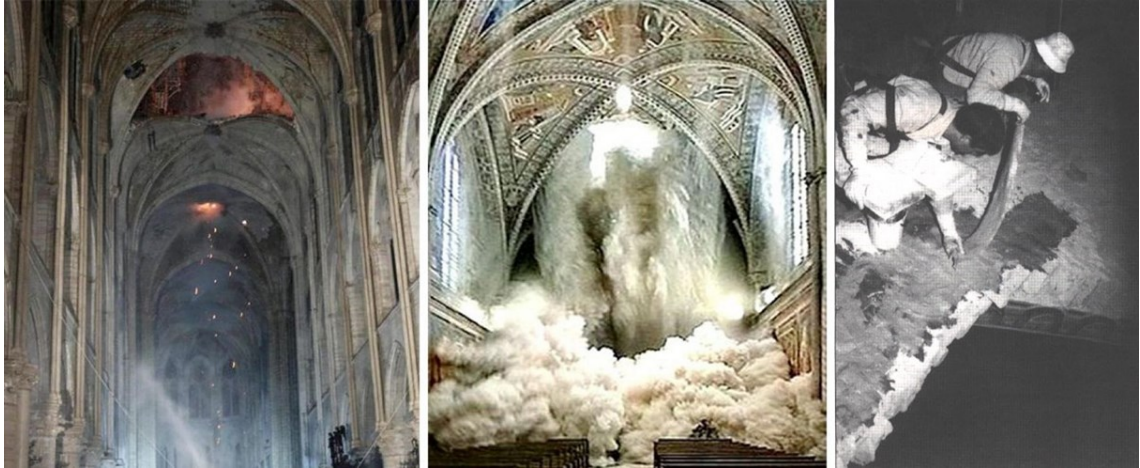
Figure 2.11 Collapse and reinforcement of Gothic vaults of San Francesco Church in Assisi

of the Gothic vaults. The ribs were reinforced using unidirectional aramidic fiber bars in the intrados and glass fiber bars at the extrados since glass is more performance under compression Figure 2.11. [40].

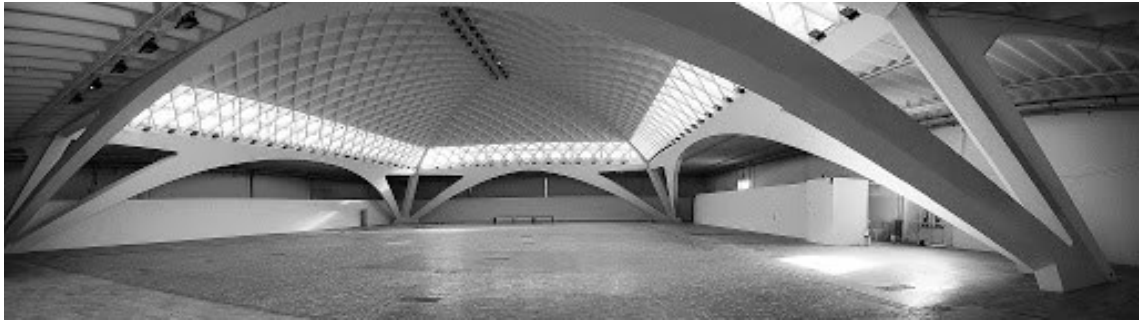
Figure 2.13 Ferrocement barrel vault of Turin Exhibition Complex built

The idea of using resistant elements in a cement matrix dating back to 1840 when Joseph-Louis Lambot, a source of the growing interest in reinforced concrete, proposed to use iron fibers immersed in a cement matrix to reinforce boat hulls, water tanks, etc. Later this idea was taken up by Pierluigi Nervi with the introduction of ferrocement (patent registered in 1943) [41]. The ferrocement consisted of layers of small diameter metal mesh on which a thin layer of cement was applied, the combination of these materials guaranteed ductility and crack resistance. This technology allowed Nervi to cover large spans with thin shell structures. The first major work he created in this material is the barrel vault of the Turin Exhibition Complex (94 m of span) built in 1948 [42].

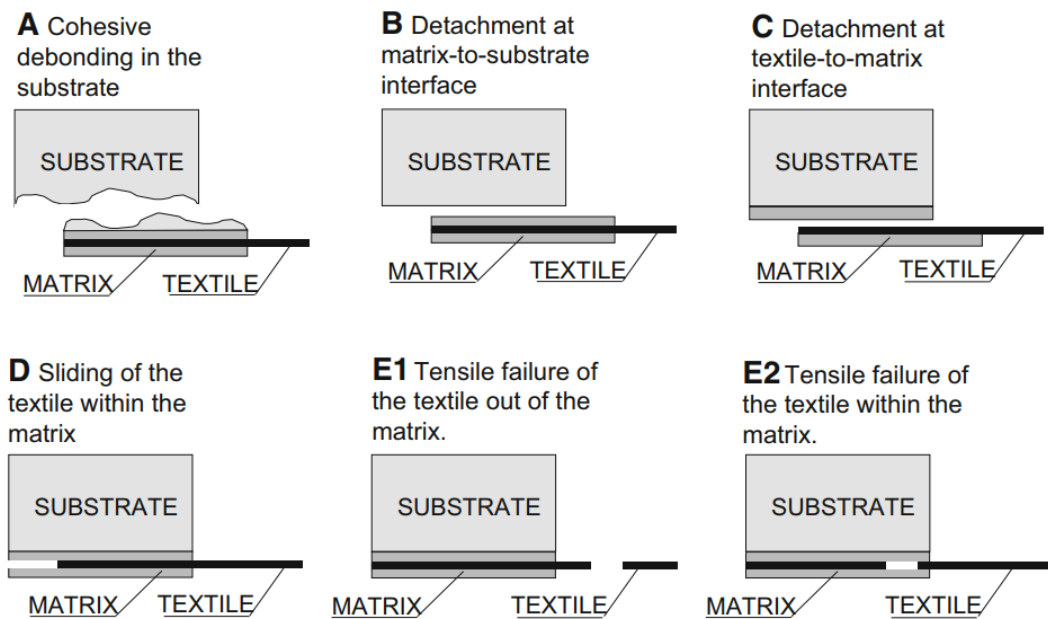
Figure 2.15 Different failure mode of the TRM [43]

This constitutive law, however, fails to fully represent the behavior of the TRM, which can fail due to the establishment of various collapse mechanisms as shown in Figure 2.15. Failure mode A usually occurs when a strong matrix is bonded to a weak substrate. Failure mode B usually takes place on relatively smooth surfaces and/or may be associated with limited substrate preparation or unfavorable curing conditions. Failure mode C is governed by the amount of the mortar through the voids between fiber bundles or cords and is often exhibited by TRM systems comprising textiles with small grid/cord spacing. Failure mode D usually takes place when dry fiber bundles (not provided with coating or impregnation) or smooth ropes, characterized by a relatively weak bond/interlocking with the matrix, are used. Finally, TRM systems comprising relatively weak textiles with small equivalent thickness may exhibit failure mode E1 (generally when fiber bundles are provided with pre-impregnation or coating) or failure mode E2 (when dry textiles are used). [43]

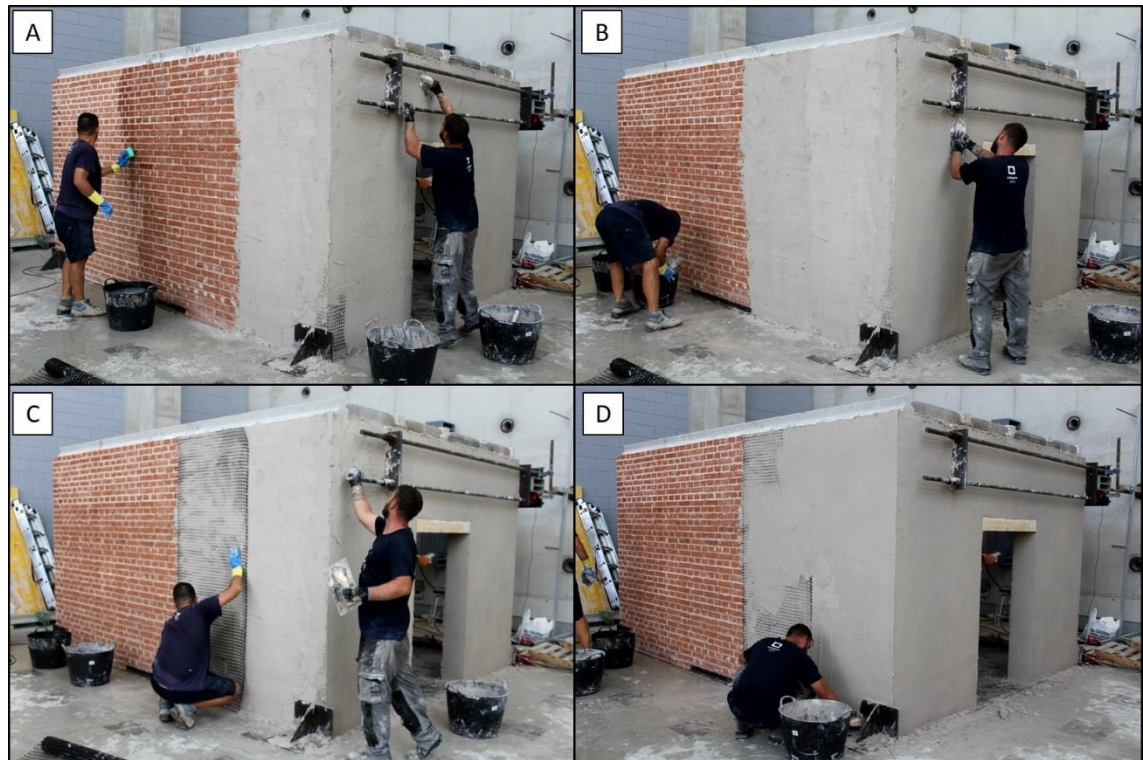
Figure 4.2 Construction phases of TRM application. a) Cleaning of the masonry support; b) Application of the first layer of mortar; c) Positioning of the glass textile and finally; d) Application of the second layer of mortar.

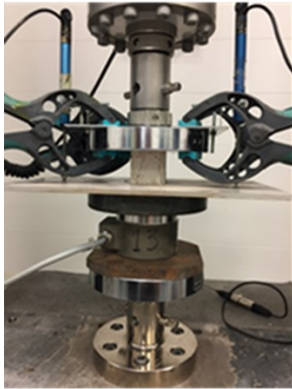
Compression test

Test at 28 days

Sample	E [MPa]	F max [kN]	σ_{max} [MPa]
Sample 1	789.977	6.184	4.105
Sample 2	810.826	5.892	3.899
Sample 3	728.348	7.039	4.658
Sample 4	578.172	6.590	4.333
Mean	726.831	6.426	4.249
CoV	0.14	0.08	0.08

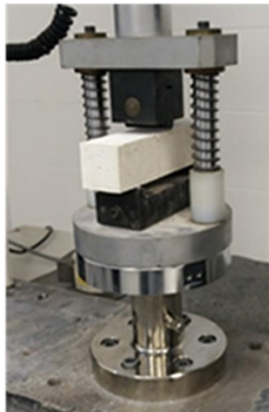
Three points bending test

Test at 28 days

Sample	F max [kN]	σ_{max} [MPa]
Sample 1	0.440	1.110
Sample 2	0.650	1.615
Sample 3	0.708	1.765
Sample 4	0.563	1.417
Mean	0.590	1.477
CoV	0.20	0.19

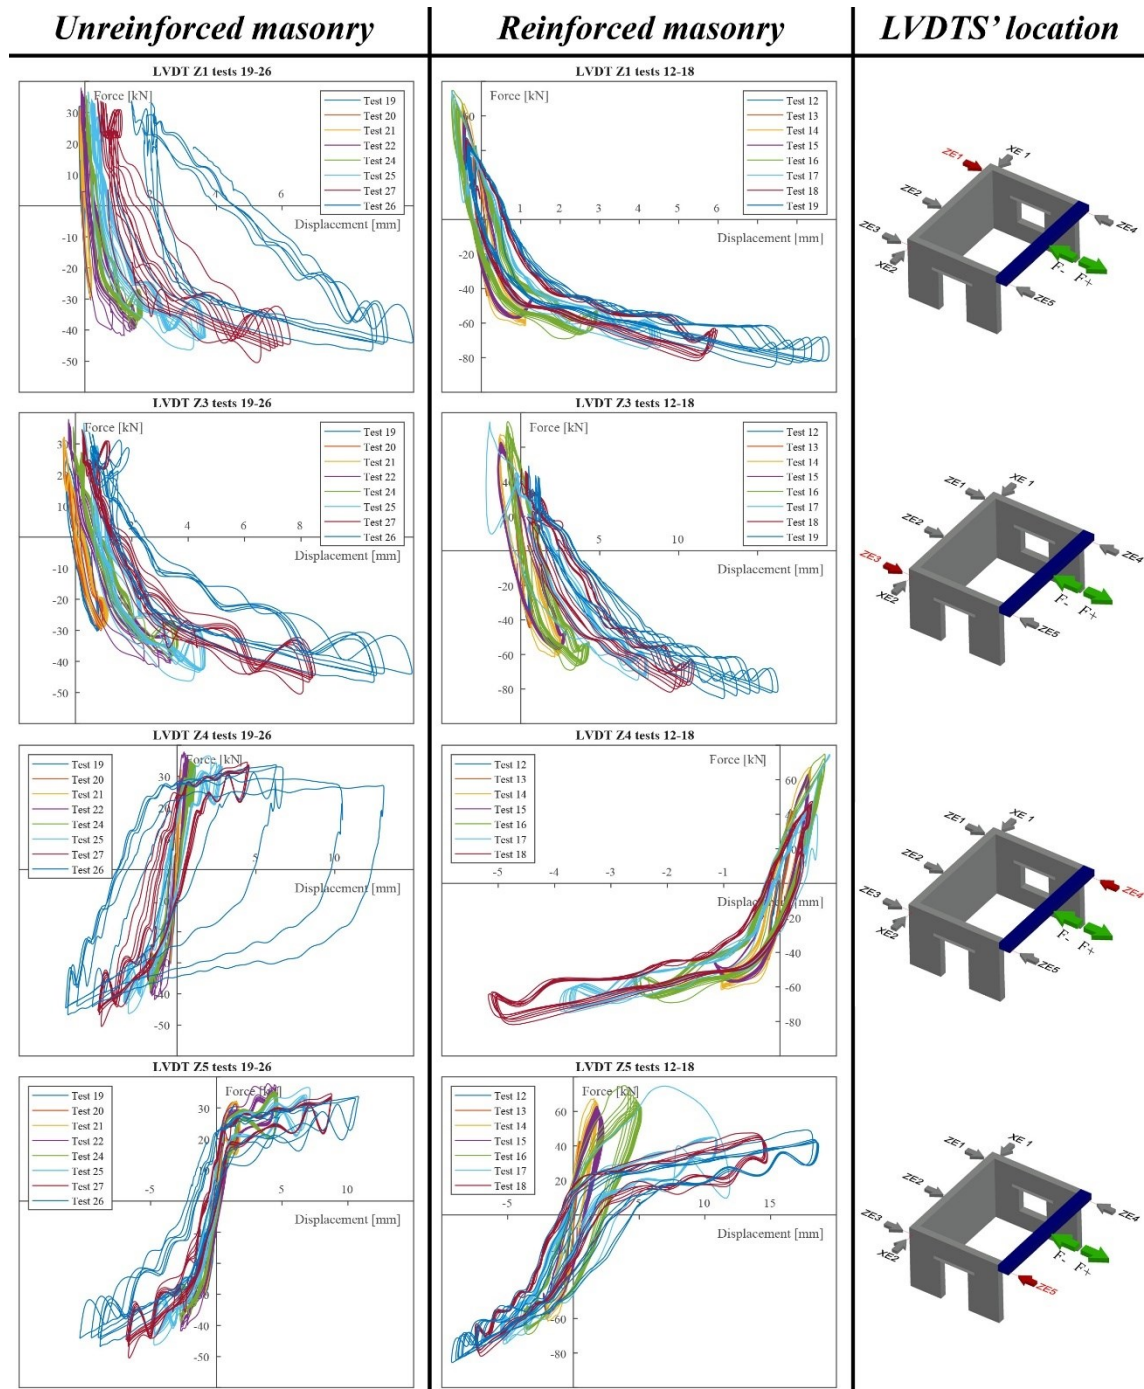
Figure 4.9 Hysteretic curves obtained from LVDT Z1, LVDT Z3, LVDT Z4, and LVDT Z5.

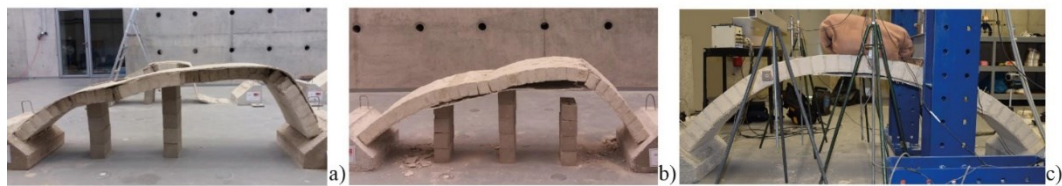
Figure 5.5 Collapse due to the TRM detachment: a) arch strengthened at the extrados (SE1); b) Arch strengthened at the intrados (SI1); c) Repaired arch strengthened at the intrados in the damage scenario before the collapse (RSI1). [116]
