## Model Updating of Cultural Heritage Buildings Through Swarm Intelligence Algorithms

Model Updating of Cultural Heritage Buildings Through Swarm Intelligence Algorithms / Gara, F., Nicoletti, V., Arezzo, D., Cipriani, L., Leoni, G.. - In: INTERNATIONAL JOURNAL OF ARCHITECTURAL HERITAGE. - ISSN 1558-3058. - (2023). [10.1080/15583058.2023.2277324]

# **Model Updating of Cultural Heritage Buildings Through Swarm Intelligence Algorithms**

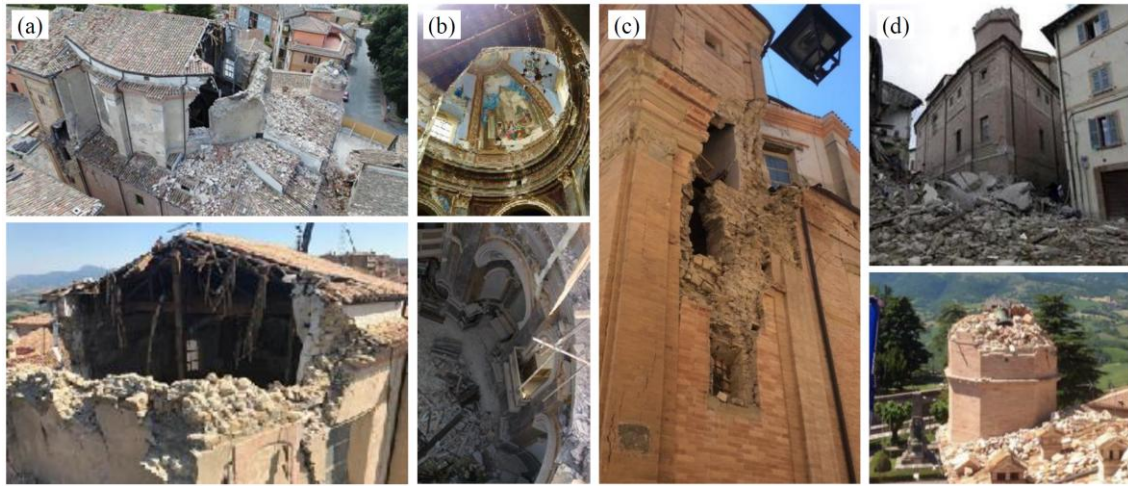
Figure 2. Earthquake damage: (a) collapse of the tiburium, (b) collapse of the dome and interior damages, (c) façade overturning mechanism, (d) collapse of the bell tower.

One of the most impressive failure mechanisms is that activated between the façade and the tiburium: the upper part of the façade is now almost 30 cm out of the vertical plane traced passing towards the low level of the walls, as it has been seen from laser scanner results obtained by surveys after the earthquakes (Arezzo et al. 2021). This damage mechanism also interested the front part of the tiburium, which suffered of diagonal cracks. The horizontal movement of the upper part of the façade explains the formation of shear crack patterns and of the subsequent masonry disaggregation also at the façade base. Finally, the church underwent other minor damages due to the bad weather conditions (heavy snowfalls) occurred during the 2017 winter season
