Automatic monitoring of the bio-colonisation of historical building's facades through convolutional neural networks (CNN)

Automatic monitoring of the bio-colonisation of historical building's facades through convolutional neural networks (CNN) / D'Orazio, Marco; Gianangeli, Andrea; Monni, Francesco; Quagliarini, Enrico. - In: JOURNAL OF CULTURAL HERITAGE. - ISSN 1296-2074. - 70:(2024), pp. 80-89. [10.1016/j.culher.2024.08.012]

# AUTOMATIC MONITORING OF THE BIODETERIORATION OF HISTORICAL BUILDING'S FACADES THROUGH CONVOLUTIONAL NEURAL NETWORKS (CNN)

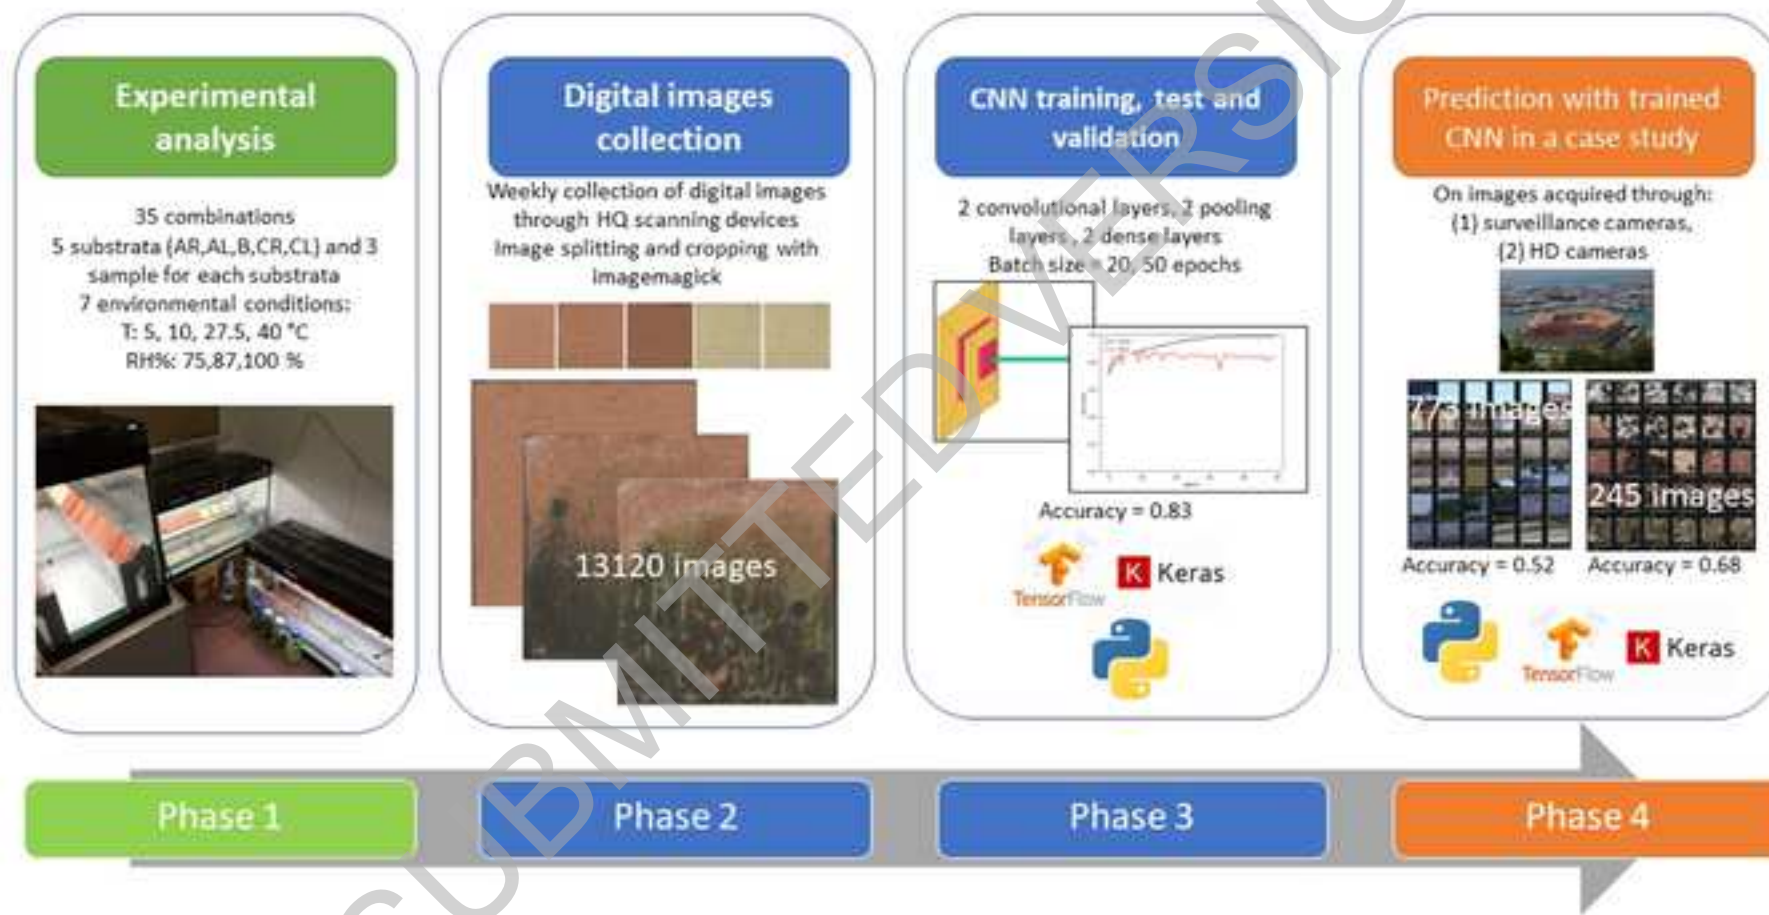
27 check the ability of the trained network to work in a real case (see 3.5). The whole research framework is  
28 depicted in Figure 1.  
29  
30  
31  
32  
33  
34  
35  
36  
37  
38  
39  
40

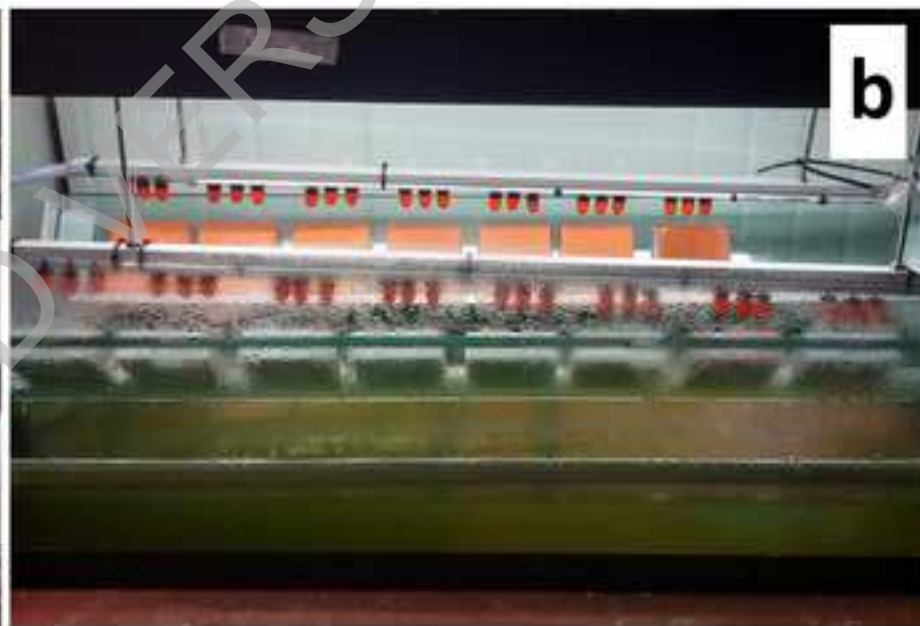
6  
7 Figure 2. Test apparatus for the evaluation of relative humidity influence on growth process (a) and for  
8 accelerated test aimed at temperature effect investigation (b).  
9

15 (about 87%) through a saturated solution of  $\text{Na}_2\text{CO}_3$ , and  $RH_3$  (about 98%) through only deionized water [77].  
16 To only consider the effect of RH, temperature was maintained at  $27.5 \pm 2.5$  °C during all the tests. At the  
17 beginning of the test, 9 different points on the surface of each sample were inoculated with 5 $\mu\text{L}$  of the mixed  
18 culture per point. After the initial inoculation, samples were positioned inside the climatic chambers, inclined  
19 at 45° on aluminum-glass racks, front-to-front along the long dimension of the chamber. The test apparatus  
20 was placed in a closed room to avoid the influence of light, temperature, and RH of the external environment.  
21 Each growth chamber was equipped with two neon lamps (Sylvania TopLife 39W) to provide an adequate  
22 illumination equivalent to day/night cycles 14/10 h (Figure 2a).  
23

24 The influence of temperature on algae growth was carried out following previous researches [25], [26], [72],  
25 [78]. Accelerated tests with a periodical water spray on the material surface were performed until the  
26 stagnation phase was reached (Figure 2b). Test apparatus consisted of growth chambers (100×40×53  $\text{cm}^3$ ),  
27 filled with 35L of BBM inoculated with the mixed cultures. Algal suspension was sprinkled on sample surfaces  
28 (8×8  $\text{cm}^2$ ) positioned above two aluminum-glass composed racks inclined at 45°. Run/off cycles were set at  
29 intervals lasting 15 min and a total of 6 hours per day (3 hours run and 3 hours off). A day/night illumination  
30 cycles (14/10 h) were provided by two 39 W neon lamps (Sylvania TopLife).  
31

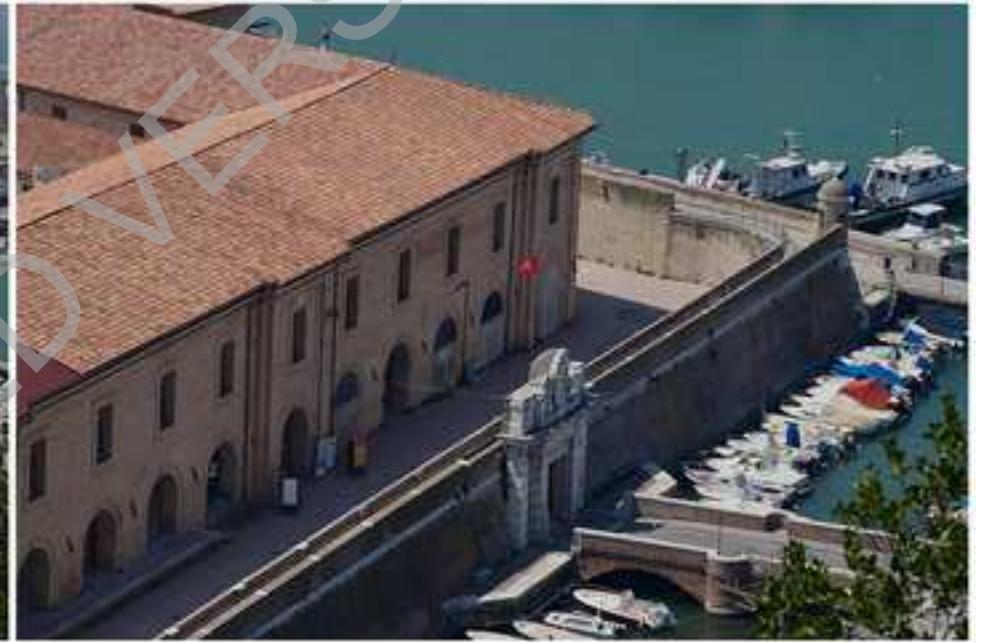
25 To show the applicability of the proposed model in real situations, a case study has been chosen. The case  
26 study is a 18<sup>th</sup> century historical building (built from 1733–1743) designed by the Architect Luigi Vanvitelli on  
27 an artificial island as a quarantine station for the port town of Ancona called “Mole Vanvitelliana”. During the  
28 last two centuries, the building has taken different functions: in 1860 as a military citadel, then in 1884 a sugar  
29 refinery. Now it is used as a site of a museum, as well as home for various exhibitions. The “Mole  
30 Vanvitelliana” main building is rounded by a town-wall. Both the building walls and the town-wall are made  
31 with the same type of mortar and bricks. Town-walls are strongly inclined, then the rain can wet the surfaces.  
32 It is possible to observe a diffuse biodeterioration process (Figure 3). On the contrary, the facades of the
