Preventive and Planned Conservation: A Knowledge-Based Tool to Manage Heritage at Risk. Strategies for the Pitti Palace in Florence

Preventive and Planned Conservation: A Knowledge-Based Tool to Manage Heritage at Risk. Strategies for the Pitti Palace in Florence / Mariotti, C., Ruggieri, P., Salvatici, T., Ceppetelli, A.. - In: INTERNATIONAL JOURNAL OF ARCHITECTURAL HERITAGE. - ISSN 1558-3066. - ELETTRONICO. - 20:2(2025). [10.1080/15583058.2025.2524758]

# **Preventive and Planned Conservation: a Knowledge-Based Tool to Manage Heritage at Risk. Strategies for the Pitti Palace in Florence**

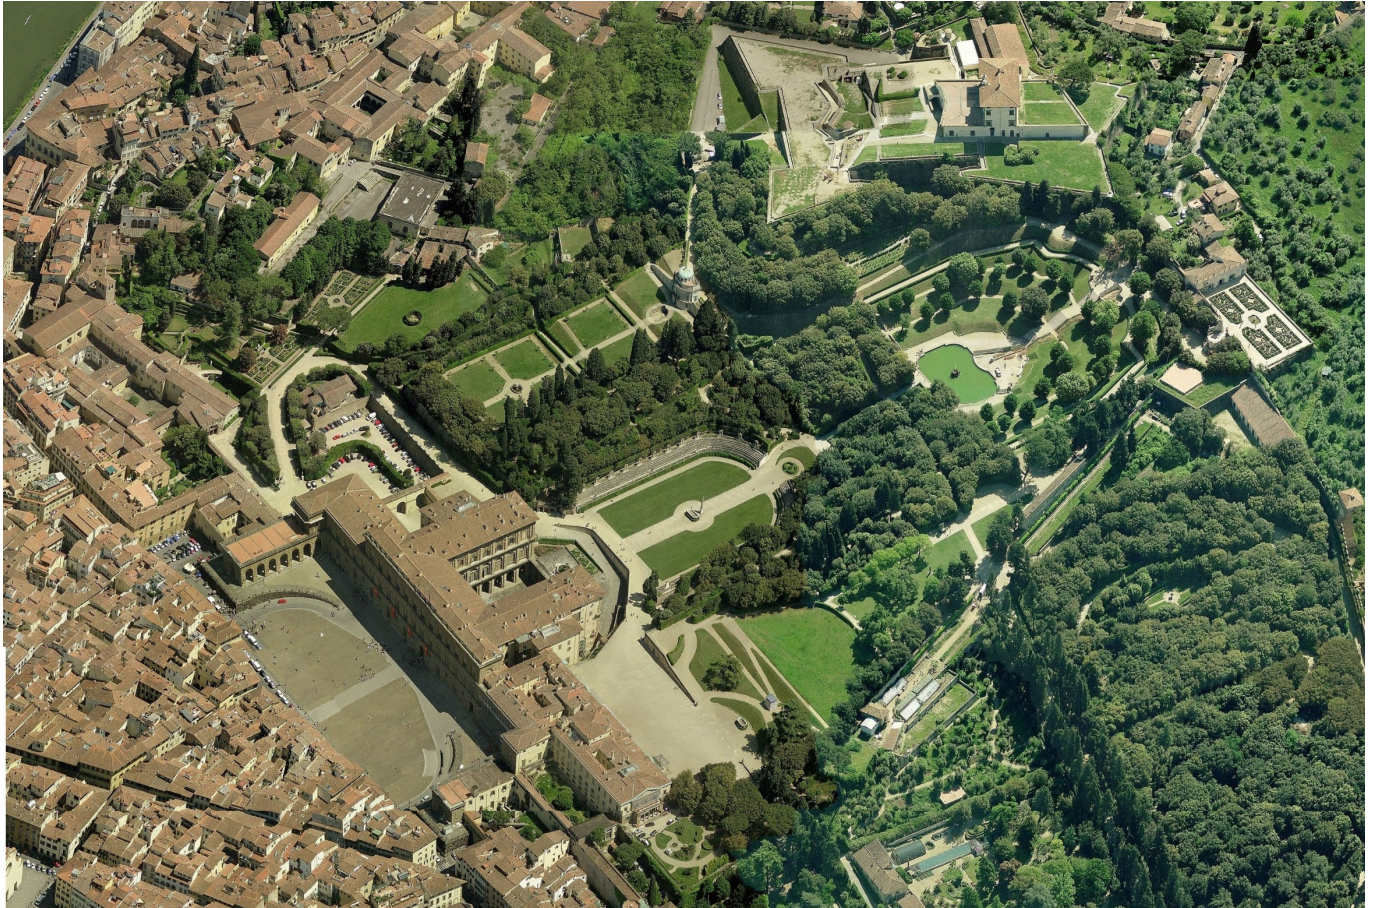
Figure 1. Florence, Pitti Palace and Boboli Garden. Aerial view highlighting the architectural configuration of the palace and its integration with the surrounding landscape of the Boboli Gardens (Photo by Uffizi Galleries 2024).

Located in the historical center of Florence – declared a World Heritage Site in 1982 – and in front of the Boboli Gardens, the Pitti Palace (Figure 1) is one of the architectures that has contributed most to the consolidation of the Florentine building tradition, which developed around the use of Pietraforte and Pietra Serena due to their durability, versatility and ease of extraction, a practice that dates back to the Middle Ages (Pecchioni et al. 2021; Fratini and Pecchioni 2024). One of the most important sources of Pietraforte in Florence was the Boboli quarry, in the Oltrarno district. It supplied Pietraforte for a wide range of construction, including palaces (e.g. Pitti Palace, Palazzo Medici Riccardi, Palazzo Vecchio, Palazzo Strozzi, Palazzo Rucellai), churches (e.g. the Church of Santa Maria Maggiore), bridges (e.g. Ponte Vecchio, Ponte Santa Trinita), to name but a few (Bastogi and Fratini 2004; Pecchioni et al. 2021).

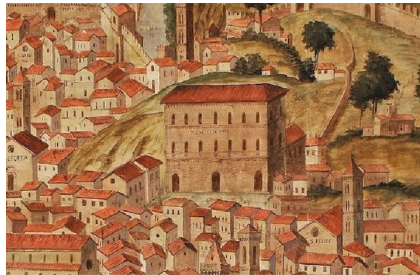
a) 1471-1482ca.

Figure 2. Florence, Pitti Palace, Cortile dell’Ammannati. Historical illustrations and contemporary photographs.

(a) *Veduta della Catena*, detail (Petrini, Petrini, 1887); (b) *Assedio della città di Firenze nel 1530* (Vasari. 1560-62); (c) *Naumachia in the Court of Palazzo Pitti* (Scarabelli. 1589-92); (d) *Veduta di Palazzo Pitti e del Forte di Belvedere a Firenze* (Utens, 1599); (e) Zocchi, Giuseppe. *XVIII Century. Veduta del Reale Palazzo de' Pitti* (Zocchi, XVIII century); (f) Fischer, Carl von. 1812. *Survey of Pitti Palace* (Fischer, 1812); (g-h) Current view of the Pitti Palace main facade and the Cortile dell’Ammannati (Photos by Alessandro Ceppetelli 2025).

In terms of architectural configuration, the palace is the result of several enlargements over time. The original core, smaller than its current structure, was built in the mid-15th century for the Florentine merchant Luca Pitti (Figure 2a-b). Although no definitive documentation exists, the design is widely attributed to Filippo Brunelleschi (Fabriczy 1979). The first expansion was carried out by architect and sculptor Bartolomeo Ammannati, who from 1561 transformed the palace into the new Medici residence, first requested by Eleanor of Toledo and then by Duke Cosimo I (Fossi 1967). Bartolomeo Ammannati's extension tripled the size of the palace, by building a central body leaning against the back of the 15th century building and two wings perpendicular to it; thus, creating the Cortile, the courtyard that became the link between the naturalistic landscape of the Boboli Gardens and the architectural landscape of the city. The construction site made use of the Pietraforte quarry in Boboli, which was located next to the palace and had already been used to build the first part of the palace, so that the material was easy to obtain and transport was reduced to a minimum, since the quarry and the construction site were practically one and the same (Rodolico 1953; Facchinetti 2000). The use of Pietraforte gave material continuity and solidity to the palace's structures, while the rusticated ashlar technique gave plasticity to the facades, with three overlapping orders featuring variations in the treatment of the

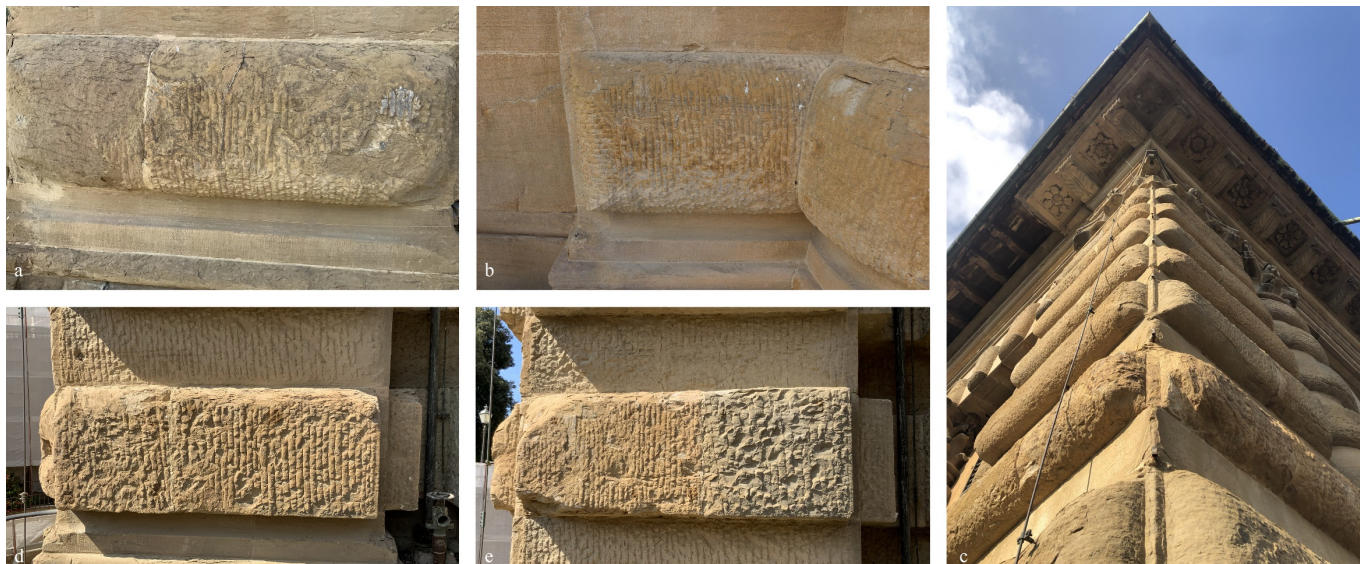
Figure 3. Florence, Pitti Palace, Cortile dell'Ammannati. Pietraforte rusticated ashlar from the second (a, b, c) and the first floor (d, e) of the western facade (Photos by Paola Ruggieri 2024).

detachment of a corbel in the Basilica of Santa Croce, which killed a Spanish tourist in 2017. At present, the persistent occurrence of detachments remains a serious hazard, including at Pitti Palace (Figure 3). Such occurrences, especially if we consider the number of buildings made by Pietraforte across the city, are of great concern to the administrations responsible for managing this heritage, which – supported by the scientific community – are maximizing their efforts to slow down the degradation processes and prolong the life cycle of historic architectures. These actions aim to preserve the heritage social utility while guaranteeing public safety, but also to make sustainable use of the public fundings allocated to heritage preservation (Mariotti et al. 2023).

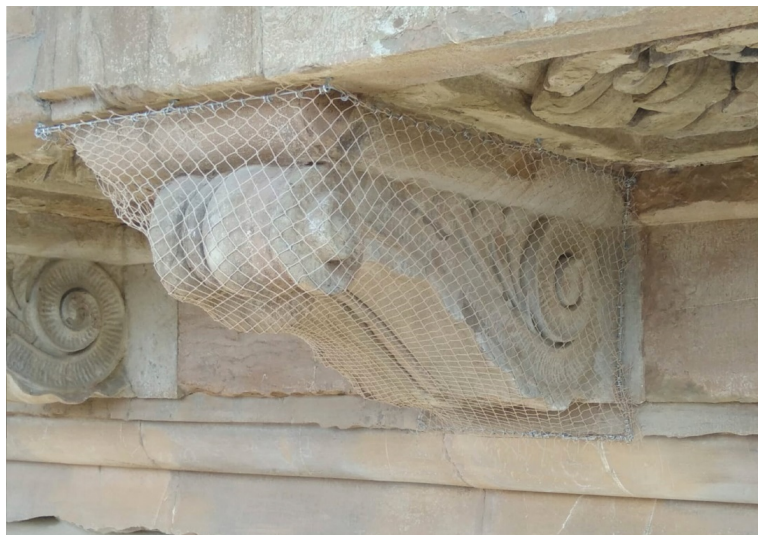
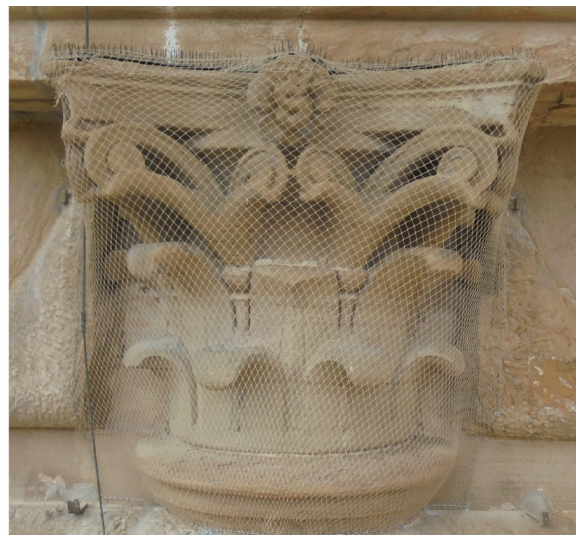
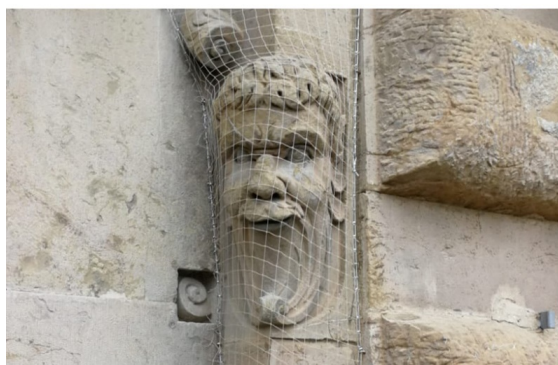
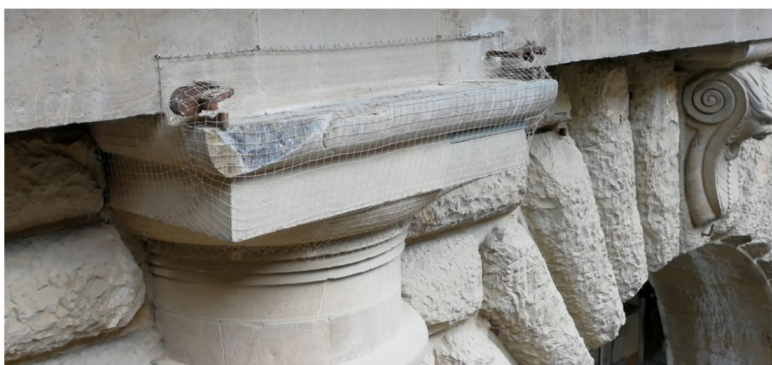
Figure 4. Florence, Pitti Palace, Cortile dell'Ammannati. Temporary fall protection systems made of nylon nets, installed on the façades during the 2018-19 monitoring campaigns (Photos by Stefano Landi and Andrea Bonaccorso 2019).

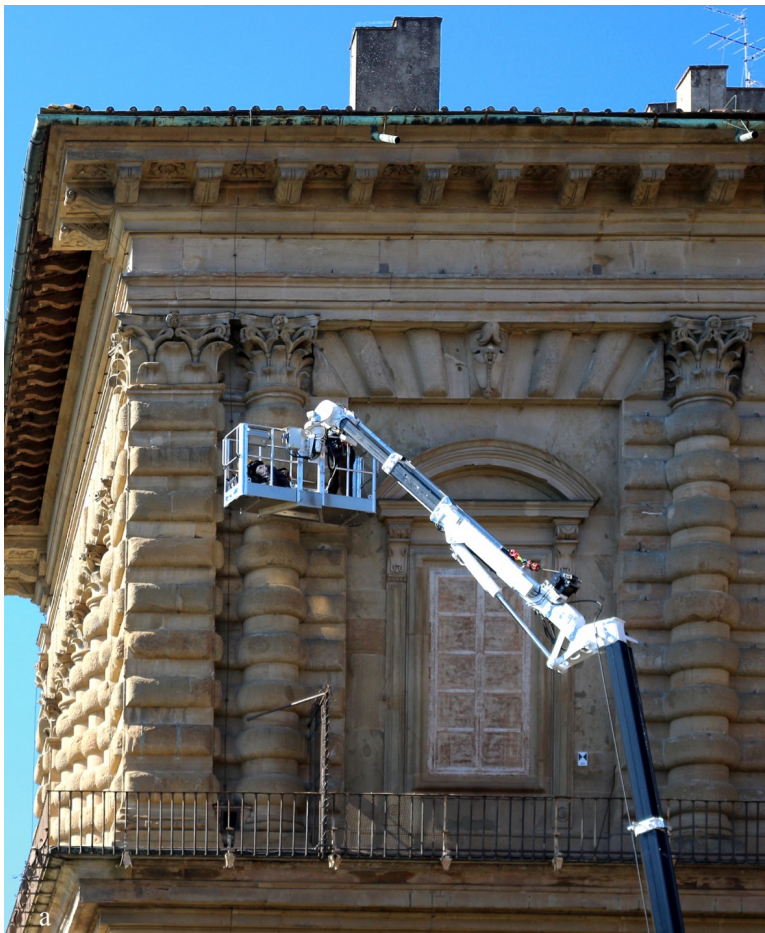
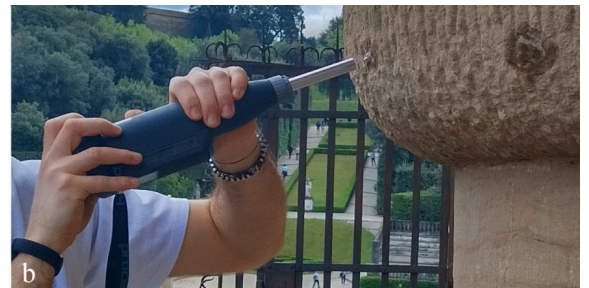
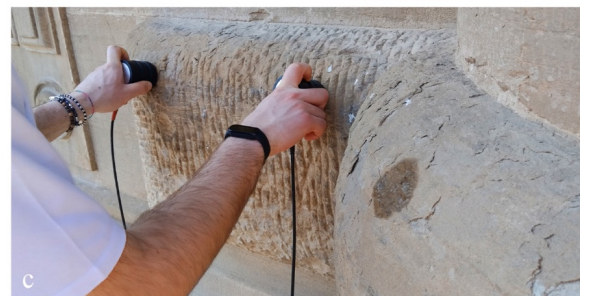
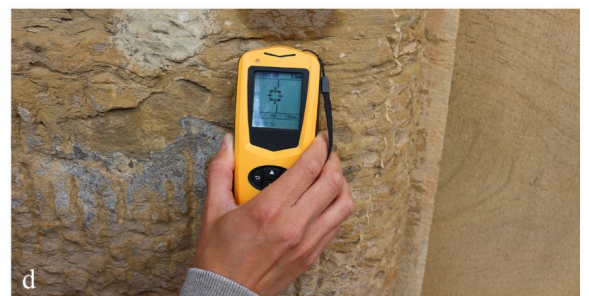
Figure 6. Florence, Pitti Palace, Cortile dell'Ammannati. Monitoring and diagnostic phases carried out by DST-LAM of Unifi: (a) Close-range visual inspection and instrumental analysis of stone surfaces conducted using an aerial platform; (b) Sclerometric testing performed with Original Schmidt live L, Proceq instrument; (c) Ultrasonic testing performed with the IMG 5200 CSD instrument; (d) Pachometric survey, which enables the detection of internal ferromagnetic metal dowels, performed with a DR3000JY, DRC Diagnostic Research Company instrument (Photos by Teresa Salvatici 2022).

DST-LAM is actively involved in extensive research linking the mineralogical, petrographic, physical, and mechanical characteristics of the Florentine sandstones with their state of conservation (Figure 6) (Salvatici et al. 2020; Centauro et al. 2022; Salvatici et al. 2023). This research is especially concerned with events of detachment and fall. In particular, the Pietraforte rusticated ashlar are often protruding architectural elements, which makes them susceptible to decay phenomena induced by weathering. The latter, combined with the physical characteristics of the stone, can lead to the detachment and loss of stone blocks. The study of Pietraforte as a geo-heritage with its morphological, mechanical, physical, mineralogical, and petrographic characterization, is an important starting point for understanding the possible evolution of the decay processes.

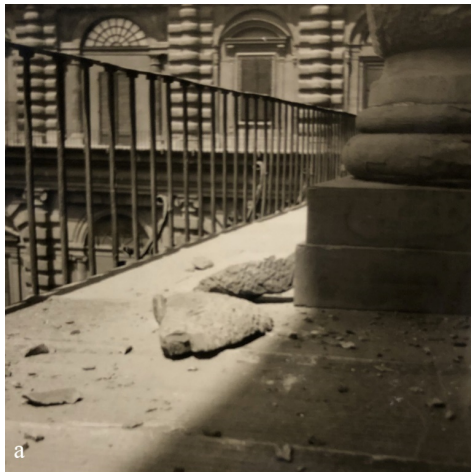
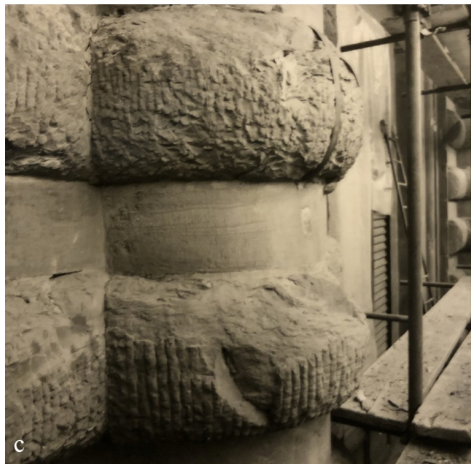
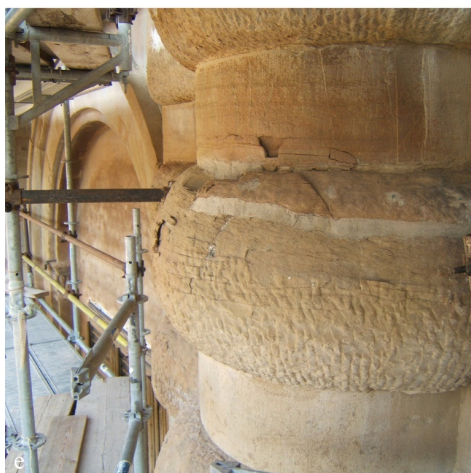
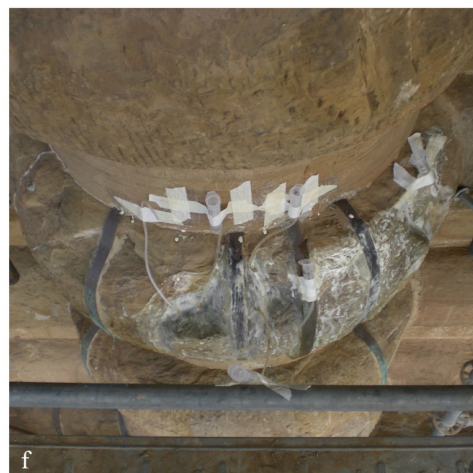
Figure 8. Florence, Pitti Palace, Cortile dell’Ammannati. A brief summary of stone ashlar in a critical state of conservation and consolidation interventions carried out during the XX-XXI century.

(a) Large rusticated ashlar fragments detached from a column on the second floor in 1965; (b) Restoration work on the west facade in 1966; (c) Critical condition of rusticated columns on the second floor in 1976; (d) Installation of metal cramps or binding elements during restoration in 1986; (e) Surface and deep detachment of a rusticated column in 2009; a trace of a previous mortar intervention is also visible. (f) Injections of fluid epoxy resin during restoration in 2011 (Photos a-d are from the Photographic Archive of the Superintendency for Archaeology, Fine Arts and Landscape Heritage of the city of Florence and the provinces of Pistoia and Prato, Palazzo Pitti - Cortile dell’Ammannati, nn. 28908, 32487, 81768, 142621, Photo courtesy of the Italian Ministry of Culture; Photos e-f are from the Uffizi Galleries Archive, Photos by Mauro Linari 2009-11).

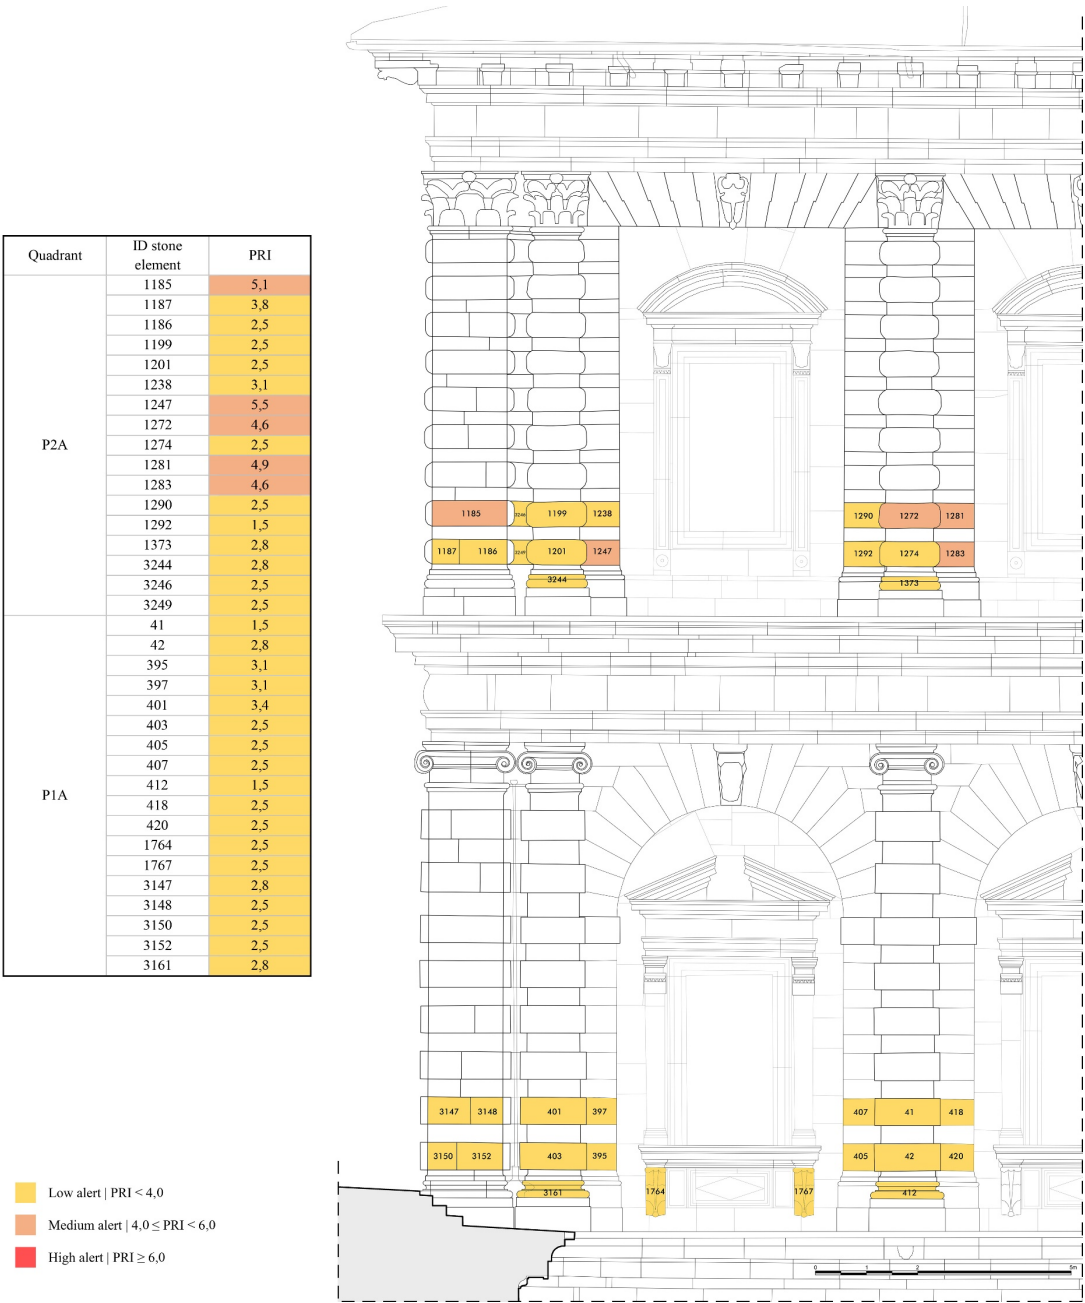
Figure 11. Florence, Pitti Palace, Cortile dell’Ammannati. Previous Restoration Index (PRI) results for sampled stone elements processed through GIS Software (Graphic by Alessandro Ceppetelli).

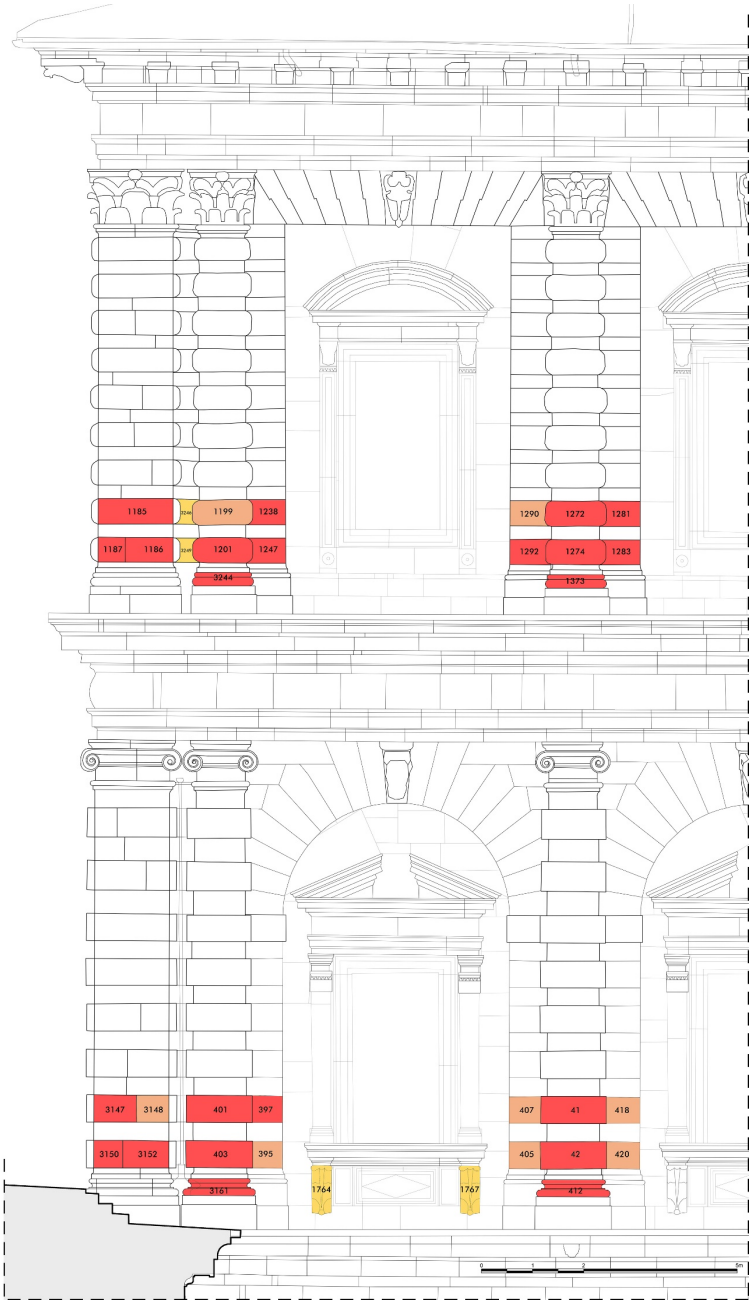
Figure 14. Florence, Pitti Palace, Cortile dell’Ammannati. Deterioration Index (DI) results for sampled stone elements processed through GIS Software (Graphic by Alessandro Ceppetelli).

(2,14) that reflects the exclusion of certain deterioration phenomena which, although having a minor impact on detachment or fall of stone fragments, do in fact exist. While M1 is statistically significant, at this stage of the research it approximates the deterioration of the stone elements, albeit with some remaining uncertainty, and remains subject to further refinement in terms of representativeness. The results of applying the M1 model to the investigated stone ashlar – as in the corresponding column of Table 7 – were subsequently integrated into the GIS environment for further analysis and the extraction of thematic maps (Figure 14).

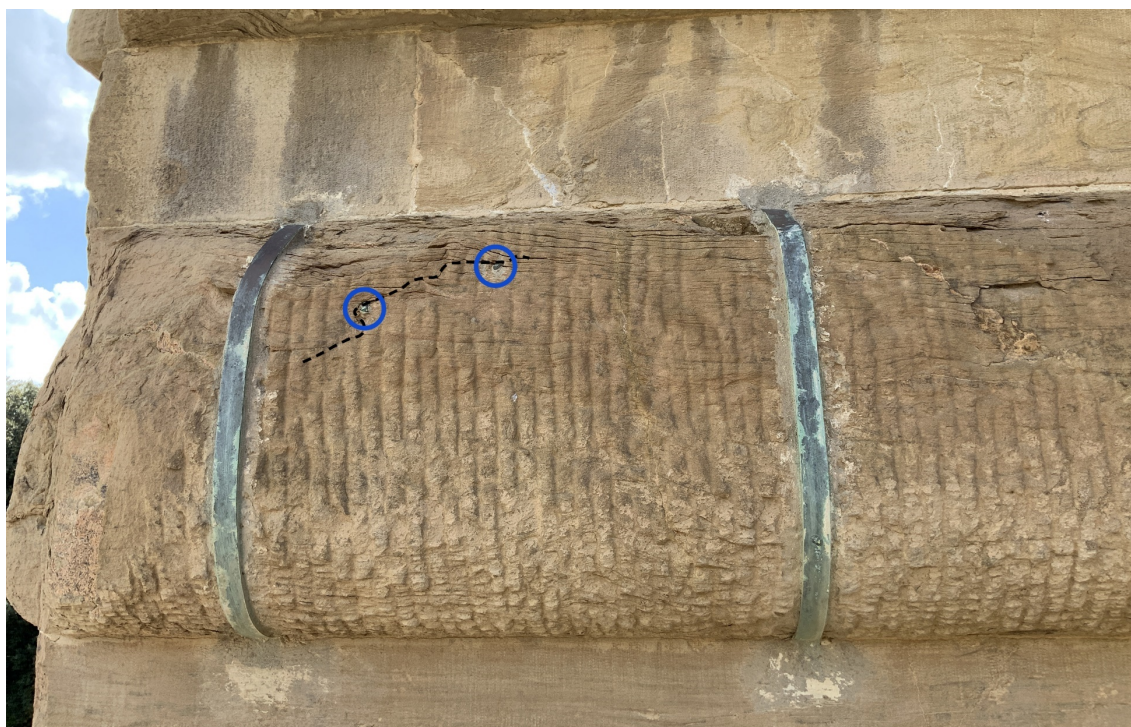
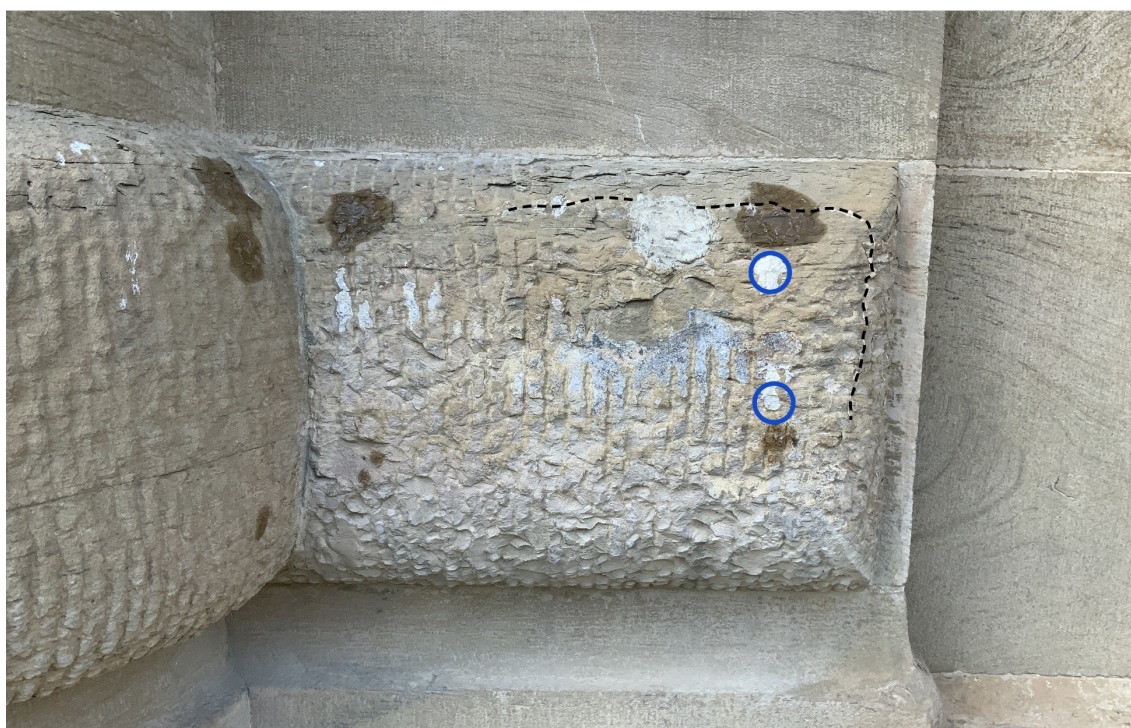
Figure 16. Florence, Pitti Palace, Cortile dell'Ammannati. Critical stone ashlars due to previous interventions and material discontinuities in the test area (Photos by Chiara Mariotti and Alessandro Ceppetelli 2022).

- Metal pin
- Calcite vein

Regarding previous restoration works, their contribution has been considered by assessing the proportional relation between the invasiveness of the interventions and the need for action for safety reasons. Although this approach tends to simplify the complexity of the real-world impact of restorations, it does not diminish the alertness to the areas most affected by conservation efforts. On closer inspection, often some restoration works are beneficial in preserving the ancient material, some have no benefit (zero contribution), while others accelerate degradation. In this regard, there are interventions that have contributed to the conservation of the stone elements; however, there are also cases where it has proved ineffective or has even increased or aggravated the deterioration, as proved by some particularly critical elements (Figure 16).
