Experimental and Numerical Investigation of Historic Brickwork Masonry with Weak and Degraded Joints: Failure Mechanisms Under Compression and Shear

Erica Magagnini *, Vanni Nicoletti and Fabrizio Gara

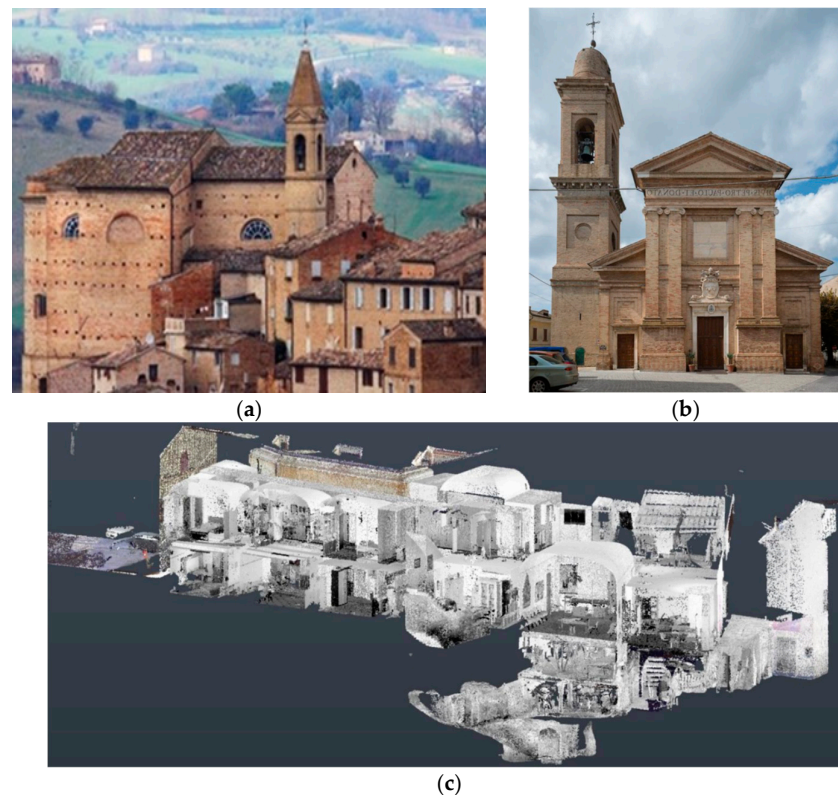
Figure 1. (a) View of the church of Santa Maria Ausiliatrice in Montottone (FM); (b) church of San Pietro in Corridonia (MC); (c) laser scanning of the building complex of the San Pietro church.

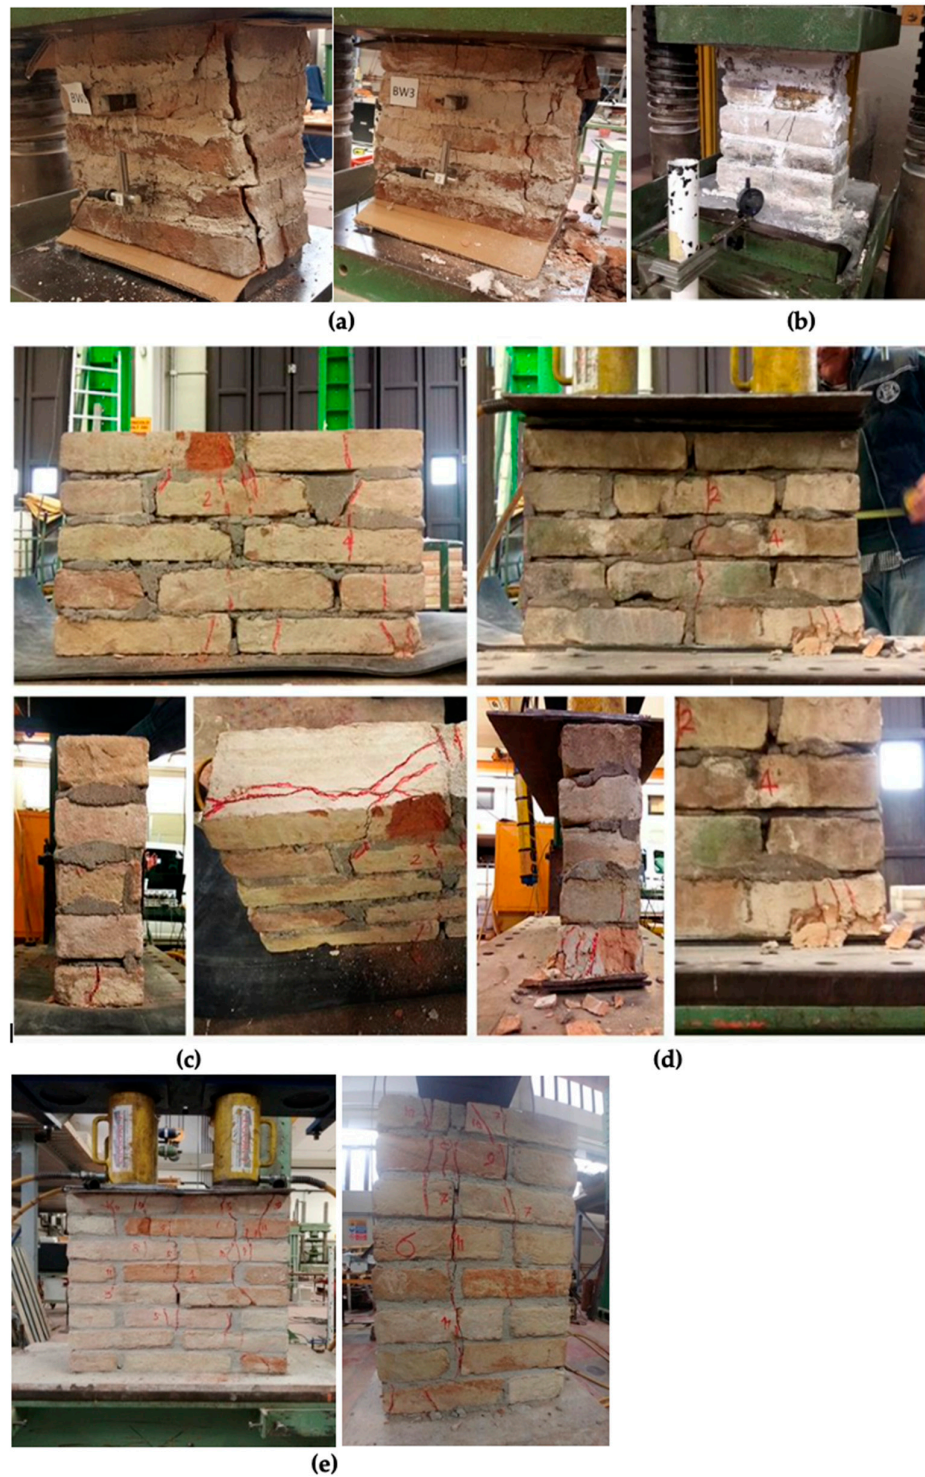
Figure 8. Failure mode of masonry specimens under compression load: (a) P2 and P3; (b) P4; (c) W1; (d) W2 and (e) W3.

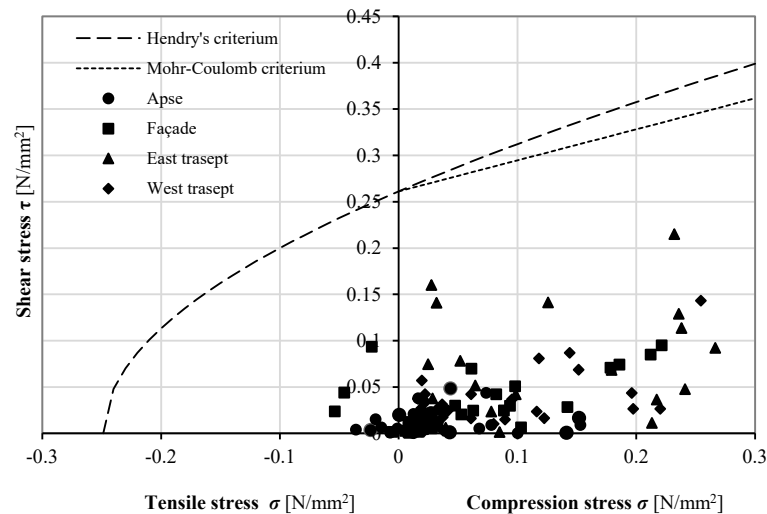
Figure 21. Comparison between stress state obtained by FEM and shear failure criteria provided by Hendry and Mohr–Coulomb.
