Stone Architecture in Abruzzo: Seismic Risk Analysis of Bell Tower of the Church of San Lorenzo in San Buono

ABSTRACT

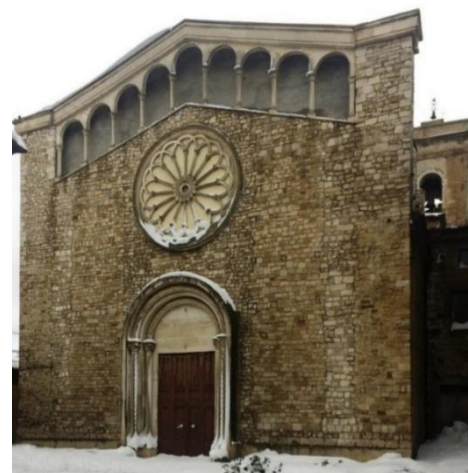
Figure 1. Main elevation

In the transformation of the above mentioned building, many important designers of the area follow one another, from the architects Di Rienzo and Aloisio in the early 19th century to the engineer Castelli and the more recent Genio Civile of Chieti in the mid-20th century (11). The church in its present form is a fusion of various earlier buildings. It is the result of the Caracciolo-Pisquizi princes' desire for renewal. Figure 1 shows the main view of the building.

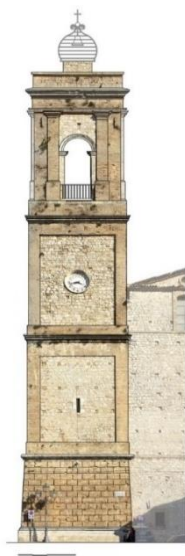
Figure 2. Belltower: elevation view

The bell tower which was restored in 1893 by the engineer Castelli, rises more than 40 metres above the main square. Its height is divided into four registers. The earth extension consists of a steep ashlar base: this is the only part in which this material is used. The first register consist of projecting brick rectangular cornices that delimit the masonry. The third register is completely empty and houses the bell tower with arches on all four sides framed by composite-style brick pilasters.

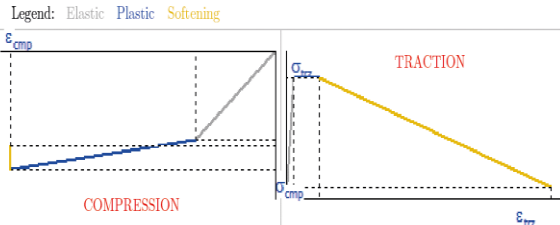
Figure 3. Constitutive law of masonry

Figure 3 shows the constitutive law for the masonry material.

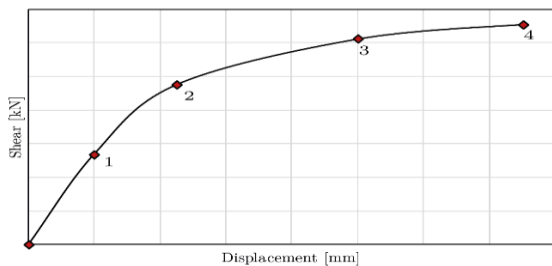
- i. Point 1: Linear branch of the curve, where the material still exhibits elastic behaviour;
- ii. Point 2: yielding of the structure; at some points, plasticisation of the material is observed and the first cracks begin to spread;
- iii. Point 3: plastic stretch, where cracks increase and almost the entire structure is in the plastic phase;
- iv. Point 4: collapse of the structure.

Figure 1. Capacity curve (qualitative)

Figure 4 shows the typical trend for a masonry capacity curve.

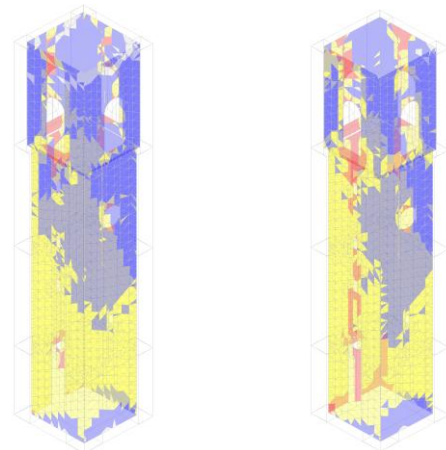
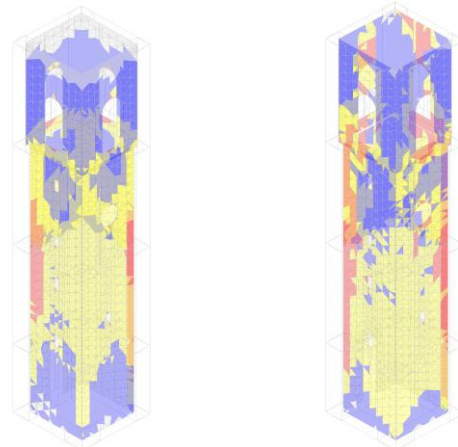
Figure 5 shows the evolution of the crack pattern for the unconfined tower, with force distribution proportional to the first mode of vibration (-x direction).

Point 3 Point 4
Figure 5. Damage evolution: unconfined tower with distribution proportional to the I mode of vibration and earthquake direction -x

The results shown both refer to the wall adjacent to the square, for the analysis in the -x direction. For both models, the first cracks appear at the belfry due to the geometric singularities of the structure. The cracks then

propagate from intermediate structural weaknesses (i.e. internal staircase lighting slits), until they reach collapse (Point 4), with cracks spreading along almost the entire shaft of the tower.

It can be seen how the influence of the degree of constraint is fundamental for the structure's crisis fashion: neglecting the interaction of the adjacent building (i.e., isolated tower) results in a different crack pattern at collapse. In fact, in the first case a brittle crisis mode can be considered, while in the second case there is a more diffuse plasticity behaviour, with cracks localized at the top of the structure instead of at the base (generalised collapse).

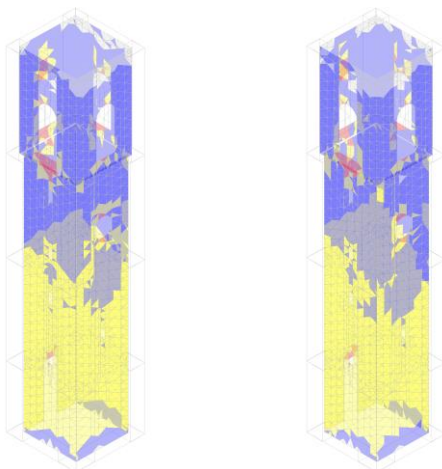
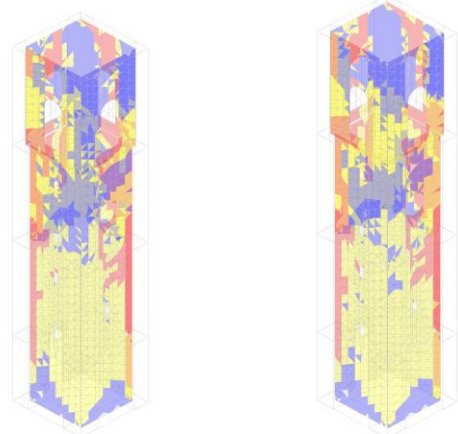
Figure 6 shows the evolution of the crack pattern for the confined tower, with force distribution proportional to the first mode of vibration (-x direction).

Point 3 Point 4
Figure 6. Damage evolution: confined tower with distribution proportional to the I mode of vibration and earthquake direction -x

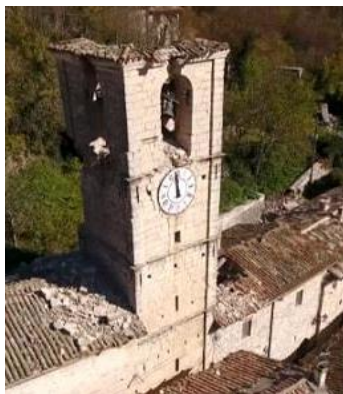
Figure 2. Belltower in Castelsantagelo, damaged by the earthquake in 2016 (confined tower)

To validate the crack evolution model, it is possible to observe the two real cases that occurred in Italy (Figure 7 and 8).

The crack patterns observed in the real cases reflects the patterns obtained by the nonlinear static analysis. Figure 9 shows the Capacity Basket for the C/D index (i.e., capacity/demand) of the tower displacement.

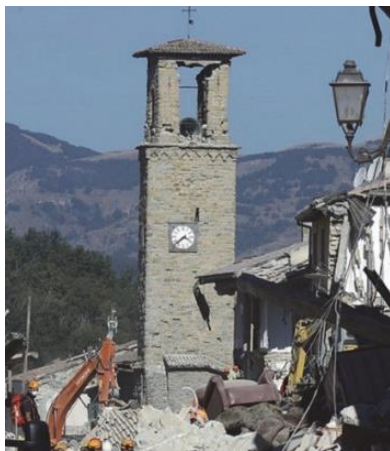
Figure 8. Belltower in Amatrice, damaged by the earthquake in 2016 (unconfined tower)

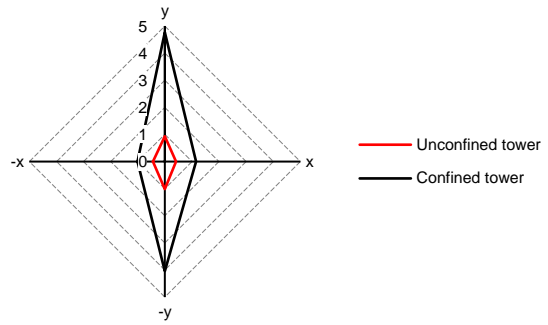
Figure 9. Capacity basket for the Capacity/Demand index with proportional distribution at I mode of vibration and earthquake direction -x

It can be observed that in the x-direction the confinement offered by the surrounding walls has the positive effect of doubling the ratio considered and increasing it significantly (+480%) in the y-direction, allowing the structure to meet the displacement requirements for both directions in the confined configuration.

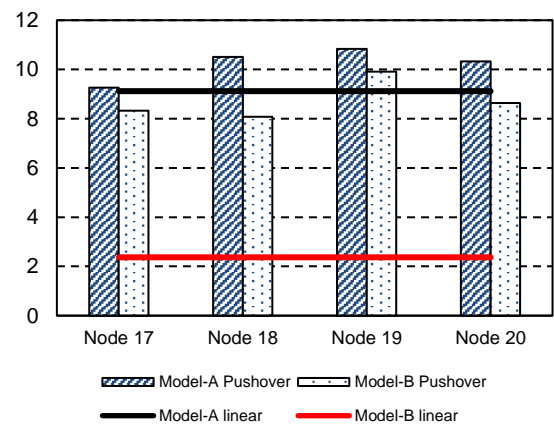
It can be observed that the linear model allows the displacement of the free cantilever to be predicted with good approximation (i.e., Model-A), while it significantly underestimates the maximum displacement in the case of the confined tower (i.e., Model-B). The effect of the confinement offered by the surrounding masonry is reflected more in the stress distribution in the masonry than in the maximum displacements. In fact, the greatest influence is observed in the mode of propagation of the crack pattern.

Figure 10. Comparison of the displacement (cm) from simplified linear and pushover analyses

Figure 10 shows the comparison between the maximum displacement results for the 4 nodes at the top of the tower according to the simplified linear model and the pushover analysis.
