# A Multisensor-Based Measurement Procedure for Seismic Damage Identification in Buildings

**Abstract**—Effectively and precisely identifying damages after a seismic event is fundamental to ensuring timely intervention and optimizing the building life cycle. The combination of multisensor inspection and artificial intelligence (AI) technologies is powerful in this context. This work presents the results of the development of a multisensor measurement procedure relying on drone-embedded visible and thermal cameras and a terrestrial laser scanner (TLS) to acquire data on a masonry church damaged by an earthquake. These data were carefully aligned into a unified reference system and enabled the reconstruction of high-resolution 3-D models of the building, from which multichannel orthophotos were extracted, with visible, thermal, and depth data, to identify surface lesions. The analysis procedure involved three main stages: 1) preprocessing using principal component analysis (PCAs) to improve feature separability and reduce redundancy between channels; 2) lesion detection using a deep learning U-Net segmentation model trained to identify surface cracks; and 3) morphological postproces

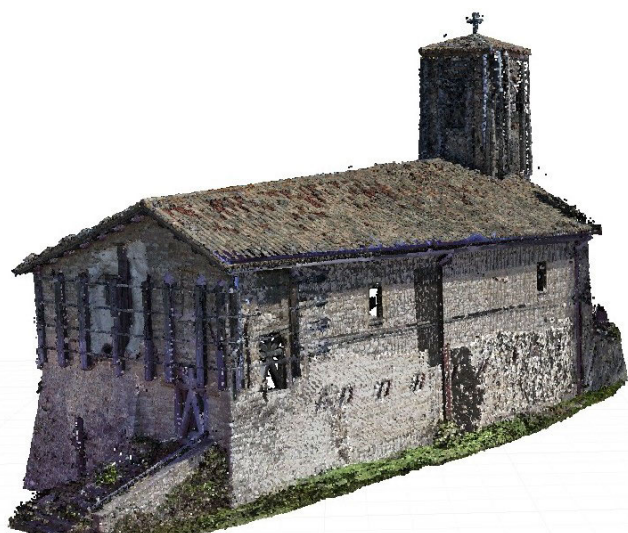
Fig. 2. Point cloud of visible (RGB) block.

The differences between qualities used in different blocks were determined by the computational power required. Figs. 2 and 3 show the point clouds obtained from the two blocks, i.e., visible and thermal, after the overall processing.

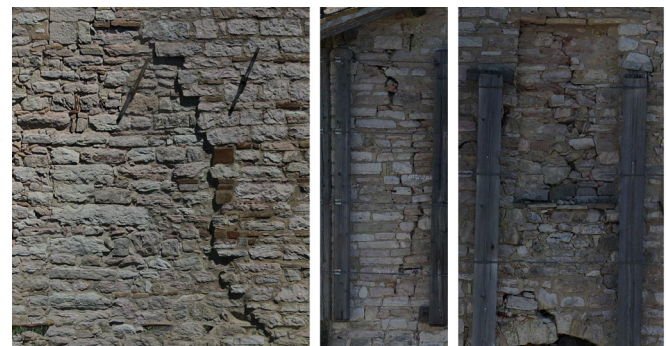
Fig. 8. Three areas of interest extracted from orthophotos: on the east façade (left) and on the north façade (center and right).

From the orthophotos obtained from the 3-D reconstruction of the façades, the three areas of interest were extracted, shown in Fig. 8, where the structural damages were most severe. The PCA applied to the three areas has produced the images shown in Figs. 9 (top), 10 (left), and 11 (top), as first and second PCs.

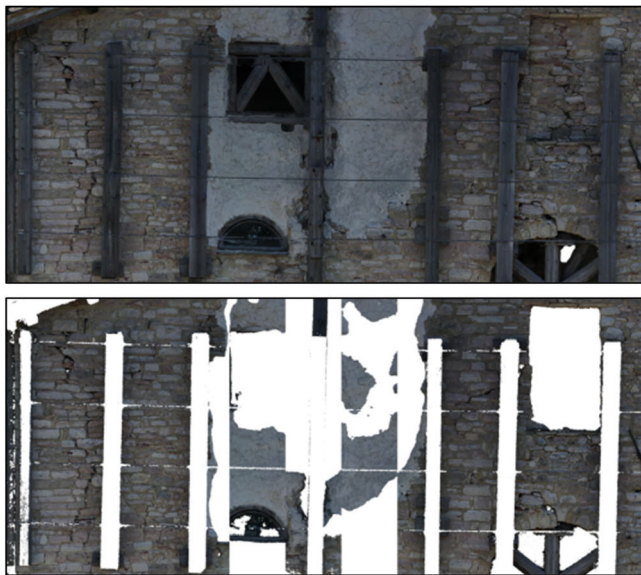
Fig. 13. Upper part of the north façade (visible bands, top), and the same after the application of the depth-based filter (bottom).

The application of the depth-based filter led to the removal of areas of out-of-plane wall; Fig. 13 compares the upper part of the north façade before and after the filter application.

For each façade, the white areas were excluded from the merged masks previously obtained, being identified as non-crack pixels due to their distance from the mean depth plane, and the resulting masks for the three areas of interest are shown in Fig. 14. On the newly produced masks, the final filter based on region properties was applied, as explained in Section II-C.
