AUTOMATIC MONITORING OF THE BIODETERIORATION OF HISTORICAL BUILDING'S FACADES THROUGH CONVOLUTIONAL NEURAL NETWORKS (CNN)

Marco D'Orazio^{a*}, Andrea Gianangeli^a, Francesco Monni^a, Enrico Quagliarini^a

^a Department of Construction, Civil Engineering and Architecture (DICEA), Università Politecnica delle Marche, via
Brecce Bianche, 60131 Ancona, Italy

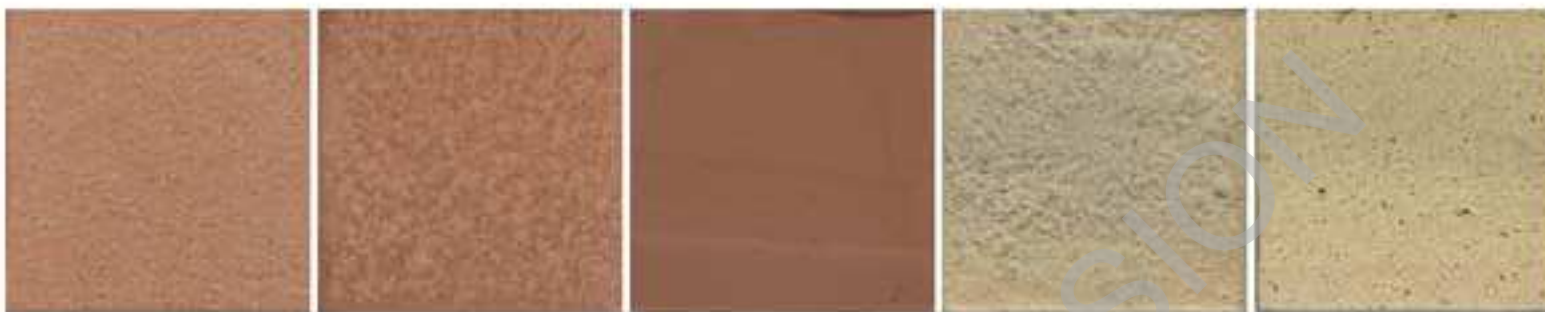
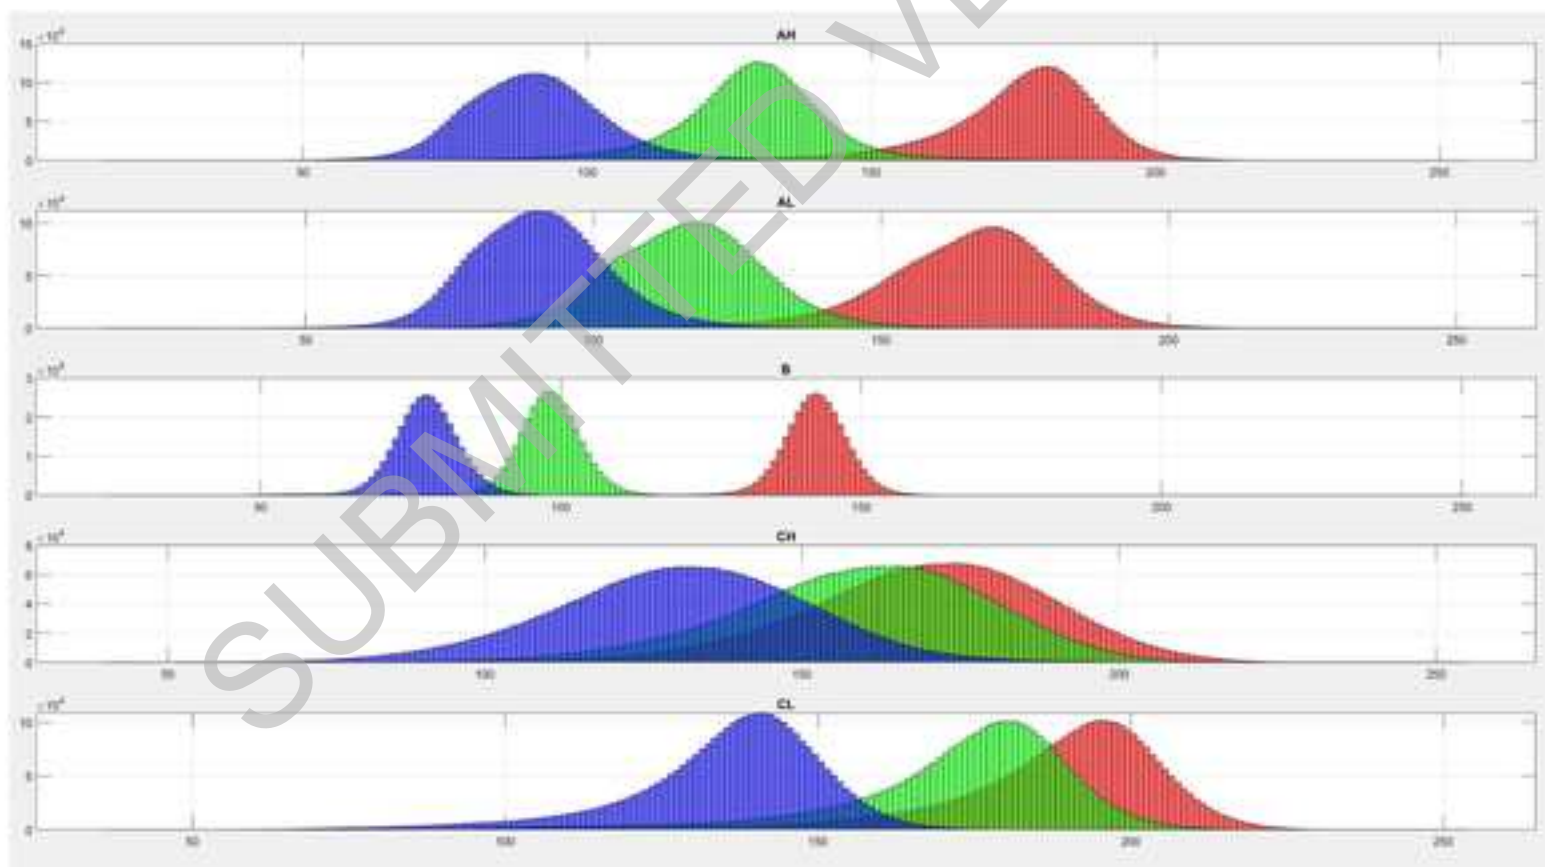
As can be seen in Figure 5a, microalgae growth initially causes the comparison of little dark green spots (2), then the spots create more large green areas interconnecting with each other (3). These areas assume a typical shape, with largest spots and "filamentous" areas due to the water drainage. In the last phase microalgae growth cause the comparison of light green spots over the initial dark-green spots (4). The shape and the color of these spots and areas can be different depending on the brick's surface characteristics, the growth's phase, and the environmental conditions (Figure 5b).

Figure 6 shows the variation of CIELab mean values (DE) of the brick's surfaces during the experimental activity. Each curve represents the mean values of 27 measurement points (9 points x 3 samples). It is possible to observe a progressive increase of the DE values. DE reached 45-55 values for CH and CL samples after 35 days, 30-35 values for B (after 65 days), and 30-40 values for AH and AL (after 112 days) due to the microalgae coverage. A slight reduction of the peak values has been observed for samples AH and AL after 133 days. Considering that just DE values ≥ 2 are clearly perceived by the human eye, the color variation is very relevant, reaching a peak of 65 (CL) and confirming the observations made with the DI (Figure 5b).
