Detection of infill wall damage due to earthquakes from vibration data

Vanni Nicoletti^{a1}, Davide Arezzo^a, Sandro Carbonari^a, Fabrizio Gara^a

Abstract

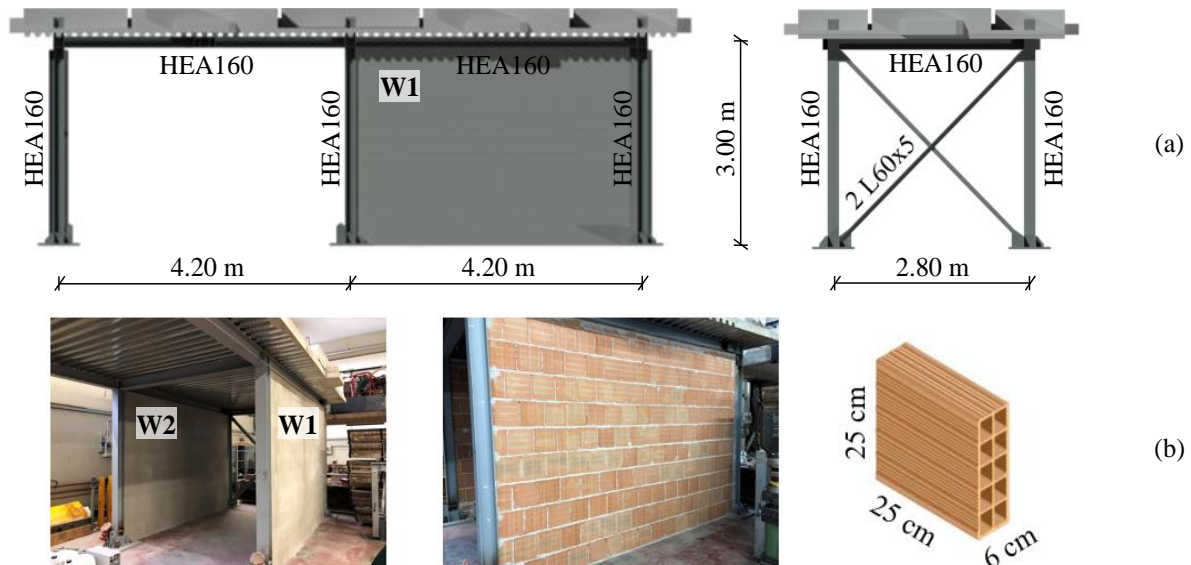
Figure 1. Laboratory mock-up: (a) longitudinal and transverse schemes, (b) infill masonry walls.

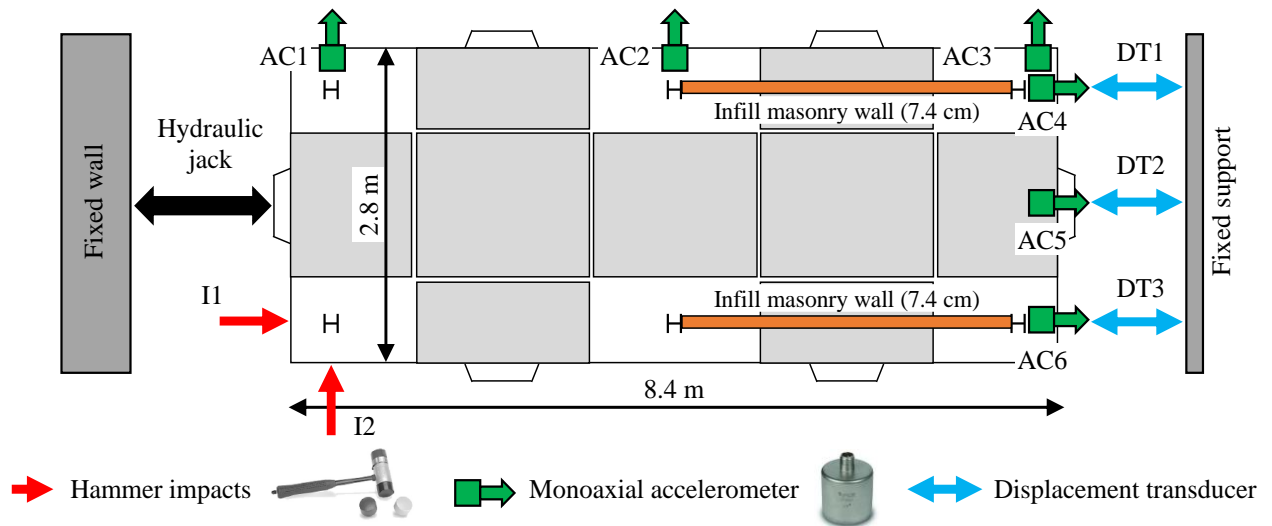
Figure 2. Instrumentation adopted for quasi-static and dynamic tests.

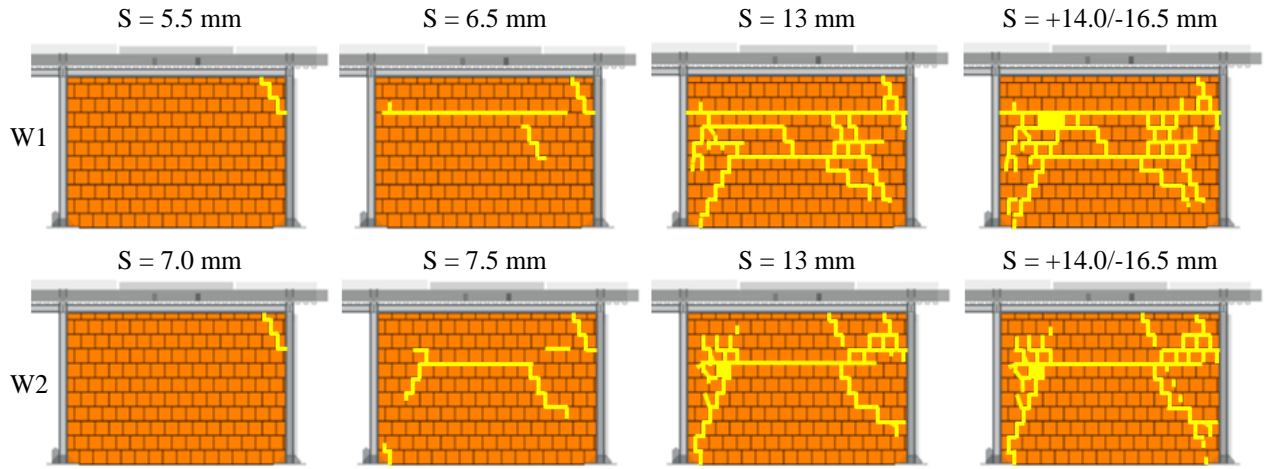
Crack patterns on infills are surveyed during the whole CLT campaign and the most significant ones for the evaluation of the damage evolution on infills are illustrated in Figure 3. Both infills exhibited no visible cracks up to an actuator stroke minor than about 5.0 mm (real drift around 0.90‰), then shallow and narrow diagonal cracks occurred on the top corners. For a stroke equal to 6.5 mm (real drift of 1.39‰), a horizontal crack around the mid height of W1 panel occurred along a bed joint, whereas a similar crack appeared in W2 at a stroke equal to 7.5 mm (real drift of 1.93‰). By increasing the actuator stroke, stair-stepped cracks began to form and to get longer in both walls. At the end of CLTs (actuator stroke of 13.0 mm and real drift of 3.90‰) both walls exhibited a similar shear failure mechanism and were completely cracked.

Figure 3. Crack patterns on infills surveyed during CLTs.

Finally, results of the +14.0/-16.5 mm (real drift of 4‰) CLT are considered and discussed. Observing the relevant crack patterns of Figure 3 it is evident that both infills experienced a further damage, with bricks spalling (yellow bricks) in both panels. The secant stiffness of the mock-up is calculated as well, and results are reported in Figure 5; the mock-up secant stiffness in the pull direction shows a more pronounced reduction, being greater the difference between the actuator stroke and the maximum real displacement registered by transducers with respect to the push direction.

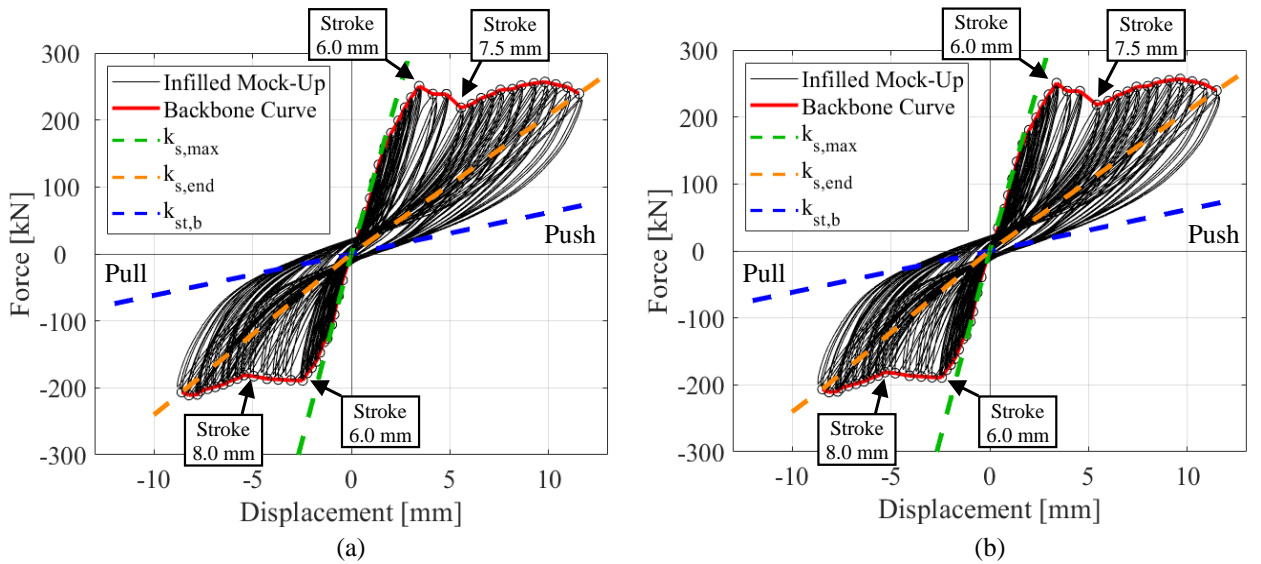
The mock-up hysteretic cycles obtained from the experimental tests are depicted in Figure 4, together with their backbone curves. The latter show sudden drops in correspondence of an actuator stroke between 6.0 mm and 8.0 mm in push and pull directions; this sharp decrease is due to an important damage of both infills that leads to a reduction of both the IP stiffness and strength of the walls. However, the IP strength of infills kept increasing after this drop, while the secant stiffness (i.e., the equivalent stiffness associated to the maximum displacement achieved during a step) continued to reduce,

Figure 4. Mock-up hysteresis loops and backbone curves: (a) DT1, (b) DT3.

tending to the static stiffness of the bare mock-up ($k_{st,b}$); the latter, represented with dashed blue lines in Figure 4, is calculated based on the ramp of the displacement-force graphs obtained from SBTs on the bare frame, which is characterised by an almost linear behaviour. The analysis of cycles obtained for different strokes highlights a peculiar trend of the shear force-displacement relationships that is due to the progressive damage of infills and to the evolution of the resisting mechanisms of the non-structural elements with respect to horizontal loads. Indeed, as also demonstrated by the crack patterns previously discussed, the infill resistant mechanism to lateral forces is firstly governed by the shear response of the wall panel as a whole, which leads to the opening of horizontal cracks on the upper side of the walls, whereas, for higher actuator strokes, a strut mechanism on infills activated, leading to the opening of diagonal stair-stepped cracks.

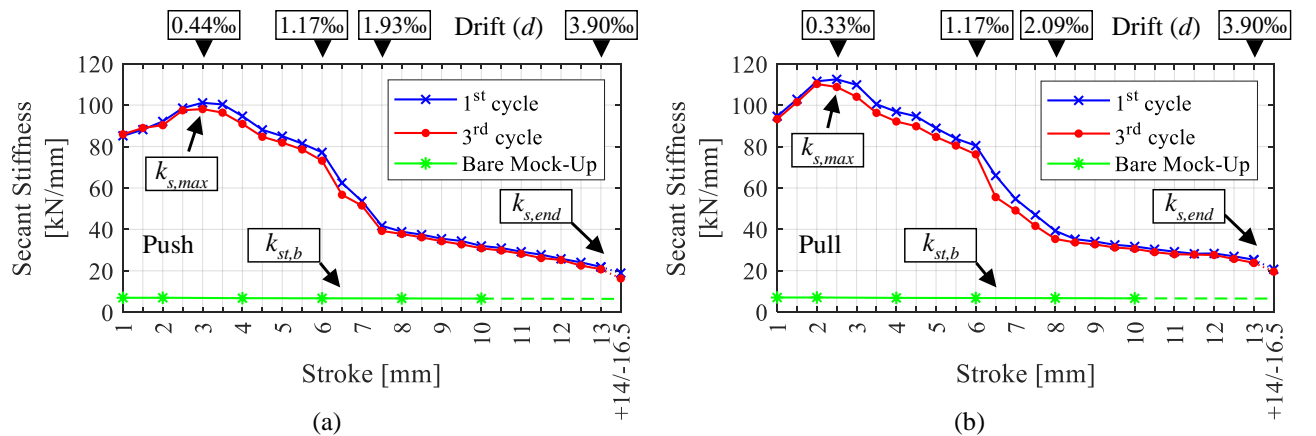
The secant stiffness is calculated based on the first and third load cycle measurements for each stroke. The obtained values are plotted in Figure 5 (data from the first and the third load cycles are separately considered, plotted with blue and red lines, respectively), differentiating for push and pull directions. With reference to the secant stiffness evaluated from the first cycle (blue lines), it can be observed an initial longitudinal stiffness increase, probably because a certain level of displacement is necessary to activate the infill resisting mechanisms; then, after reaching the peak, a decrease is observed, and a sudden drop is well visible for strokes ranging between 6.0 and 8.0 mm (real drifts varying from 1.17% and 2.09%). Finally, an almost constant decrease is noticeably up to the end due to the degradation of the final resisting mechanisms (essentially constituted by the frictions forces developing between cracks). The last stiffness values, although much lower than those relevant to the undamaged infills, are higher than the static stiffness relevant to the bare mock-up, demonstrating that the damaged walls, which have suffered almost 4‰ of interstorey drifts, still contribute to the longitudinal stiffness of the structure. To obtain a further comparison, the maximum ($k_{s,max}$) and the final ($k_{s,end}$) secant stiffnesses, together with the static one relevant to the bare frame ($k_{st,b}$), are represented with dashed lines in Figure 4. The secant stiffness calculated from data of the third load cycle of each step are also shown in Figure 5 with red lines. For strokes below 2 - 2.5 mm, the blue and red lines are almost superimposed; then, when infills start to damage, little differences are observed, and the red curves are always below the blue ones because of the degradation of the resisting mechanism due to the increasing number of cycles. In the last part of the graph, the two lines are still almost superimposed, revealing that the number of cycles no longer contributes to the degradation of the resisting mechanism.

Figure 5. Mock-up longitudinal secant stiffness evolution: (a) push and (b) pull direction.

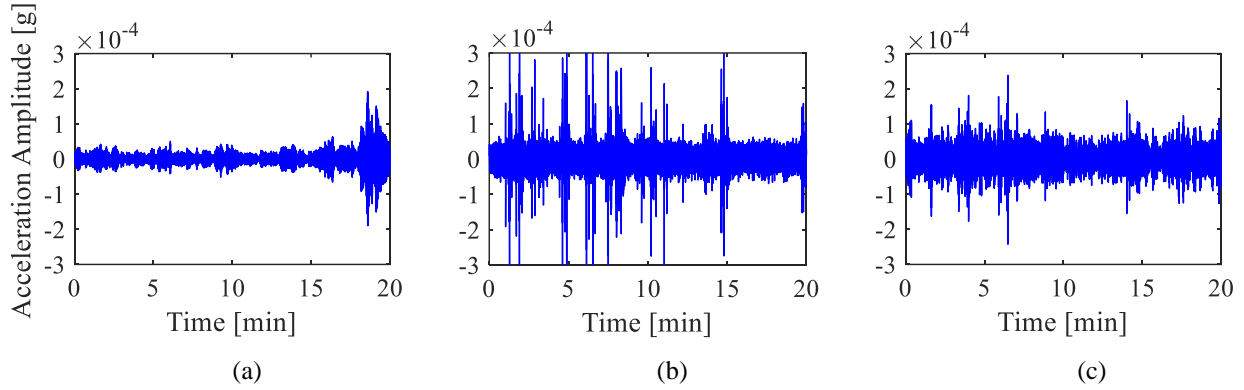
Figure 6. Accelerations recorded during AVTs: (a) bare mock-up, (b) mock-up with undamaged infills, (c) mock-up with damaged infills.

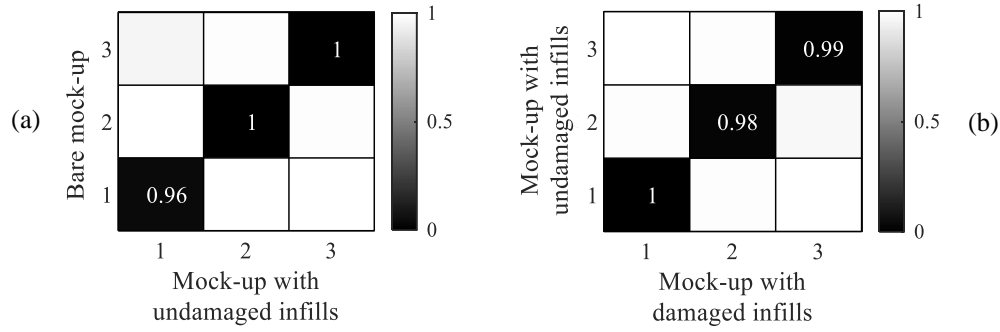
Figure 7 depicts the mode shapes identified from the three performed tests, while in Figure 8 the Modal Assurance Criterion (MAC) indexes are reported. The latter are calculated between the same vibration mode shapes relevant to two consequent tests and provide an indication of how the mode shapes are similar to each other: the closer the index to one (black box), the more the mode shapes are similar. Observing Figure 8 it is possible to state that the mode shapes remain almost always the same, both after the infill construction and after the infill damage, and also the MAC indexes are very close to one. Only the first mode shape (relevant to the longitudinal mode) changes a bit after the infill construction, as can be also noted from the mode shapes represented in Figure 7, where the longitudinal mode relevant to the undamaged infills is slightly coupled with the rotation, probably due to the non-perfect symmetry of the two walls.

Figure 8. MAC indexes between the identified mode shapes: (a) bare mock-up vs mock-up with undamaged infills, (b) mock-up with undamaged infills vs mock-up with damaged infills.

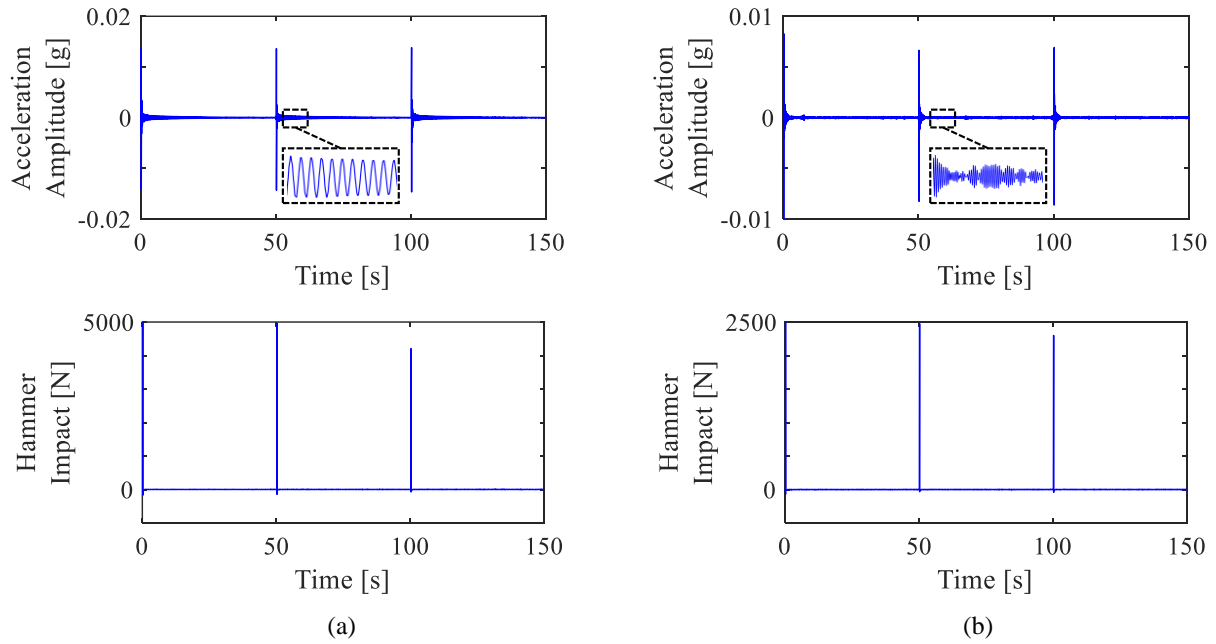
Figure 9. Examples of acceleration and impact records: (a) bare and (b) infilled mock-up.

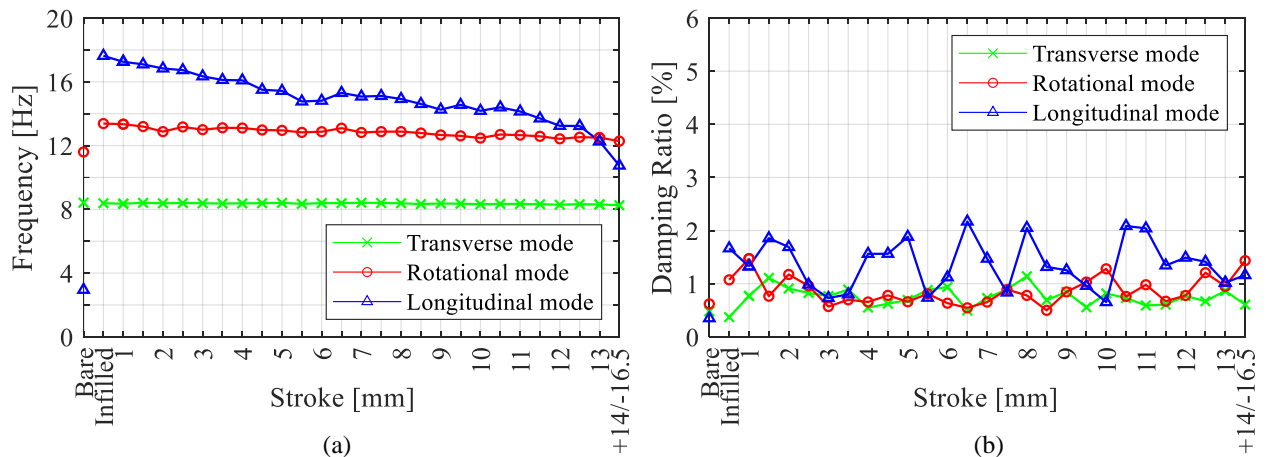
Figure 10. Mock-up modal parameters identified from ILTs: (a) resonant frequencies, (b) damping ratios.

Identified damping ratios are plotted in Figure 10b; in this case, no evident trends are visible. Nonetheless, it is worth observing that damping of the transverse and torsional modes are around 1% (values that are fully compliant with those obtained from the AVTs) while damping relevant to the longitudinal mode presents a higher variability, with values varying between 1 and 2%. This higher variability can be reasonable justified by recognising that the infill damage mainly affects the mock-up response in that direction, even if values are still low.

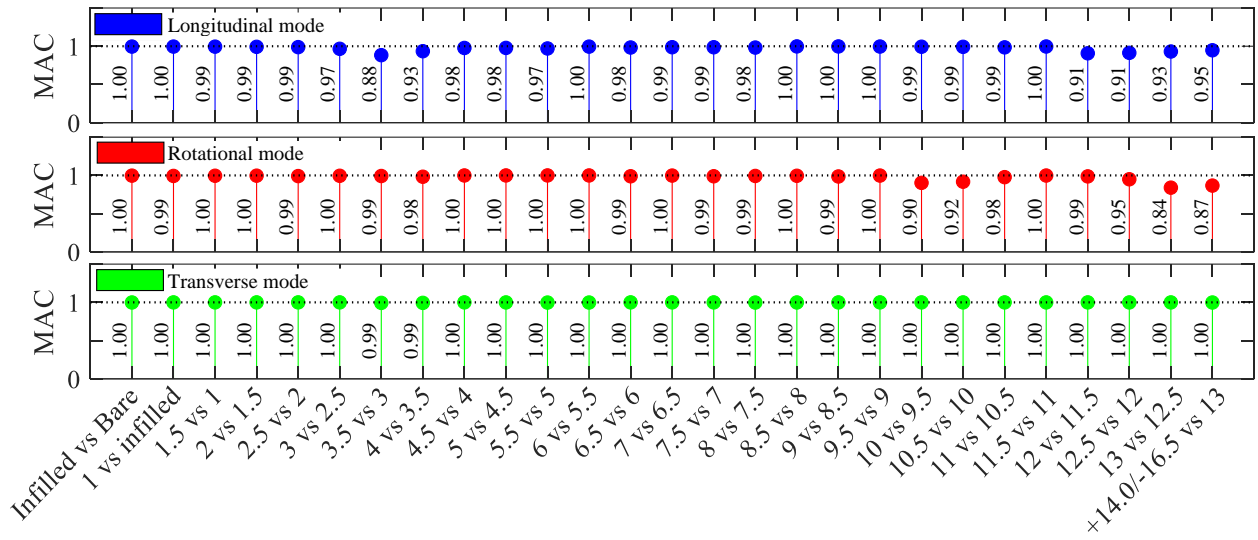
As before, mode shapes are compared using MAC indexes, and results are reported in Figure 11. Each mode shape is compared with the corresponding one at the previous step of the experimental campaign. For what concerns the longitudinal mode, the highest variations in the mode shapes are observed at the beginning of the CLTs (between strokes of 3.0 and 3.5 mm) and at the end of the experimental campaign (for strokes between 11.0 and +14.0/-16.5 mm), even if these variations are almost negligible, due to the relative high values of MAC indexes (never lower than 0.88). The changes found at the beginning are probably uncorrelated with the infill cracking, while changes found at the end of the experimentation are probably attributable to the development and enlargement of infill cracks. Similar considerations stem

Figure 11. MAC indexes between mode shapes identified from ILTs.

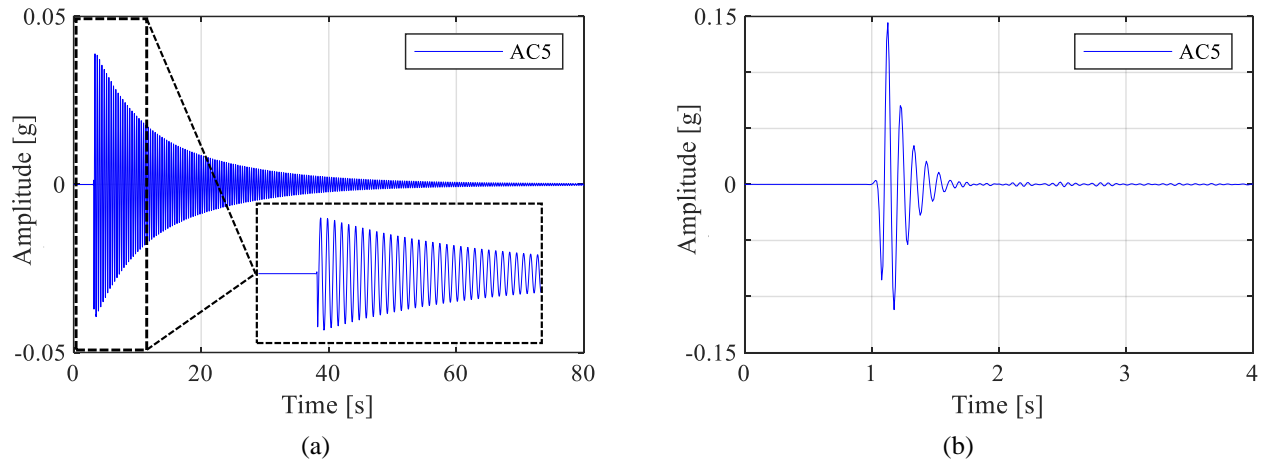
Figure 12 shows the accelerations recorded from sensor AC5 during the tests with 2.0 mm of stroke, both for bare and infilled structure. It can be noted that the acceleration amplitudes experienced by the bare mock-up are much lower than those of the infilled one, due to the much higher stiffness of the latter. Moreover, SBTs on the bare mock-up produced a very high number of cycles, contrarily to what happened to the infilled structure, where the higher structural damping quickly dampens the oscillations. During the SBTs performed on the infilled mock-up, the acceleration amplitudes ranged from around 0.05 g (for the stroke of 1.0 mm) to 0.5 g (for the stroke equal to 13.0 mm).

Figure 12. Accelerations recorded by AC5 during the 2.0 mm SBT: (a) bare and (b) infilled mock-up.

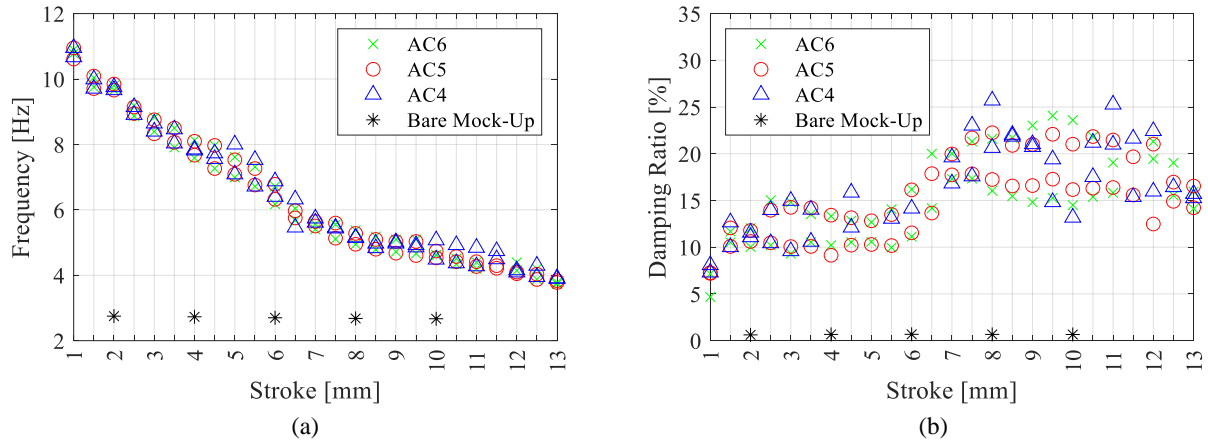
13b. In this case, some trends are clearly evident: from the beginning up to a stroke of 5.5 mm, the damping is almost constant with values around 10-15%, then it increases up to a stroke equal to 7.0 mm, due to the development of the main damage on infills, and finally it remains almost constant, with values around 15-25%.

Figure 13. Modal parameters of the mock-up longitudinal vibration mode: (a) frequencies, (b) damping ratios.

The lower frequency value reached for each SBT (f_{STFT-l}) is determined analysing the STFTs, together with a rough estimation of the higher frequency values to which the mock-up tends after the oscillation (f_{STFT-h}). Indeed, the latter frequency is quite difficult to be estimated from STFTs since the free vibration parts of the accelerometric signals present a wide frequency band rather than an evident peak, as clear from Figure 14. The range of f_{STFT-l} and f_{STFT-h} at each SBT is reported in the candlestick graph of Figure 15, where it is evident that the trend of f_{STFT-l} is very similar to that reported in Figure 13a.

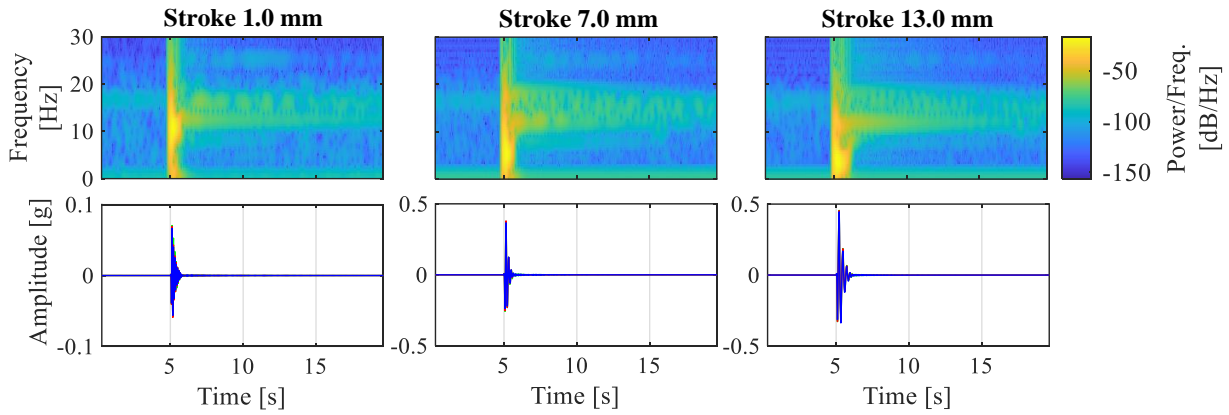
Focusing on a single SBT, it is worth noting that the frequency of the longitudinal vibration mode exhibits a non-stationary evolution over time. This phenomenon is evident observing Figure 14, where Short Time Fourier Transforms (STFTs) of accelerations measured by accelerometers for three different actuator strokes (1.0, 7.0 and 13.0 mm), are depicted. In all cases it is possible to see a sharp decrease of frequency in correspondence of the beginning of oscillations, namely when the mock-up is suddenly released; then, the frequency tends to return to higher values. The frequency decrease is mainly due to the high level of oscillation amplitudes at the beginning of test, which activate non-linear mechanisms on infills, as frictions between the steel members and the infills, and frictions between cracks, resulting in a high deformability of the mock-up. After that, the oscillation amplitudes sensibly decrease, and the frequency tends to increase. Above phenomena have been also treated in other scientific works^{49,50}.

Figure 14. STFTs of the SBT accelerometric signals for strokes of 1.0, 7.0 and 13.0 mm.

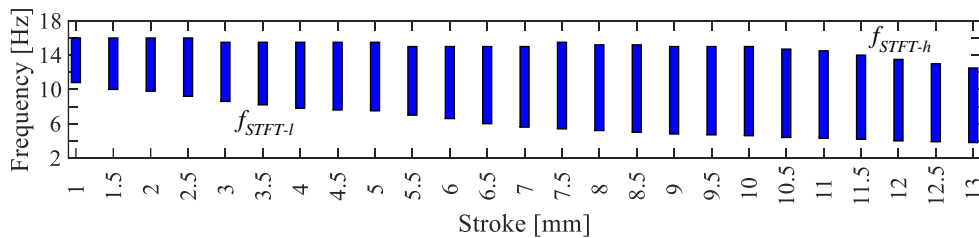
Figure 15. Range of frequency values estimated for each SBT from STFTs.

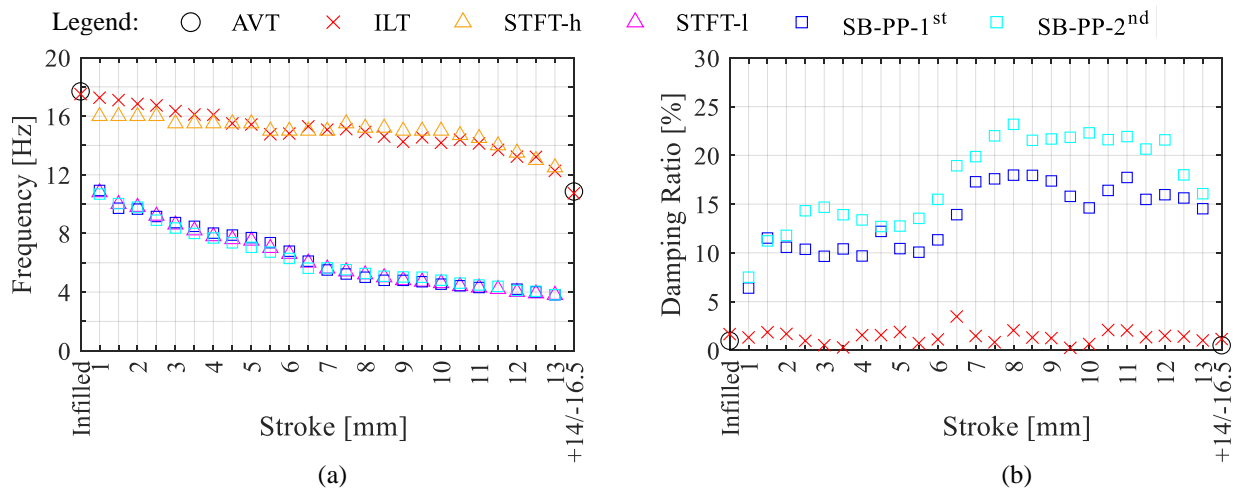
At first, the resonant frequencies identified at each step of the CLT procedure are considered, and reported in Figure 16a. As can be noted, two different groups are well visible: the first one on the upper part of the graph refers to frequency values identified from AVTs and ILTs, together with those estimated from the free vibration part of the STFT graphs (STFT-h); the second one, placed on the bottom level, refers to frequencies identified through peak picking method starting from SBT measurements (Snap-Back Peak-Picking considering the 1st cycle, SB-PP-1st, and Snap-Back Peak-Picking considering the 2nd cycle, SB-PP-2nd), and frequencies estimated from STFT graphs in correspondence of the mock-up release during SBTs (STFT-l). These two frequency groups identify two test groups that are characterised by different level of amplitude excitations; in detail, the first one gathers frequencies identified from tests with low level of input excitation, while, for the second one, the level of excitation increases. The frequency interval between them demonstrates that longitudinal frequency is sensitive to oscillation amplitudes on which non-linear phenomena depends. Nevertheless, it is noteworthy to point out that a frequency decay is always visible, considering all performed test typologies, demonstrating a mock-up global stiffness decrease due to the progressive infill damage. Hence, it can be asserted that tracing frequency values is a useful tool to monitor the health status of a structure and to support the damage identification procedure. However, the observed frequency decay is almost linear, so that it cannot help to detect the specific phases of the experimental campaign (strokes and drifts) in which the main damage occurred. This is also evident by observing data of Table 3; indeed, focusing on the percentage variations calculated based on frequency values identified from low-amplitude tests, no evident variations are found in correspondence of the horizontal cracks formation (for which an almost constant frequency trend is evident). However, when infills are completely damaged (horizontal and diagonal cracks are occurred), the drop in frequency is very important (-30%). The same considerations stem from the analysis of high-amplitude frequency trends. It is interesting to observe that the drastic drop of longitudinal secant stiffness experienced by the mock-up for strokes between 6 and 8 mm (as visible in Figure 5) is not associated to an equally sharp decrease in longitudinal frequency. In fact, as previously observed, the frequency decays detected from low- and high-amplitude tests are almost linear. For low-amplitude tests this may be reasonably since the dynamic excitation provided to the mock-up is not so high to activate non-linear and dissipative mechanisms; as for high-amplitude tests (SBTs), the phenomenon may be justified by the fact that the non-linear mechanisms (e.g., due to frictions) are activated only for the few cycles characterised by the higher amplitudes, as can be seen from Figure 12b. It is worth pointing out that for real buildings a frequency decay should be detected for all vibration modes and, especially, for the first translational ones, which are those mainly influenced by the IP stiffening contribution of infills. Moreover, a non-uniform damage of infills (as well as of structural members) can also lead to changes on the dynamic response of a building, which means that both frequencies and mode shapes may vary. So, tracing the frequency decay together with controlling the mode shapes could allow the triggering of possible damage and, in some cases, also to locate it.

Figure 16. Longitudinal mode of the infilled mock-up: (a) resonant frequency and (b) damping ratio evolutions.

The group on the bottom part of Figure 16b (AVTs and ILTs) does not show any visible trend; contrarily, the group on the upper part (SBTs) illustrates two evident trends: low damping values at the beginning followed by a noticeably increment (starting from a stroke of 5.5 mm) up to a value that remains almost constant till the end. Differently from frequencies, damping ratios identified from tests with a low excitation level are not useful to investigate dissipative capabilities of the damaged mock-up since no significant trends are recognised, so their use in a SMH monitoring is not meaningful. On the other hand, damping ratios identified from SBTs are capable to capture steps when the main damage to non-structural components occurs. This is also confirmed by observing data of Table 3, in which a high increasing in damping is observed when the horizontal cracks occurred in the infills (about +50%). The almost constant damping ratio after the horizontal and diagonal crack opening demonstrates that infills have developed a stable dissipative mechanism that is independent on the amplitude of oscillations. Summarizing, it can be asserted that the evolution of damping ratios can be suitably identified from recordings of SHM systems in case of low seismic events (or during the seismic swarm following a main shock). In other words, outcomes of this research relevant to SBTs can be correlated to those achievable from the analysis of acceleration (and/or velocity) records due to earthquakes, able to activate non-linear phenomena on the building.

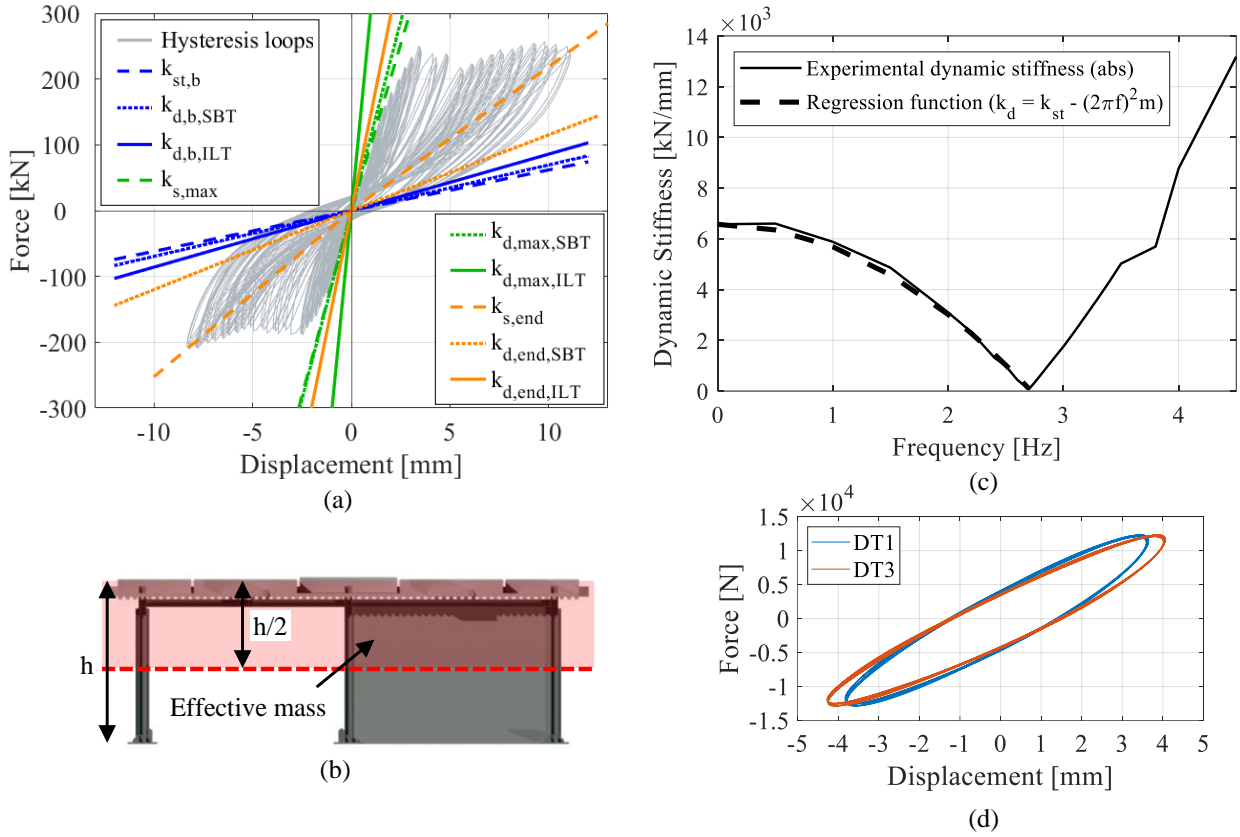
Also, quasi-static tests (CLTs) and dynamic ones (AVTs, ILTs and SBTs) can be compared in terms of stiffness that characterises the mock-up longitudinal behaviour. Figure 17a reports hysteretic cycles obtained from DT1 measurements (those of DT3 provide a very similar graph) and secant stiffnesses calculated in crucial phases of the experimental campaign. It is worth remembering that these secant stiffnesses need to be considered as an equivalent stiffnesses for the mock-up, especially once it experienced a certain level of damage. The dynamic stiffnesses (k_d) are calculated starting from results of different tests and assuming that the mock-up behaves as a SDOF system in longitudinal direction, which is a reasonable hypothesis considering that the majority of mock-up mass is concentrated at the floor level. Thus, the simple formula providing the fundamental frequency of a SDOF systems can be adopted to get the system dynamic stiffness according to $k_d = 4\pi^2 f^2 m$, where m is the effective mass and f the natural frequency of the longitudinal vibration mode.

Figure 17. (a) stiffnesses overlapped to hysteresis loops, (b) hypotesys effective mass calculation, (c) experimental dynamic stiffness and regression function for the bare frame mass estimation, (d) example of steady hysteretic cycles for $f = 2$ Hz on the bare frame.

To compute the contribution of infills on the effective mass m , half height of walls is considered, as reported in Figure 17b, while the effective mass of the bare mock-up is determined exploiting results of FVTs. The latter are performed on the bare mock-up at different frequency excitations and for a stroke equal to ± 4 mm (Table 1). From FVTs, the dynamic stiffness of the bare mock-up (i.e., the force necessary to produce a harmonic displacement of amplitude 4 mm) can be determined by dividing the output (displacement) by the input (force) evaluated at stationary conditions. The obtained absolute values of the dynamic stiffness as a function of the excitation source frequency, are shown with a black continuous line in Figure 17c. Instead, Figure 17d shows typical hysteretic cycles obtained from tests at steady conditions. By supposing the damping of the bare structure to be negligible, the dynamic stiffness of the SDOF system can be determined with the regression function $k_d = k_{st} - (2\pi f)^2 m$, and the contribution of the bare frame to the effective mass can be estimated by adopting the previous formula to interpolate experimental data once k_{st} is known. The latter term (k_{st}) is obtained from SBT results executed on the bare frame. At the end of these procedures, the effective mass of the bare mock-up is estimated equal to 24 t, and the relevant regression function is shown in Figure 17c with a dashed black line. Consequently, the total effective mass of the infilled mock-up is obtained adding the effective mass of the bare mock-up with that of the infills, obtaining $m = 25$ t. It is worth mentioning that the real value of the mass of each infill is evaluated during the wall demolition by weighting all waste materials.
