Università Politecnica delle Marche  
Scuola di Dottorato di Ricerca in Scienze dell'Ingegneria  
Curriculum in Ingegneria Civile, Ambientale, Edile e Architettura

# **Existing Bridge Vulnerabilities: The Case of Prestressed RC Dapped-end Beams**

XXXVI edition

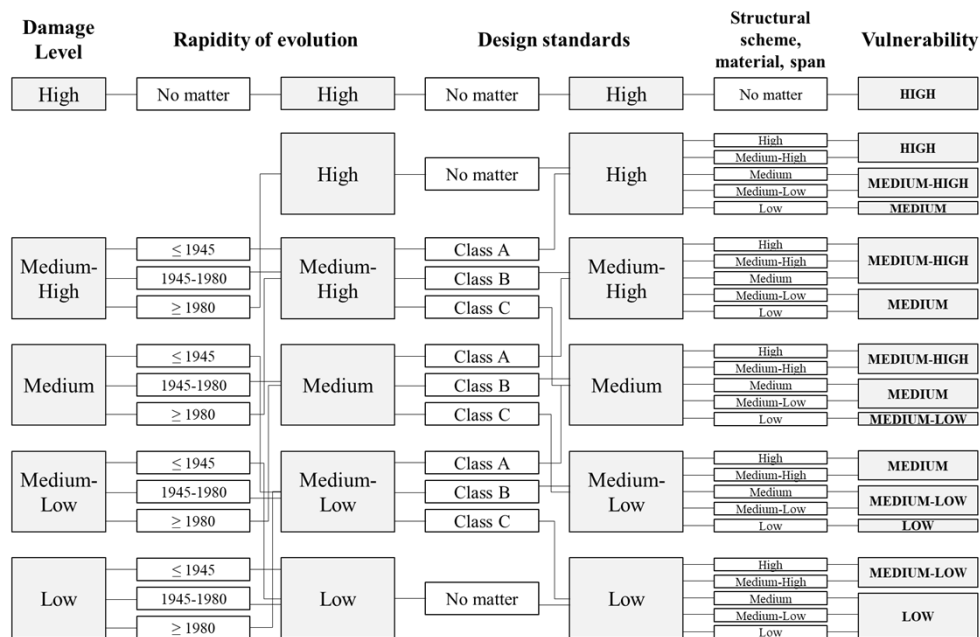
Figure 4. Vulnerability class of the structural and foundation Class of Attention.

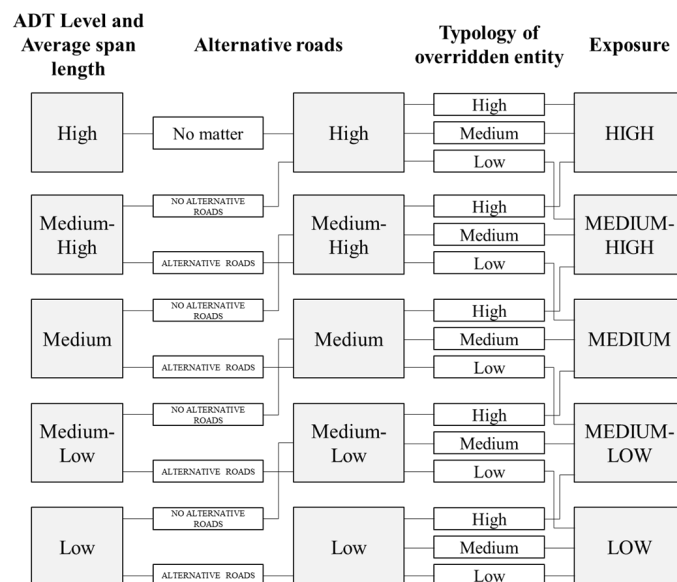
Figure 6. Exposure class of the structural and foundation Class of Attention.

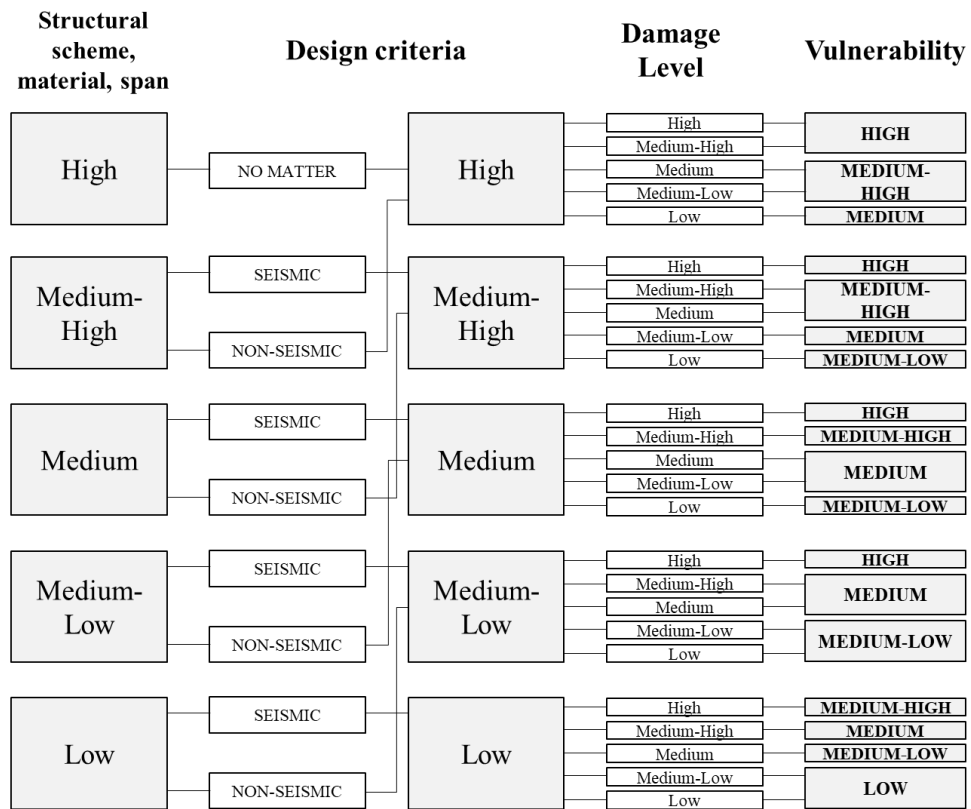
Additional parameters affecting the seismic vulnerability of the structures are related to the design criteria, which can be defined as seismic or non-seismic depending on the year and design standard adopted and the level of damages. The latter is assessed based on visual inspections conducted at Level 1 and is based on the judgment criteria adopted for structural and foundational damage level assessment, focusing on any defects in critical sections such as supports and pier ends or critical conditions such as ongoing kinematics or loss of support. The vulnerability class is determined by following a logical path that starts from the vulnerability associated with the structural scheme, the number of spans and material, and ends with the design criteria and damage level (obtained from on-site inspections), as shown in Figure 11.

Figure 11. Vulnerability class of seismic class of attention.

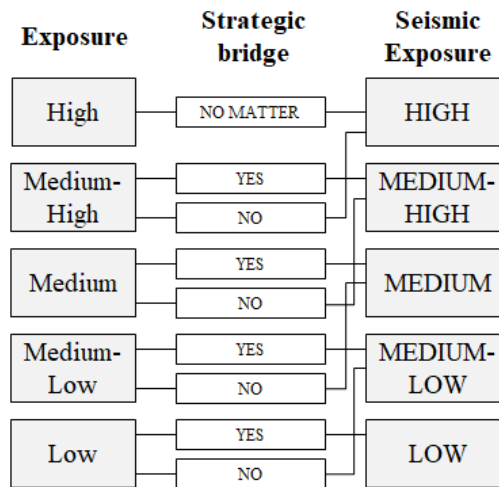
The assessment of seismic exposure class starts from the exposure level related to the structural foundation attention class; specifically, the latter is increased if the bridge is defined as strategic in case of emergencies, or remains unchanged for non-strategic bridges (Figure 12).

Figure 12. Seismic exposure class of seismic attention class.

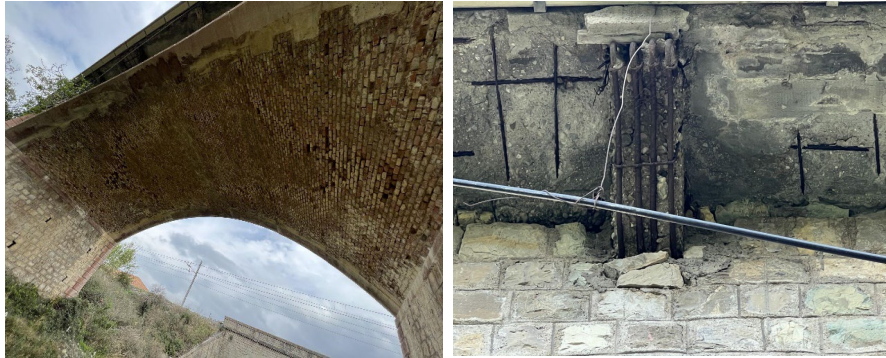
the cover spalling has exposed the reinforcement that appear corroded (right picture of Figure 16).

*Figure 16. Material degradation on the arch (left) and cover spalling and reinforcement corrosion on the concrete slab (right).*

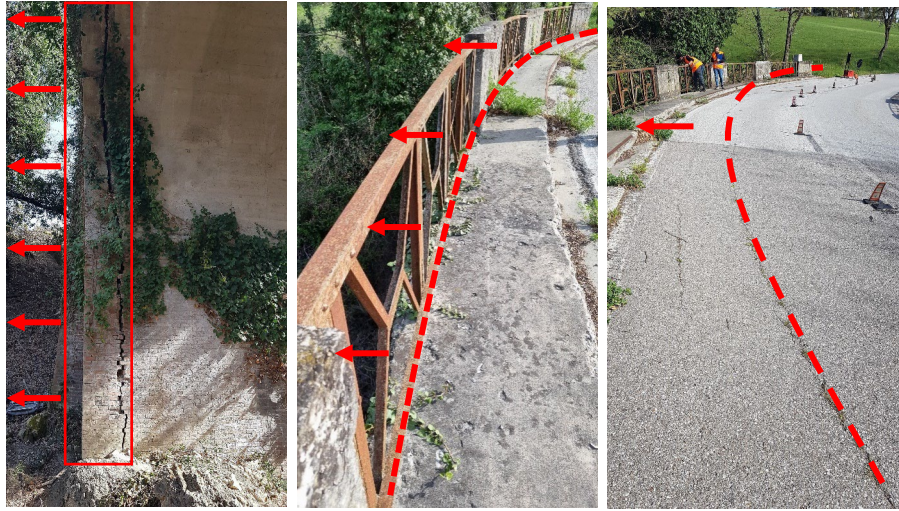
An ongoing mechanism that is causing a portion of the masonry to overturn out of plane was detected in the second curved masonry arch bridge.. The out of plan failure mechanism, is visible from the road pavement, where it is possible to notice a deformation of accessory elements and pavement (Figure 17), and by inspecting both the arch and the abutments, where there are wide cracks along the masonry texture (Figure 18).

*Figure 17. Out of plane failure mechanism of the curved masonry arch bridge.*

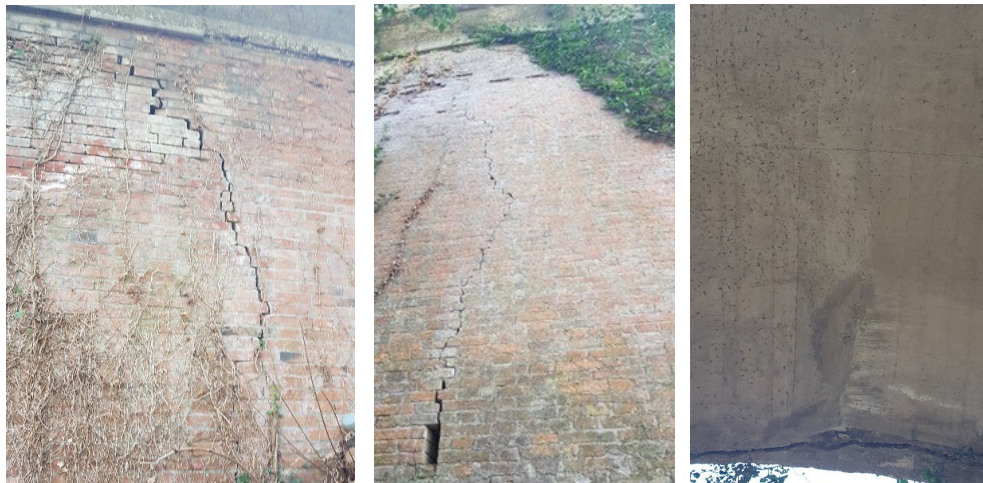
*Figure 18. Cracks along the masonry texture on abutments and concrete arch.*

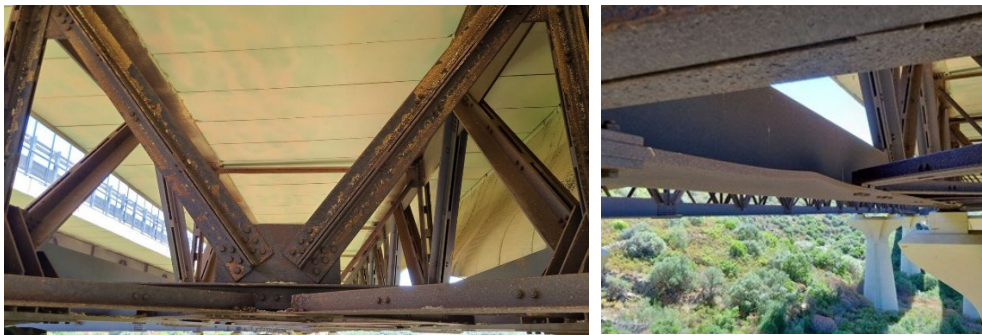
Figure 21. Steel corrosion of the Corten steel (left) and impact damages on beams (right).

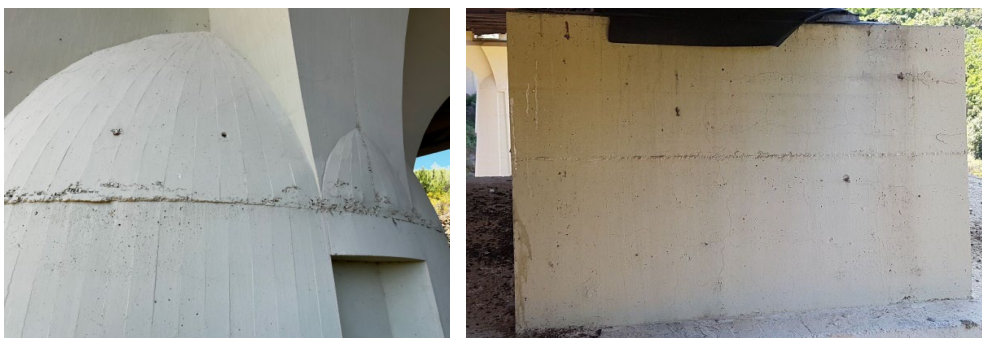
Figure 22. Concrete honeycombs on pier (left) and shrinkage cracks on concrete cap (right),

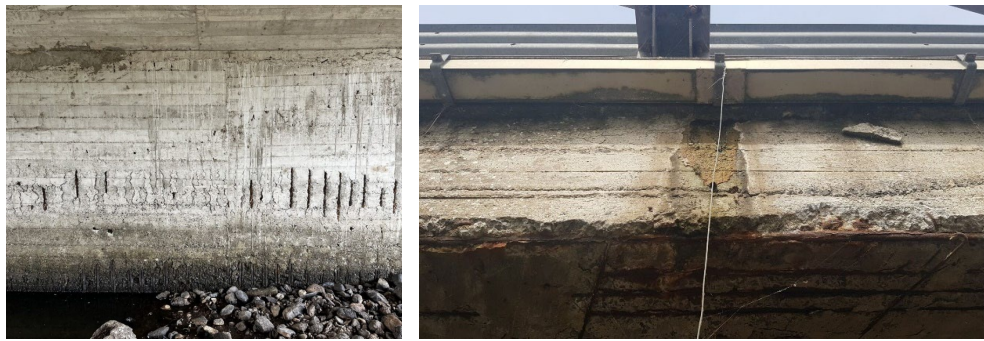
of humidity and washing away of the concrete on piers and abutments. The level of defectiveness of the bridge, despite the presence of high severity defects such as reinforcements corrosion, was classified as Medium-Low.

*Figure 24. Covert spalling and reinforcement corrosion.*

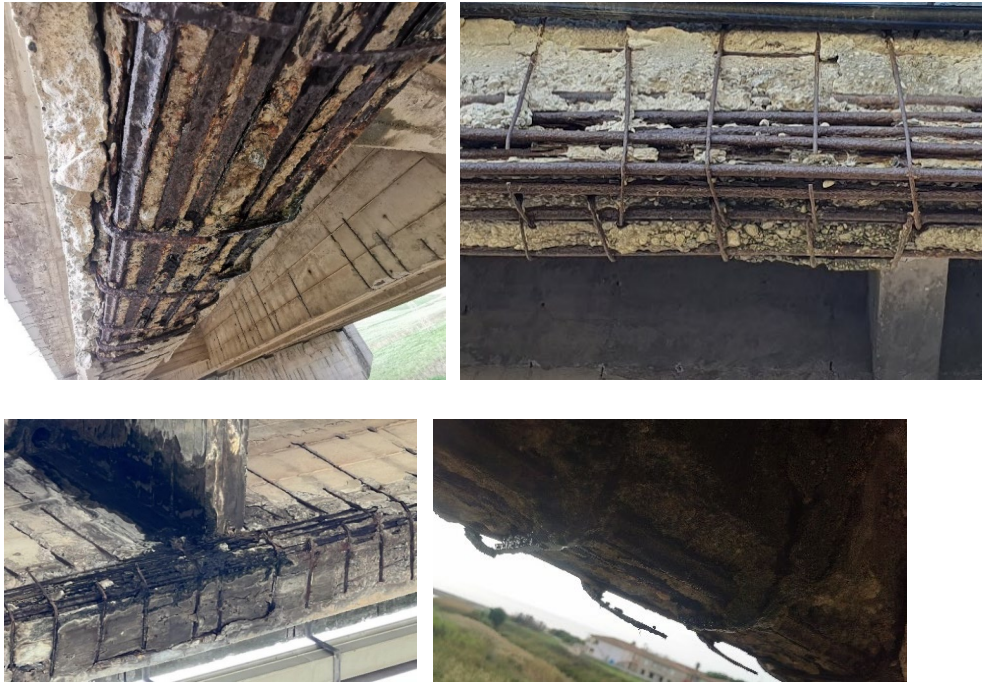
Multi-span bridges with supported beams are made with concrete beams cast in place both with variable and constant section heights. On these bridges were found important defects that concerned critical sections such as the mid-span section or the supporting section of the beams. The majority of the defects is caused by concrete decay due to the presence of water in the road pavement and to exceptional flood events of the rivers. The reinforcements are very corroded, as it is shown in the pictures taken during the inspections, and some points, such as to cause the breakage of the shear stirrups (Figure 25).

*Figure 25. Reinforcement corrosion and stirrups failure in the mid-span section of RC beam.*

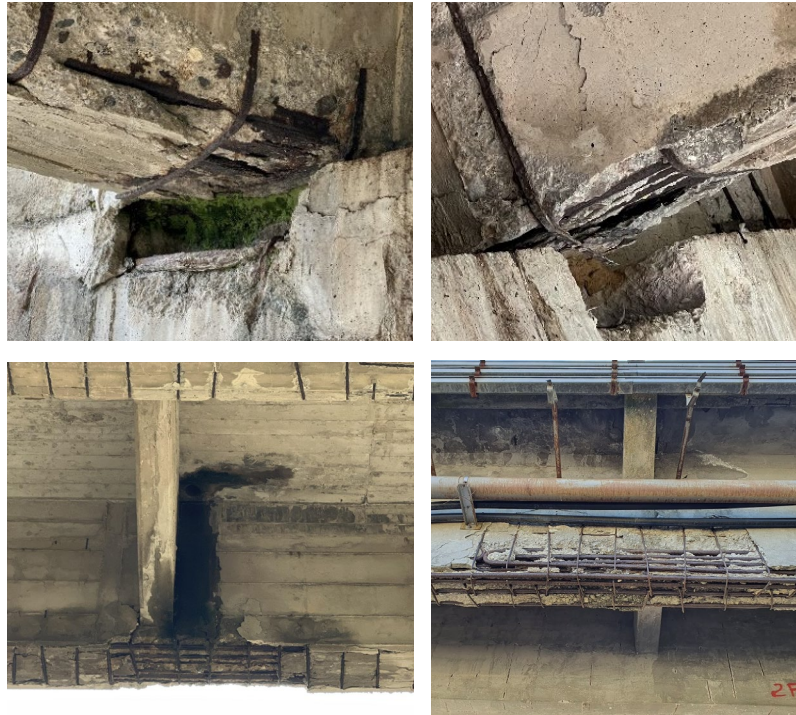
The reinforcement corrosion and cover spalling on the beams concerned sections critical to structural stability such as supporting sections and mid-span sections of the beams where the bending moment is maximum (Figure 26).

*Figure 26. Corrosion and stirrup failure on the support section (upper) and on mid-span section (lower)*

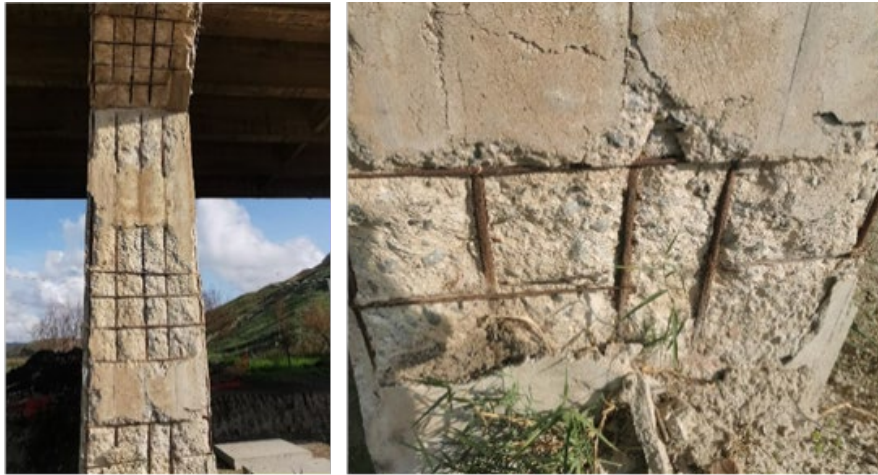
The piers were, also, affected by corrosion phenomena and concrete cover detachment causing the failure of several shear stirrups in areas where, in the event of seismic activities, the shear stress is maximum and thus exposing the elements to brittle and non-ductile failures (Figure 27).

*Figure 27. Concrete cover detachment and stirrup failures on concrete pier.*

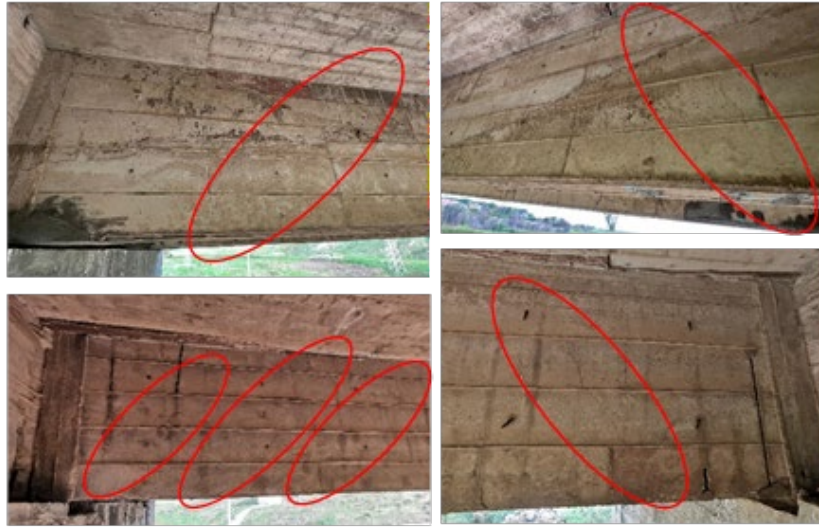
The beams show signs of the shear-resistant mechanism of the Ritter's and Morsch's truss model. On the concrete beams were, also, found 45 degrees inclined cracks in the support areas that extend from the lower edge to the upper one of the beam and are repeated with constant spacing along the beam development. On almost all the beams, with an accurate inspection, it is possible to detect several diagonal cracks on the support zones as shown in Figure 28.

*Figure 28. Diagonal cracks on the support zones of the RC beams.*

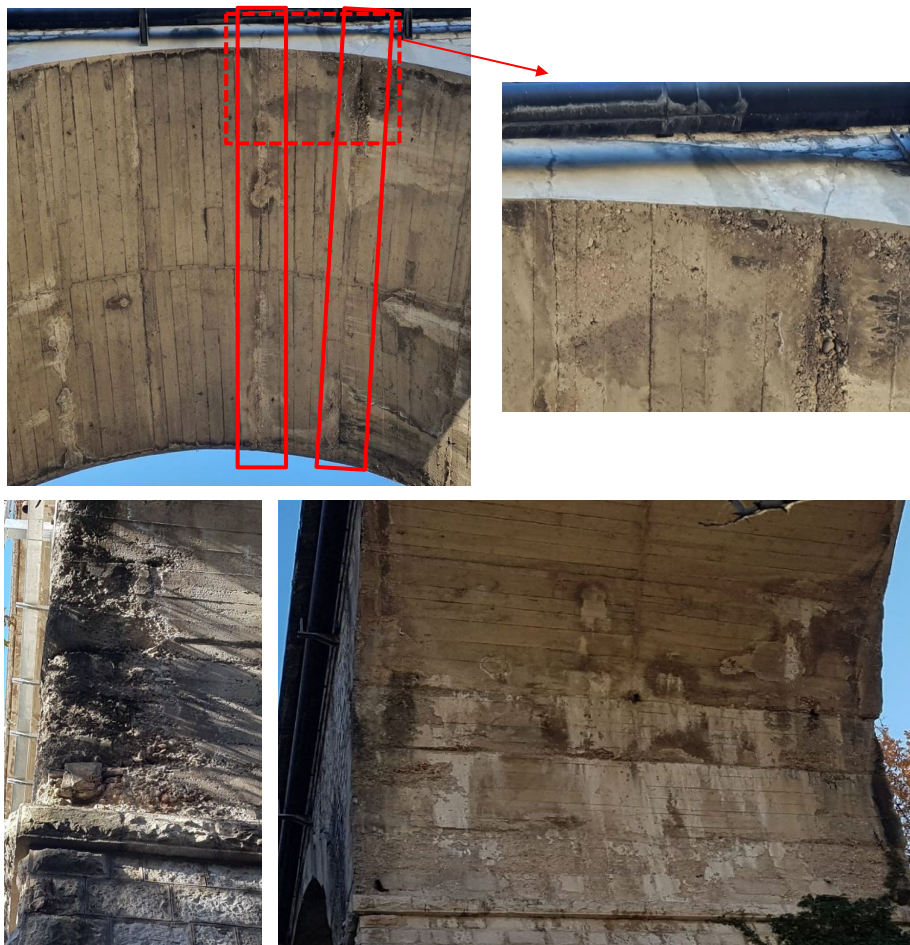
Major defects are localized on the concrete arches that show extended transversal cracks of medium intensity, but not so much to undermine the static of the bridge (Figure 30); in addition, on these elements are present wide humidity stains and material degradation connected to the water presence. Additional defects are encountered on the lateral curbs of the concrete slab; on these elements, the concrete cover detachments and oxidized and corroded reinforcements, are present.

*Figure 30. Transversal cracks on concrete arches (upper) and concrete degradation and humidity (lower).*

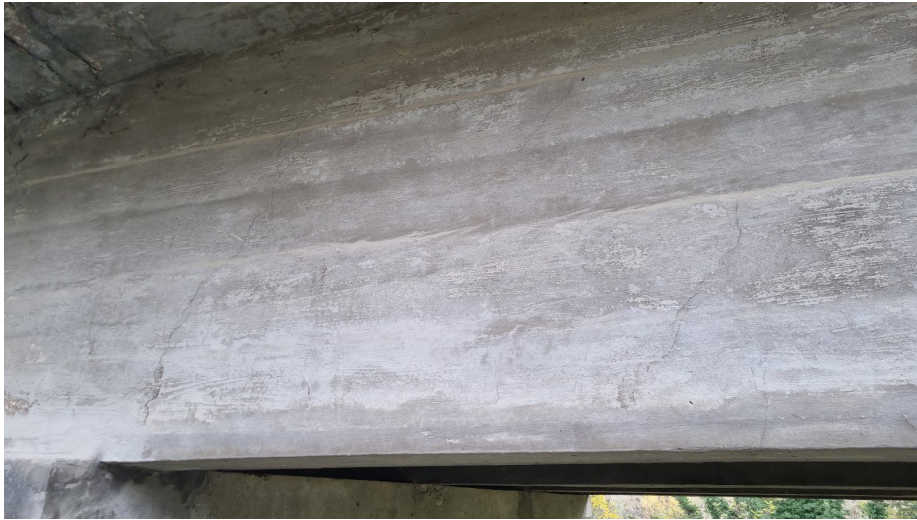
*Figure 33. Bending cracks of the external concrete beam near to the support.*

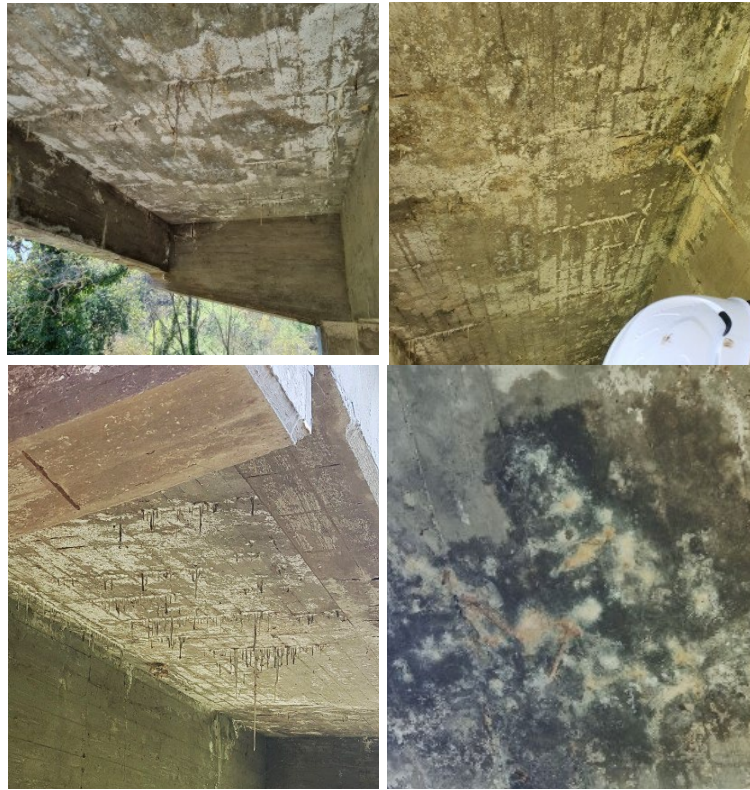
The bridge, also, shows very pronounced defects related to humidity and water presence that can infiltrate through the road pavement and the concrete slab causing wide portions of degraded concrete. On vast portions of the slab, it is possible to notice active and passive humidity stains in the form of white calcium carbonate efflorescences. In some cases, white efflorescences turn to orange suggesting iron oxides presence coming from the reinforcements. The intensity of this phenomenon is such that it is possible to notice stalactites and flowstone formations on the beams and slabs (Figure 34); the origin of the phenomenon is, presumably, due to the intense use of road salts on the pavement.

*Figure 34. Efflorescences and stalactites on concrete slabs.*

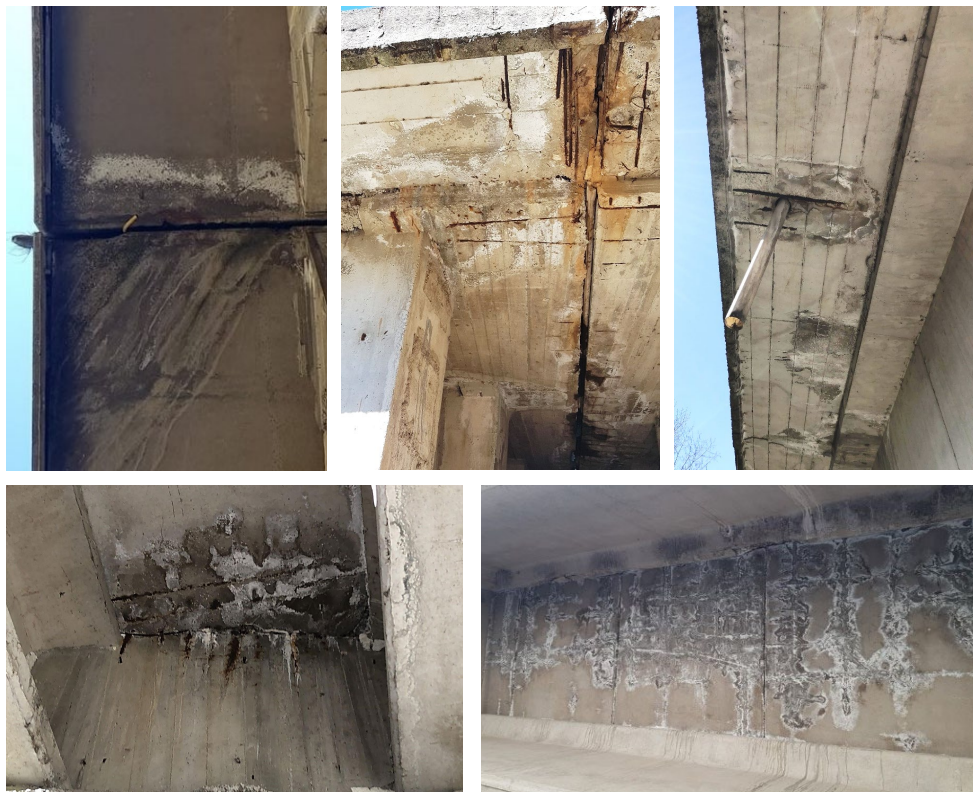
The concrete slabs often show defects related to water presence that infiltrate from the road pavement and flow through damaged draining systems. The portions of the slab most affected by material degradation and presence of moisture, are the outer portions most exposed to weathering. In areas with intense water presence and with a highly degraded concrete, is often noticed the concrete cover expulsion and the corrosion of the reinforcement bars (Figure 36).

*Figure 36. Photos of moisture, concrete spalling and steel corrosion in the concrete slabs.*

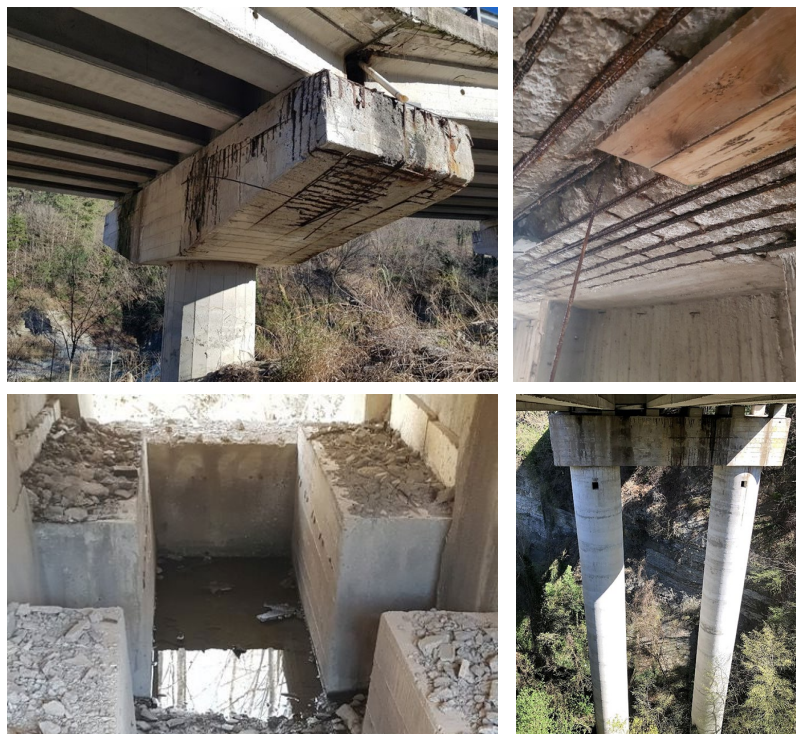
*Figure 37. Concrete spalling and reinforcement corrosion on pier caps and water infiltrations and stagnations on the top of the cap.*

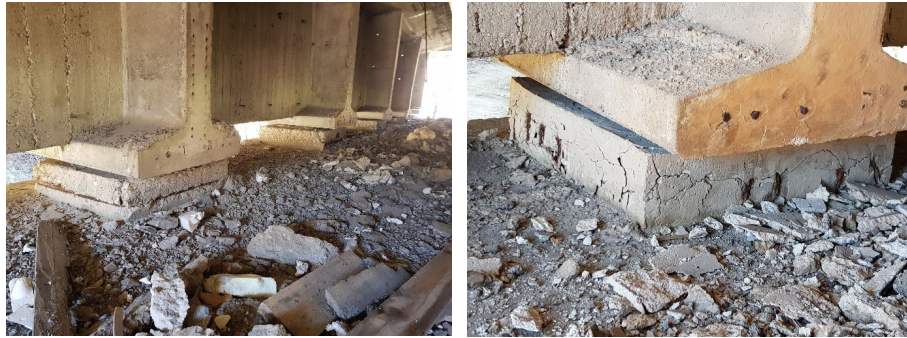
These elements, as well, have more defects especially in the outer lateral faces and near the caps, where, often, water infiltrates from the road joint and stagnates on the top of the cap (Figure 37). An additional defect, that is associated with the pier element but relates to the bearings, are the defects found on the concrete pedestals of the supports that have the function of adjusting the elevation course of the bridge and transmitting loads to the pier cap. In many cases, these elements are made with a mixture of poor class concrete and show material degradation and compression cracks; such defects, if too significant, may compromise the statics of the supported beam (Figure 38).

*Figure 38. Cracks and concrete degradation on the support pedestals.*

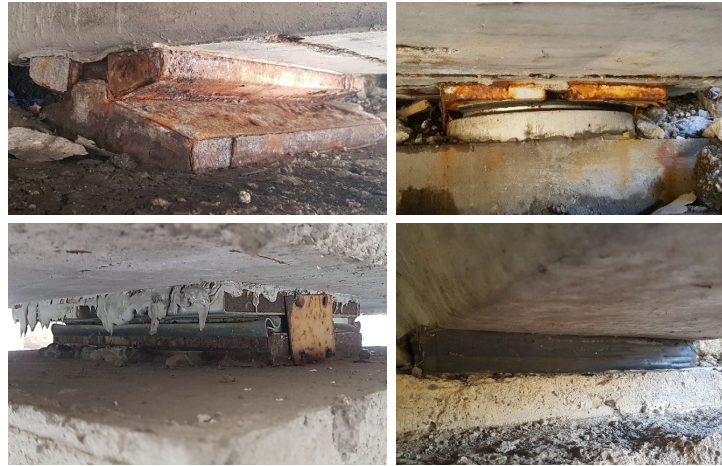
Supporting devices exhibit defects due to aging and weathering exposure, specially the ones with metal components which are subjected to oxidation and corrosion due to water infiltrations. The rubber bearings show aging of the rubber and, in some cases, crushing phenomena; in case of reinforced rubber devices, evidences of oxidation of the steel plates embedded in the rubber can be detected. Other characteristic defects are the presence of debris that can compromise the regular operativity of the devices and the incorrect installation. Some of the above mentioned defects are shown in Figure 39 below.

*Figure 39. Oxidation and corrosion of metal support devices and crushing phenomena on reinforced rubber bearings.*

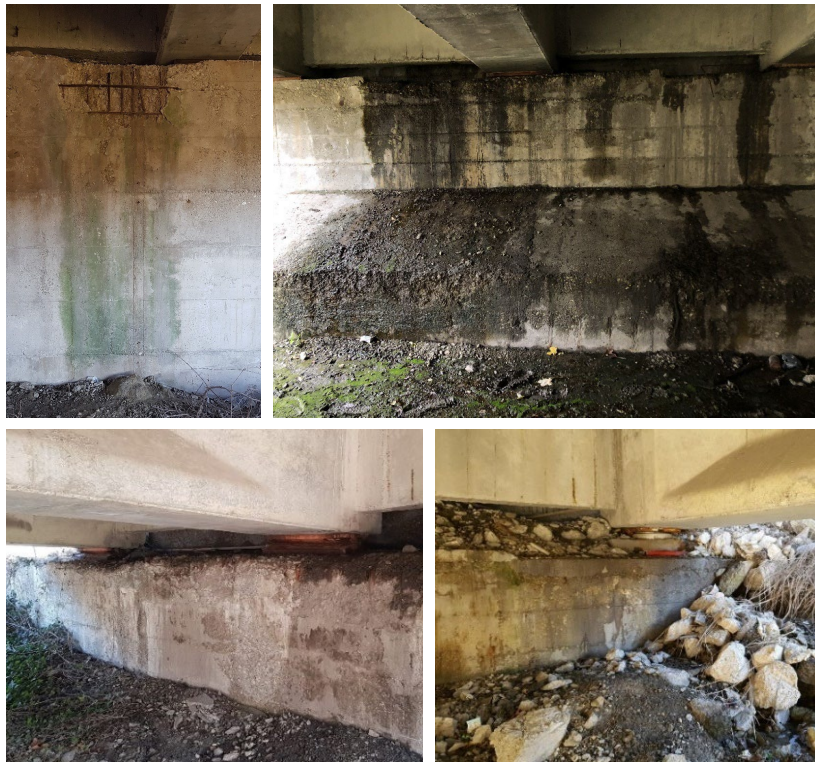
The abutments are often affected by widespread phenomena of rainwater leakages due to the non-sealing of the pavement joint and/or the infiltration of water from the road embankment, which causing phenomena of concrete degradation and corrosion of the reinforcement bars. These defects on gravity abutments are not critical for the structure stability, as they are designed to resist the horizontal forces of the ground with their self dead weight, instead, they are characterized by large geometric sections with a large amount of reinforcements. Some pictures taken during inspections of three different bridges all with the same defect of drainage traces from the road embankment are shown in Figure 40: water infiltration and biological biofilms are visible on large portions of the concrete.

*Figure 40. Photos of abutments affected by water infiltration from road embankment and pavement.*

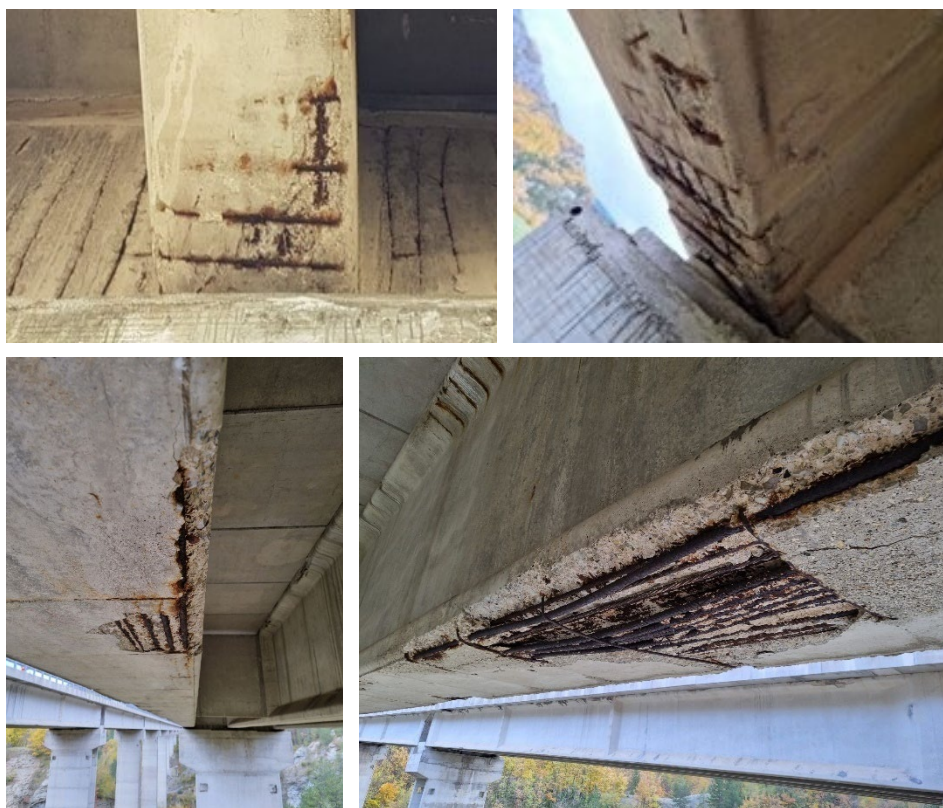
The most recurring defect on all beams, besides minor damages related to water and humidity presence, is to uncovered and oxidized stirrups which occurs locally in the slab bulb of the beams in the support area and diffusely on the lower flanges; such defect is, presumably, due to a poor concrete cover depth which, in some cases, is almost absent. On the external girders, more exposed to weather conditions, detachments of concrete cover were detected on the edges of the lower bulb, exposing reinforcements and prestressing cables that were oxidized and corroded (Figure 41).

*Figure 41. Concrete spalling and steel corrosion on Prestressed RC beams.*

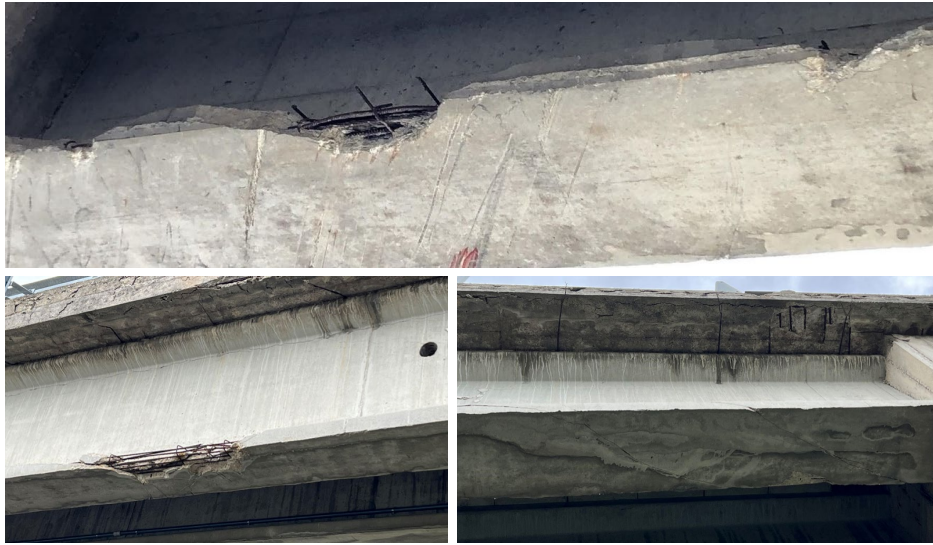
*Figure 42. Impact damages on the bottom flanges of the beams and crack patterns on concrete.*

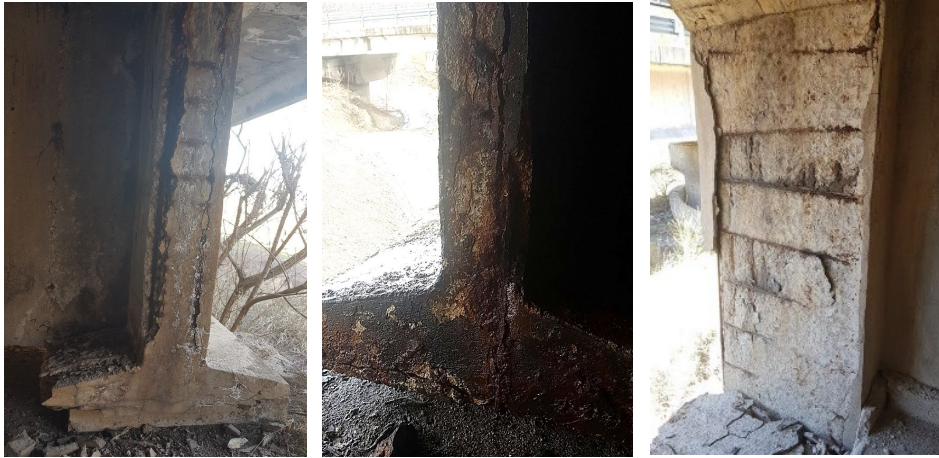
*Figure 43. Concrete spalling and corrosion on the beam ends.*

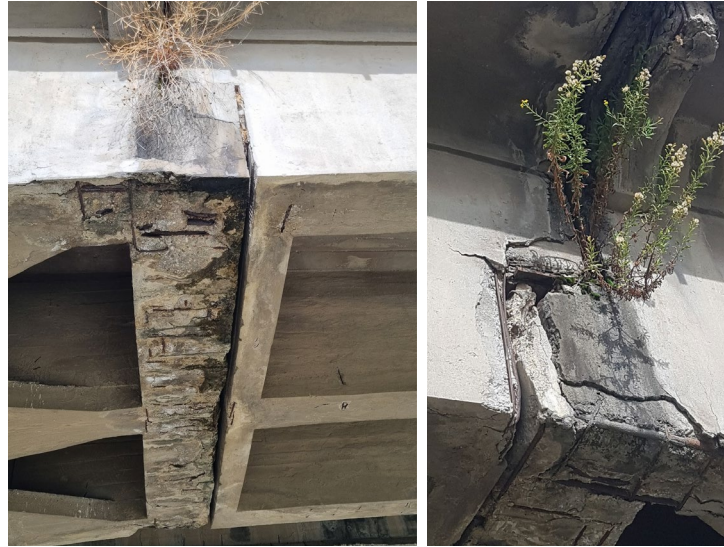
*Figure 44. Concrete degradation, cover spalling and steel corrosion on dapped-beam ends.*

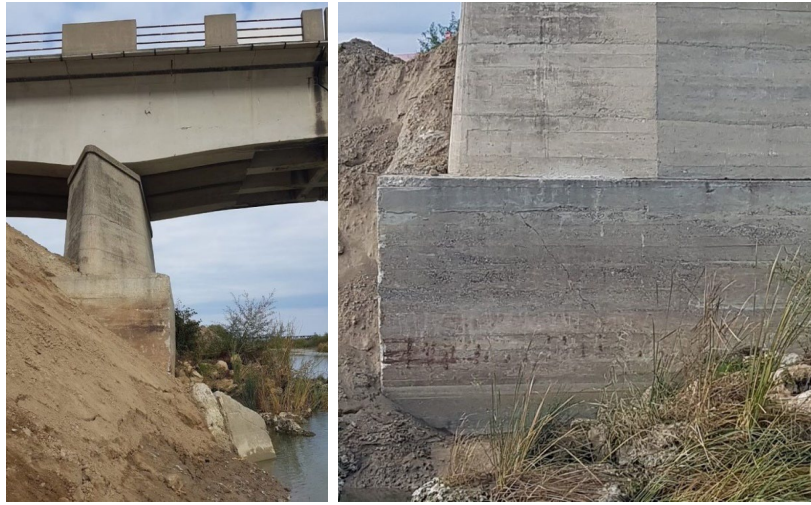
*Figure 45. Central pier scour (left) and diagonal cracks on the pier foundation (right).*

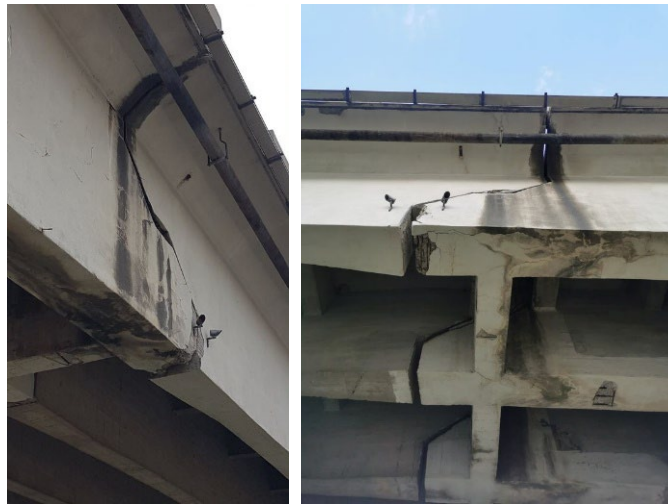
*Figure 46. Compression cracks and water traces on the dapped-beam ends.*

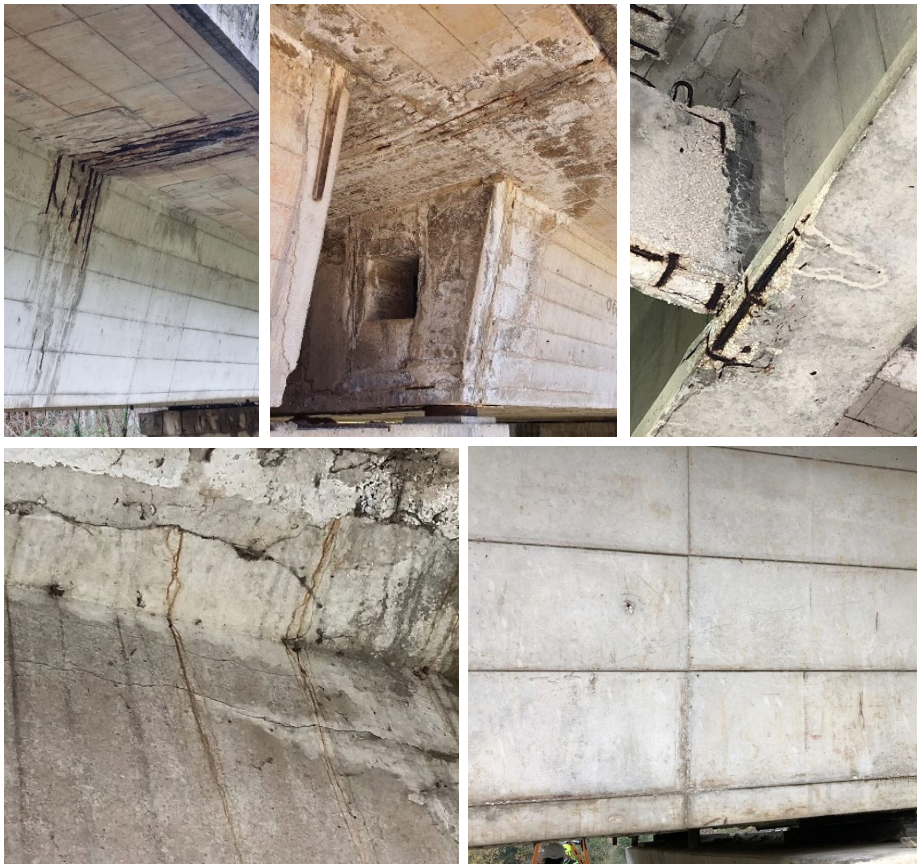
*Figure 47. Humidity traces, concrete degradation and steel corrosion on box girders (upper) and cracks along the post-tensioning cable paths (lower).*

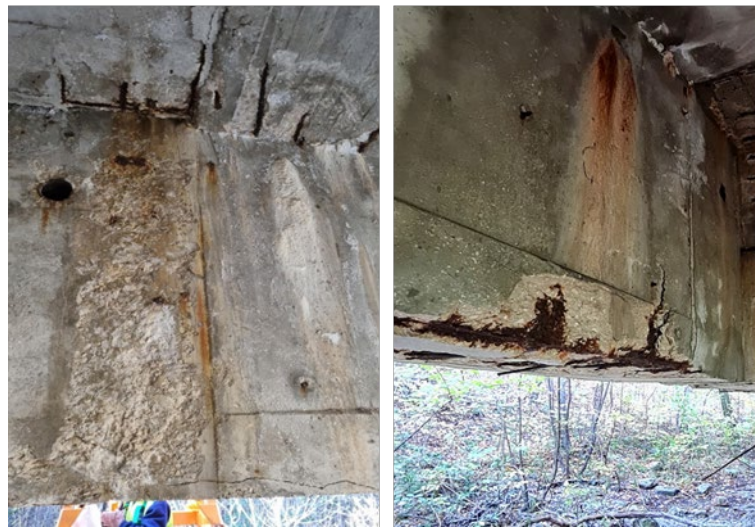
*Figure 48. Damages on RC beams due to water infiltration: calthemite flowstone, reinforcement corrosion and concrete spalling.*

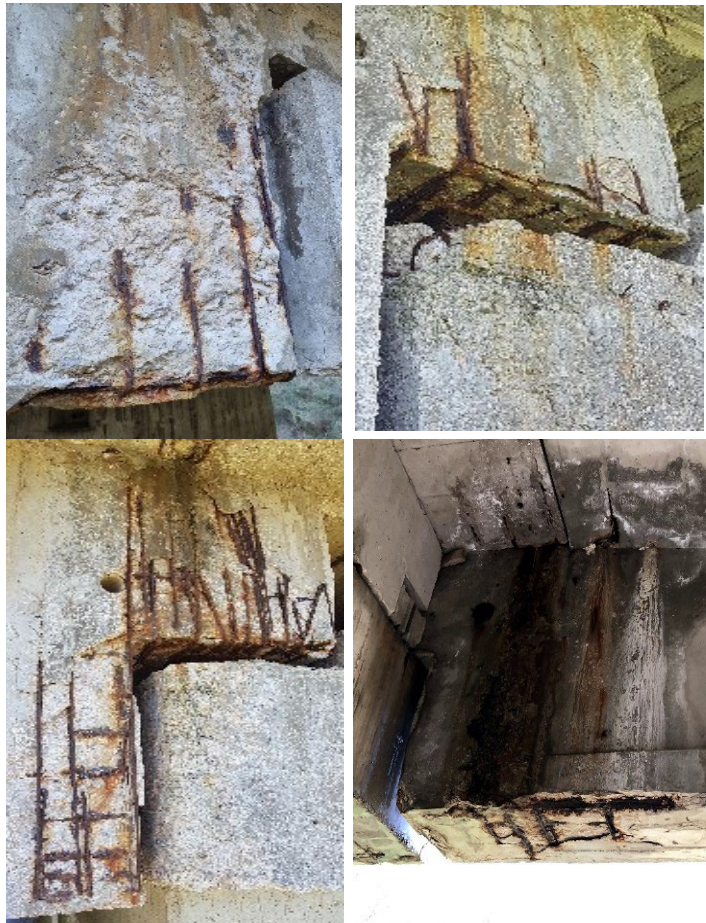
*Figure 49. Damages on dapped-end beams due to water infiltration.*

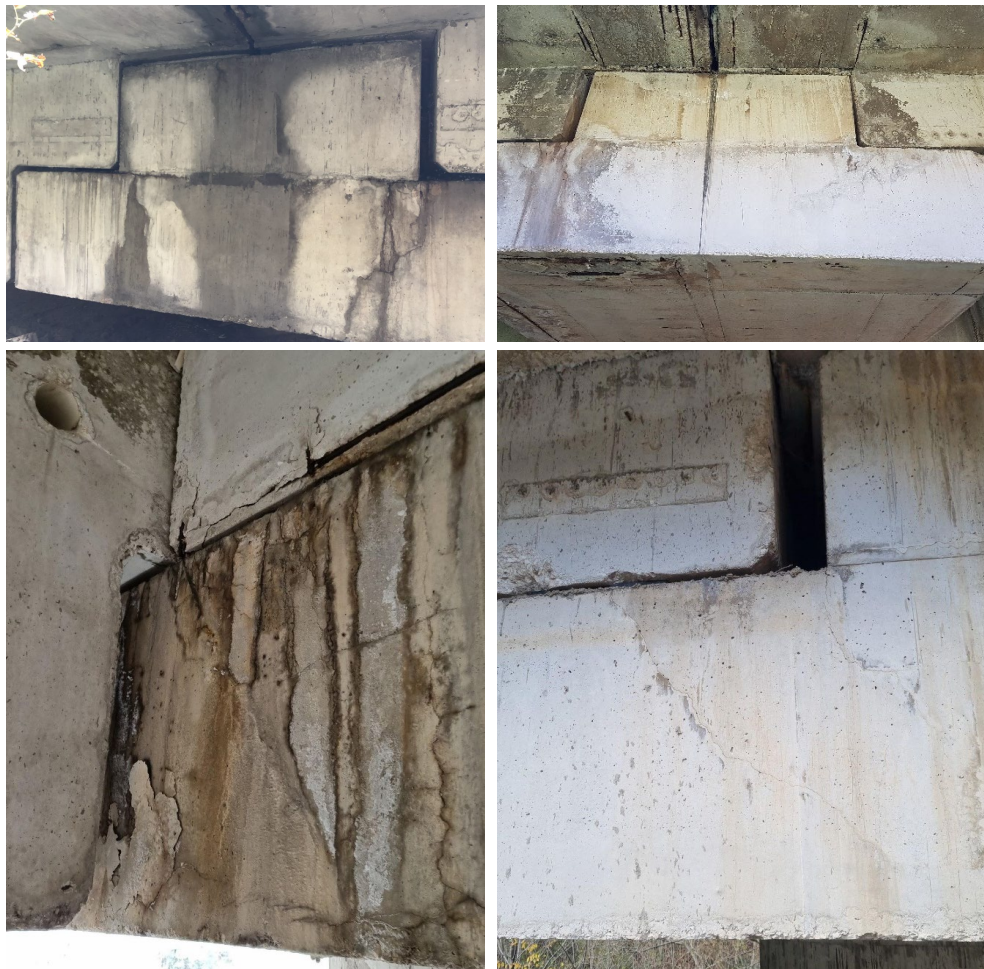
*Figure 50. Diagonal cracks on the dapped end of the pier caps.*

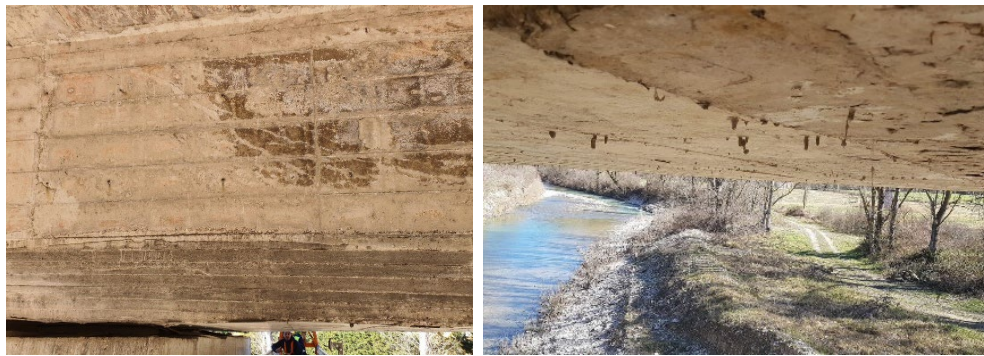
*Figure 51. Crack along the prestressed cable paths in the beam ends (left) and water stagnations inside the box girder (right).*

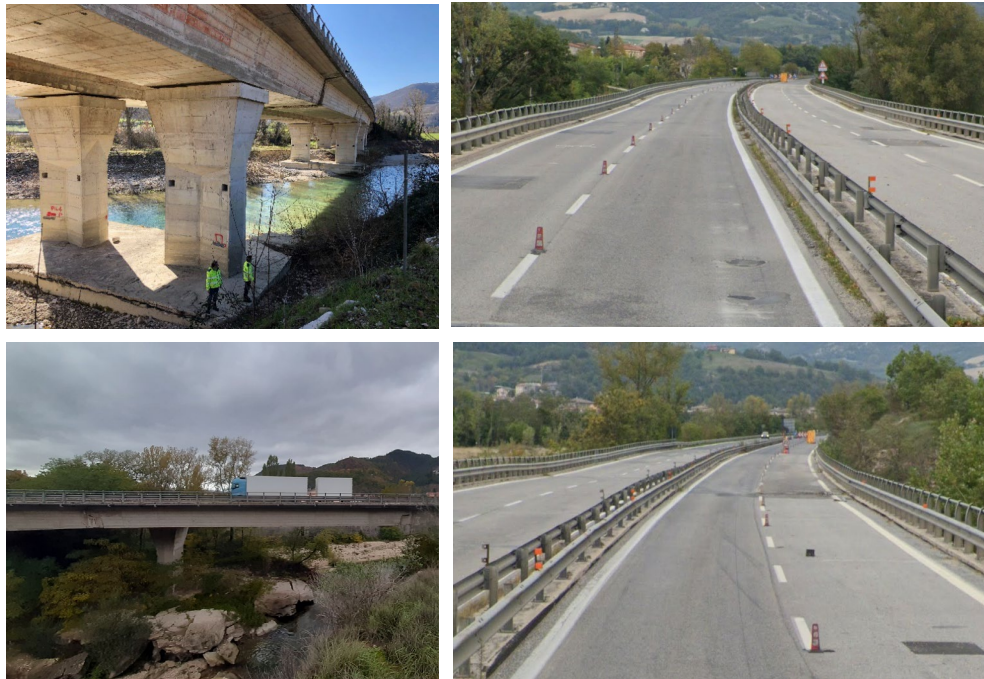
*Figure 52. Permanent deflection of the suspended spans.*

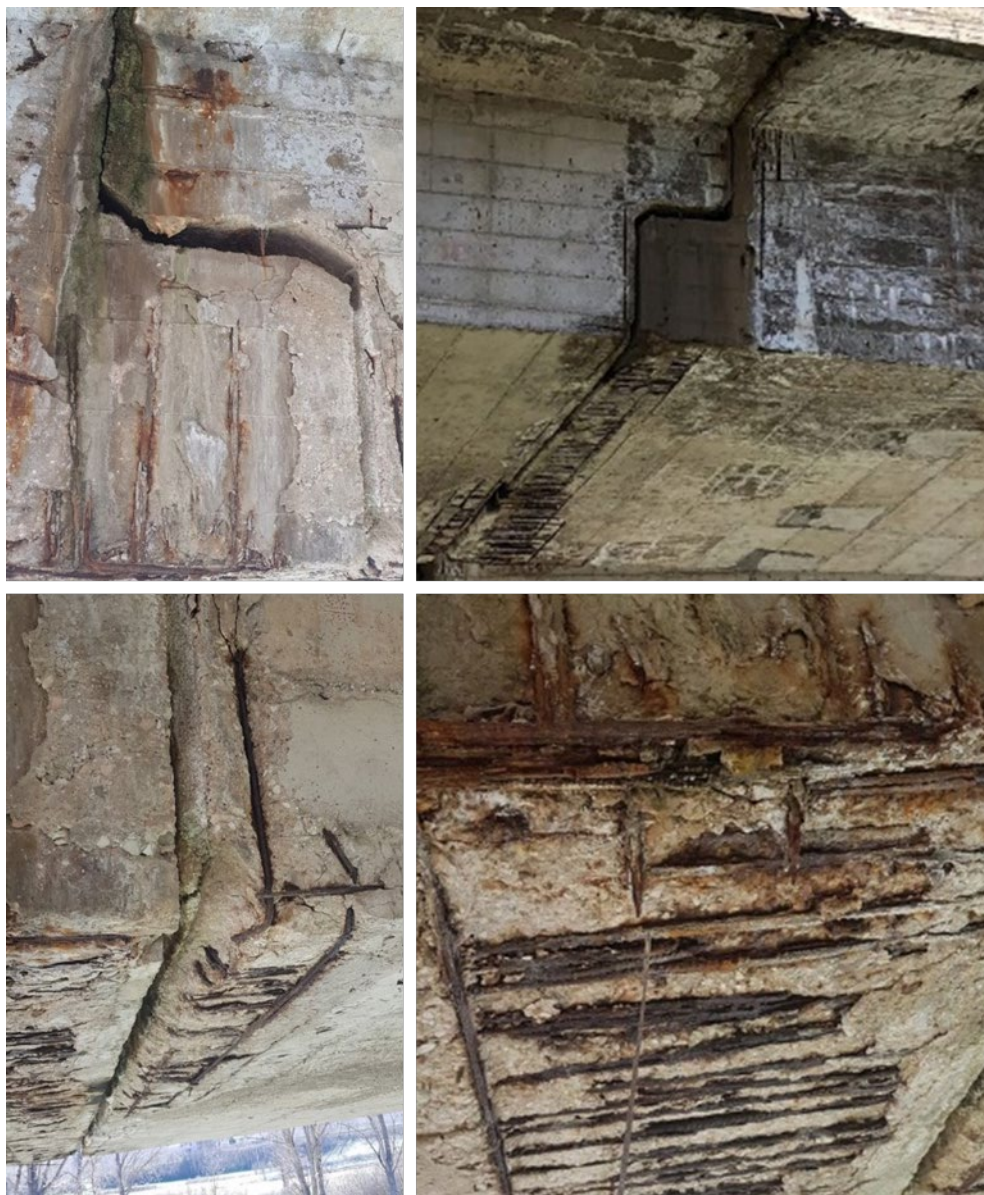
*Figure 53. Damages on box dapped-end beams due to water infiltration.*

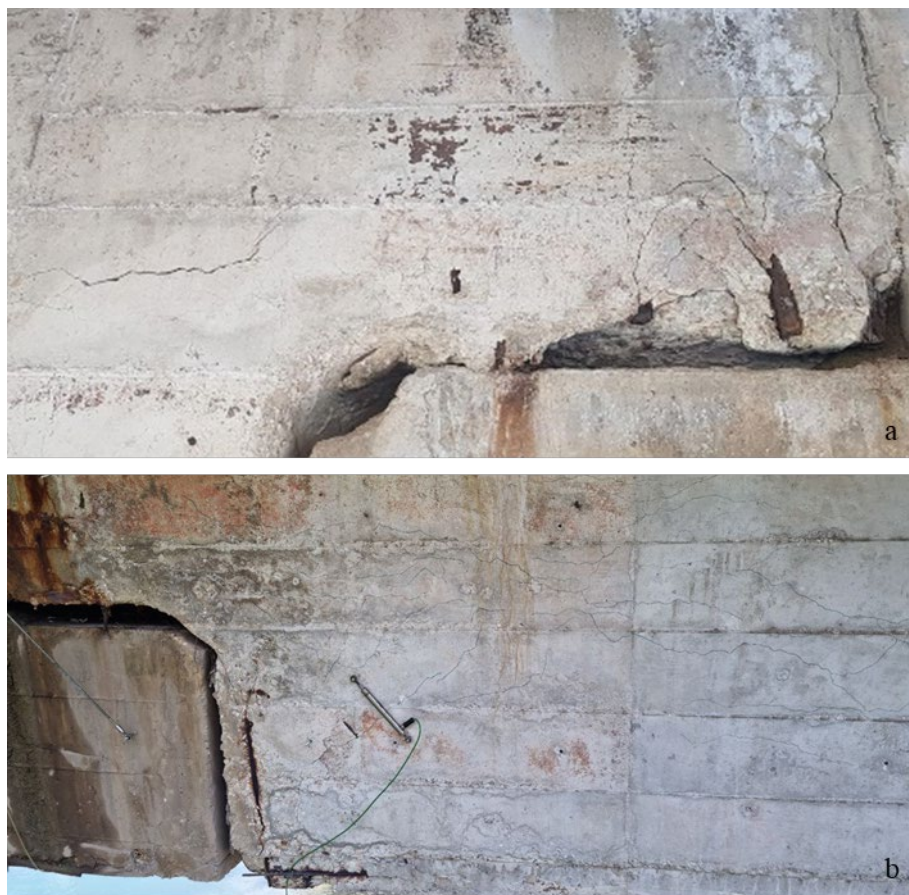
*Figure 55. Potential failure mechanism of the box dapped-end beams.*

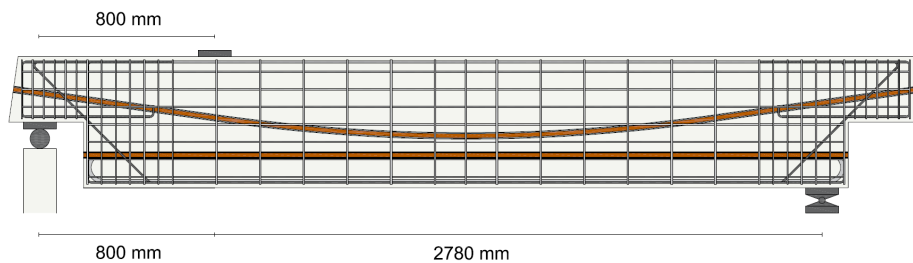
Figure 65. Summary representation of the unsymmetrical three point bending test applied to dapped-end beams.
