Università Politecnica delle Marche  
Scuola di Dottorato di Ricerca in Scienze dell'Ingegneria  
Curriculum in Ingegneria Civile, Ambientale, Edile e Architettura

# **Existing Bridge Vulnerabilities: The Case of Prestressed RC Dapped-end Beams**

XXXVI edition

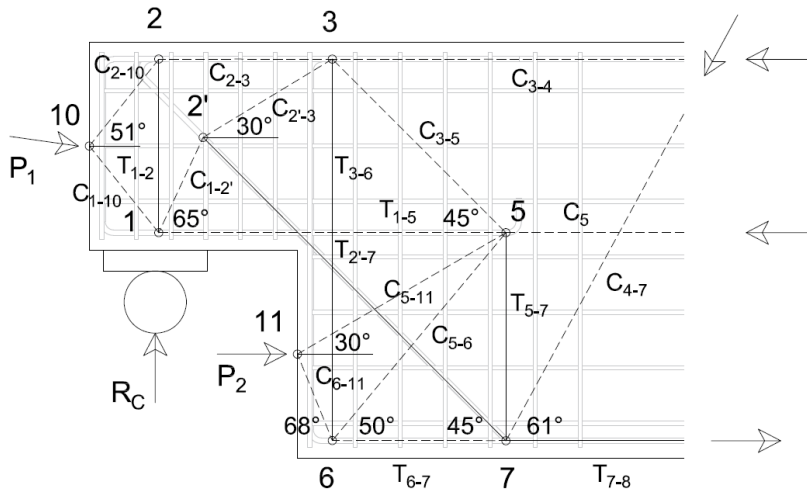
Figure 68. Stage 1 of the stut-and-tie model C.

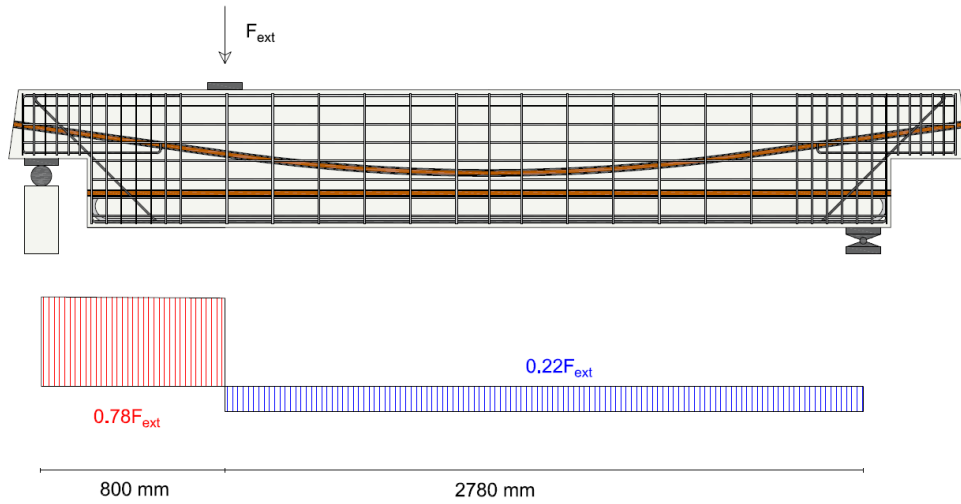
Figure 83. Shear diagram of the isostatic beam.

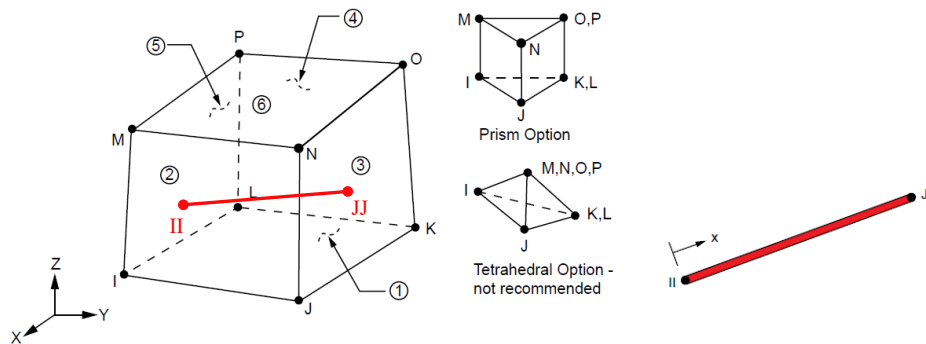
Figure 85. CPT215: 3D element with 8 coupled nodes from ANSYS Mechanical Library.

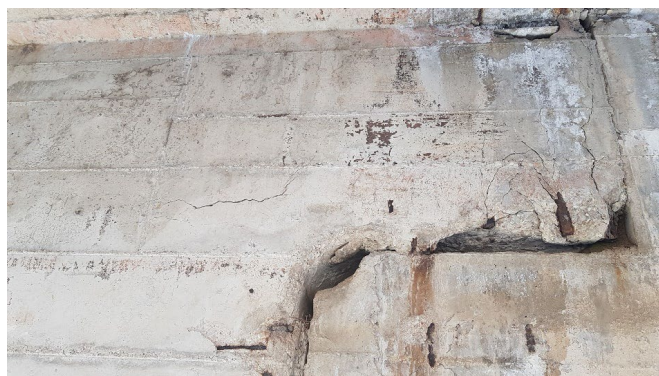
*Figure 103. Cracks on the dapped-end beam.*
