Experimental study of the mechanical behaviour of a new extruded earth block masonry

Title: Experimental study of the mechanical behaviour of a new extruded earth block masonry

Article Type: Research Paper

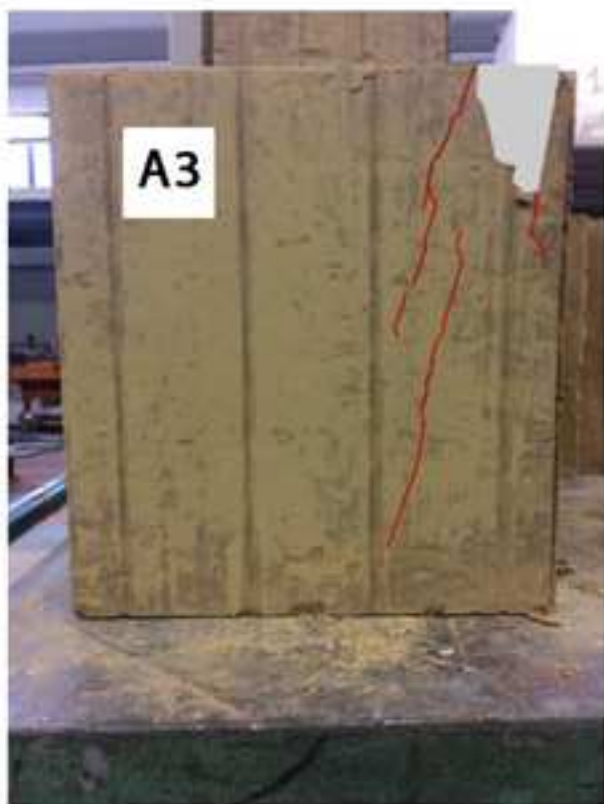
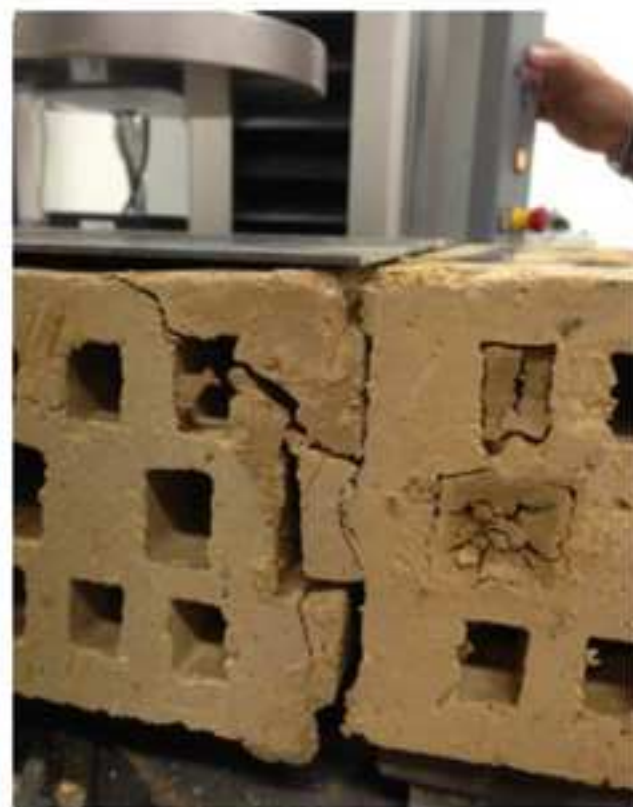
Figure 7
[Click here to download high resolution image](#)

The failure mode was the same for all the specimens tested, with cracks originating before the peak load (Fig. 7a). Cracks were located on the front and backsides of the blocks, close to the point of application of the load.

Fig. 7. Failure modes of (a) the earth block, (b) of the triplet (configuration A) and (c) of the triplet (configuration B).

The failure mode was the same for all the specimens tested, with cracks originating before the peak load (Fig. 7a). Cracks were located on the front and backsides of the blocks, close to the point of application of the load.

48
49 Fig. 7. Failure modes of (a) the earth block, (b) of the triplet (configuration A) and (c) of the triplet
50 (configuration B).
51

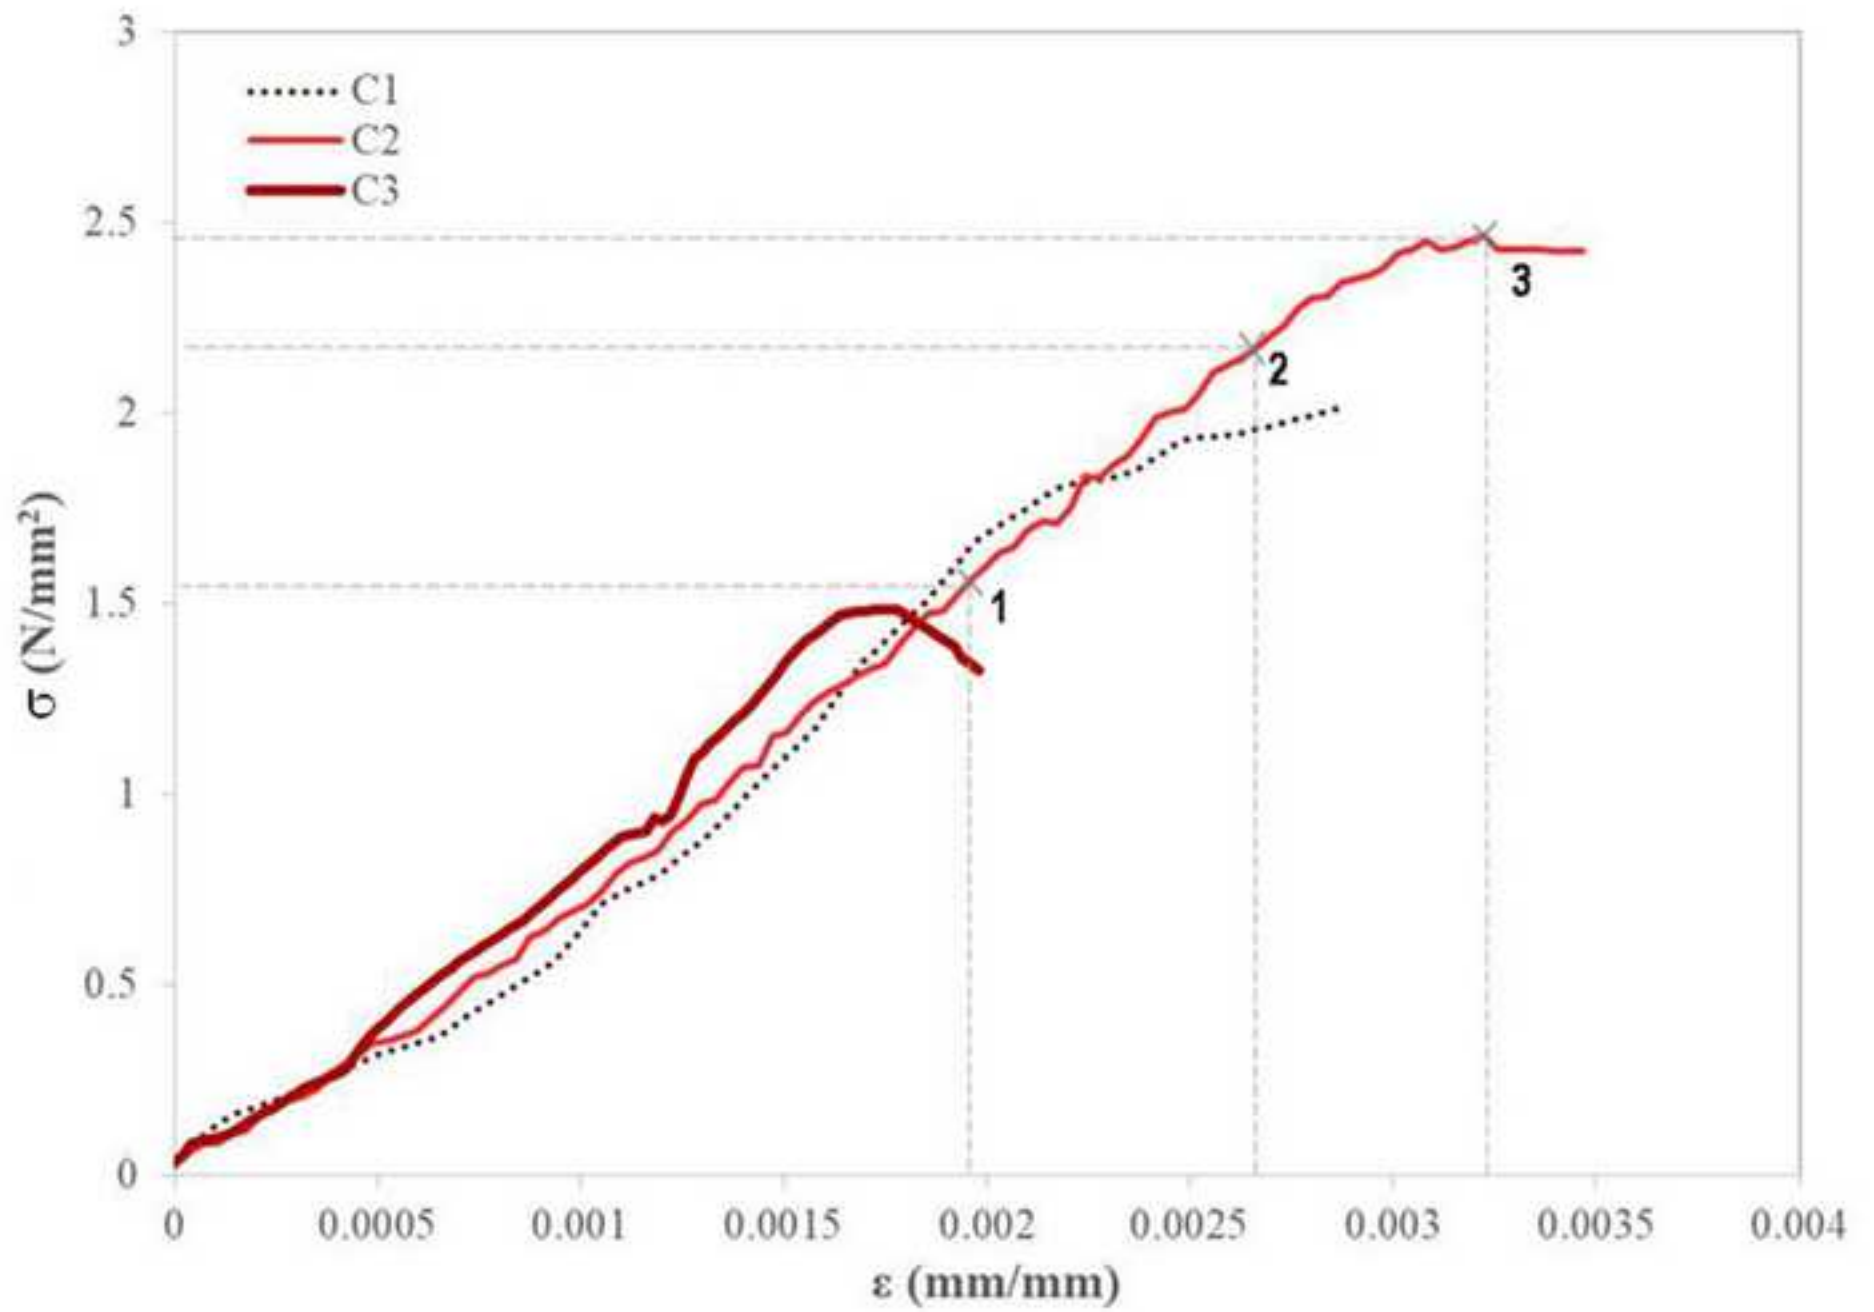
Figure 8
[Click here to download high resolution image](#)

16 The stress – strain $\sigma - \varepsilon$ diagrams for the 3 wallettes are shown in Fig. 8, where the strain values
17 were obtained through DIC and post-processed in MATLAB. The specimens exhibited an
18 approximately linear behaviour up to the maximum load with a brittle failure.
19
20
21
22

16 The stress – strain $\sigma - \varepsilon$ diagrams for the 3 wallettes are shown in Fig. 8, where the strain values
17 were obtained through DIC and post-processed in MATLAB. The specimens exhibited an
18 approximately linear behaviour up to the maximum load with a brittle failure.
19
20
21
22

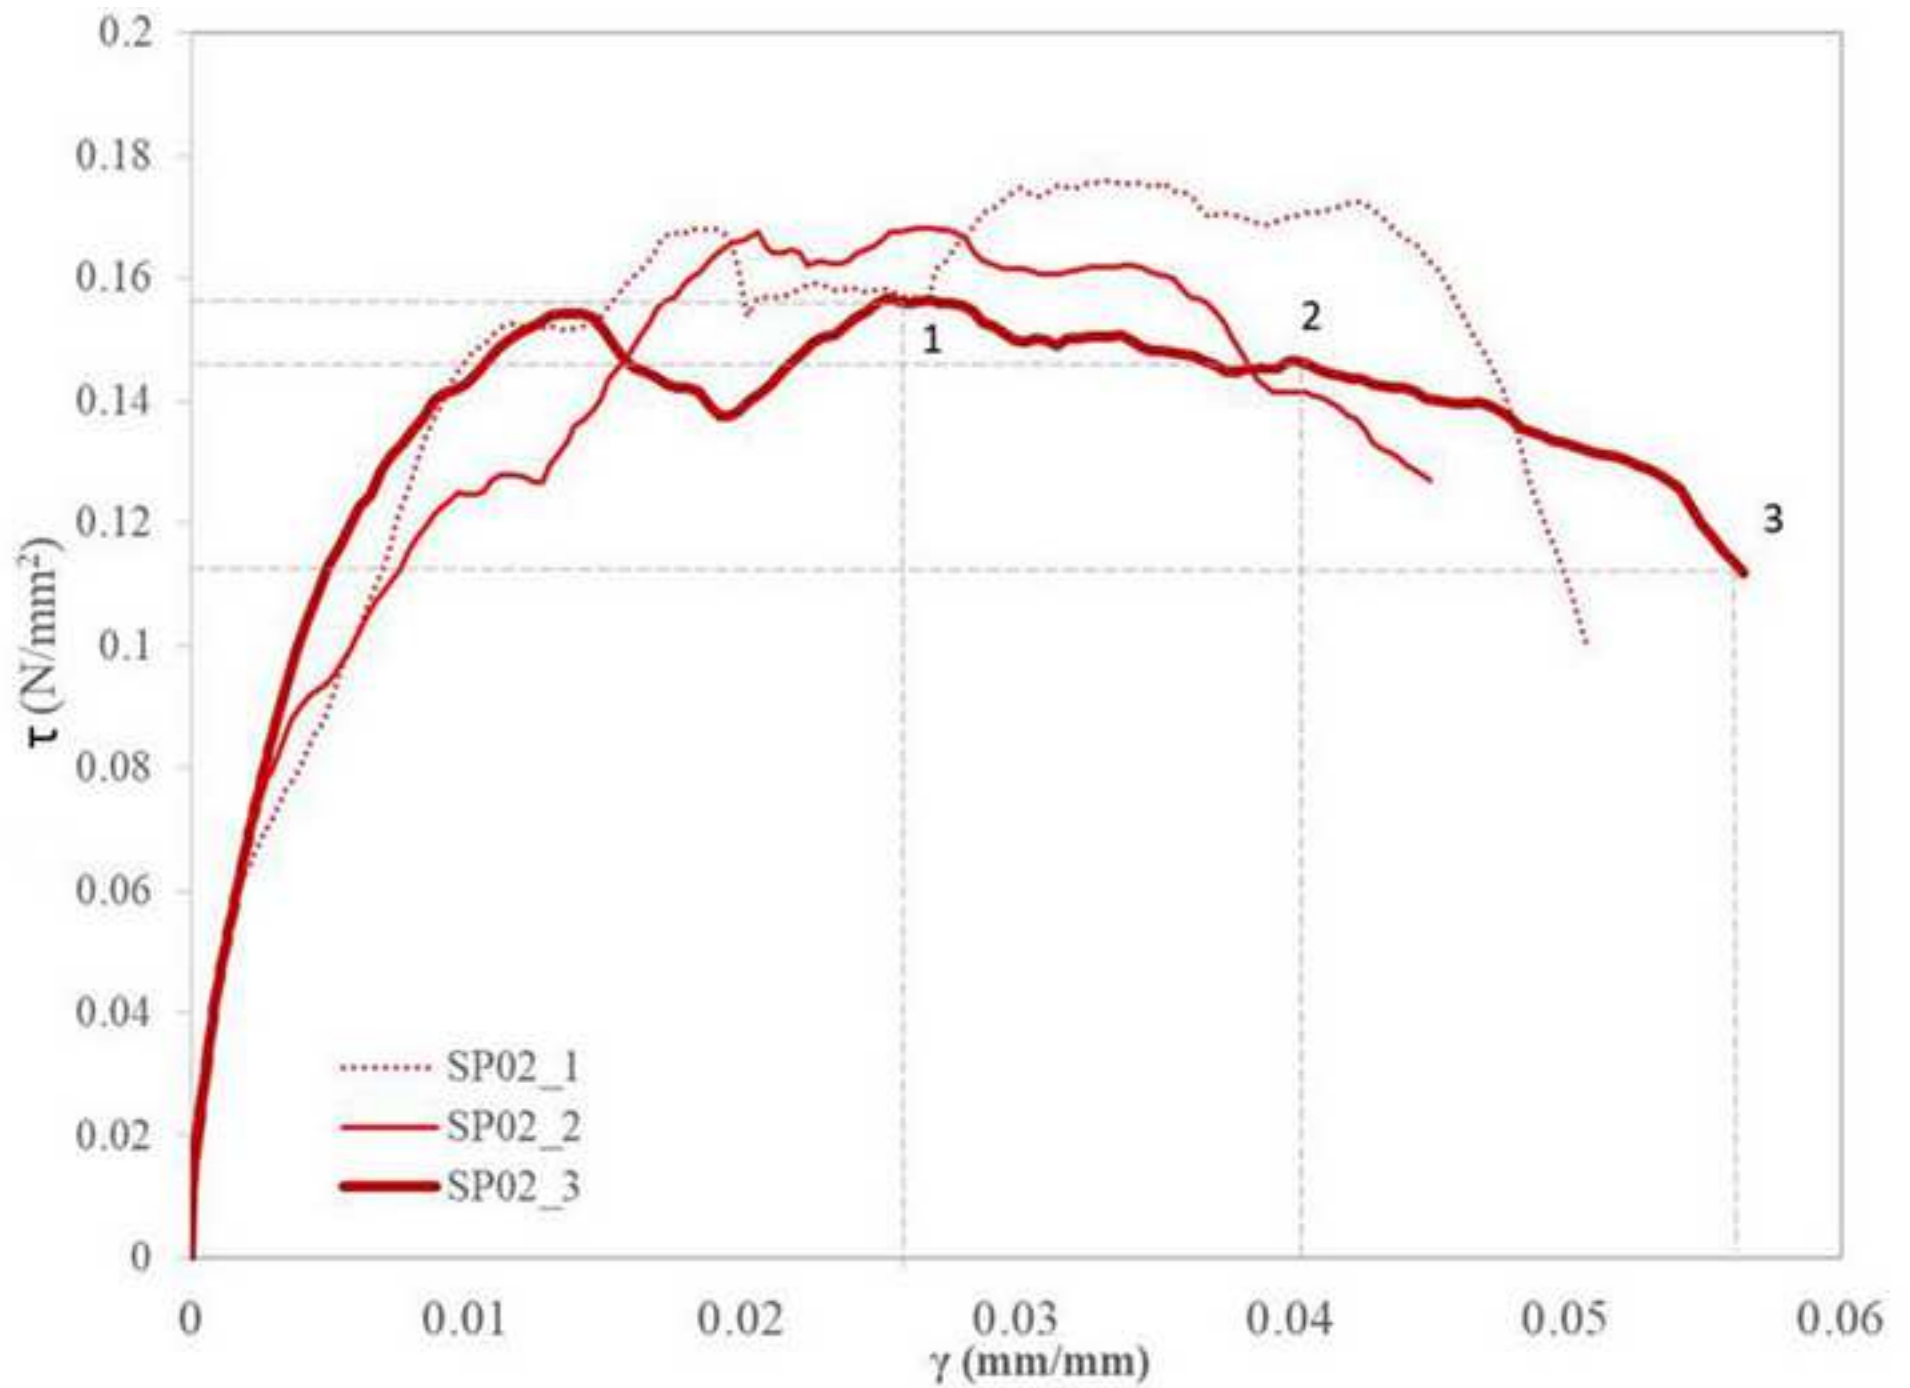
Figure 14
[Click here to download high resolution image](#)

1 The results of the shear stress–strain τ - γ diagrams for the 3 specimens subject to a pre-compression
2 load of 0.2 N/mm^2 are presented in Fig. 14. In the first part, the curves showed a linear trend until
3 the first crack appeared. Then, a plastic region occurred with formation of other diagonal cracks.
4 The trend showed a ductile behaviour, typical of shear tests with pre-compression. The tensile
5 strength τ_m , shear modulus G and shear strain γ of the wallettes are collected in Table 9. As
6 expected, the test showed a slight increase (about 2.4%) in terms of tensile strength with respect to
7 the diagonal tensile findings without pre-compression.
8
9
10
11
12
13

1 The results of the shear stress–strain τ - γ diagrams for the 3 specimens subject to a pre-compression
2 load of 0.2 N/mm^2 are presented in Fig. 14. In the first part, the curves showed a linear trend until
3 the first crack appeared. Then, a plastic region occurred with formation of other diagonal cracks.
4 The trend showed a ductile behaviour, typical of shear tests with pre-compression. The tensile
5 strength τ_m , shear modulus G and shear strain γ of the wallettes are collected in Table 9. As
6 expected, the test showed a slight increase (about 2.4%) in terms of tensile strength with respect to
7 the diagonal tensile findings without pre-compression.
8
9
10
11
12
13
