International Journal of Architectural Heritage

Simplified Vulnerability Assessment of Historical Churches in Banat Seismic Region, Romania

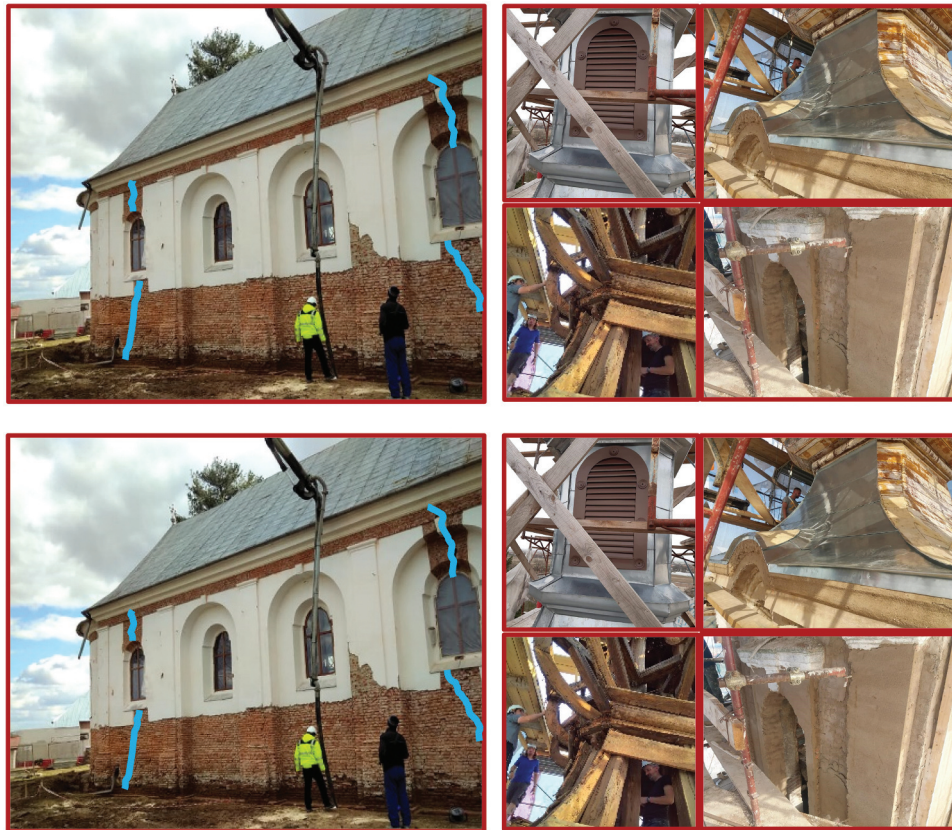
Figure 4. Constructive details of the Belint church.

As a conclusion of the typological structure and architecture of all investigated churches, the bearing walls, and the bell tower are made in brick or mixed stone-brick masonry, the vaults are made in brick masonry or plaster-board-wooden plank, the spire and mezzanine are made in wood, and the pitched roofs are also made in wooden frameworks. All six churches are configured with a single central nave, one central bell tower incorporated in the main façade, and a rounded sanctuary. The differences are related to the dimensions of the six churches, the highest of them being the one in Bocsa, with a bell tower height of 35.33 meters. Some constructive details can also be seen in [Figure 4](#).

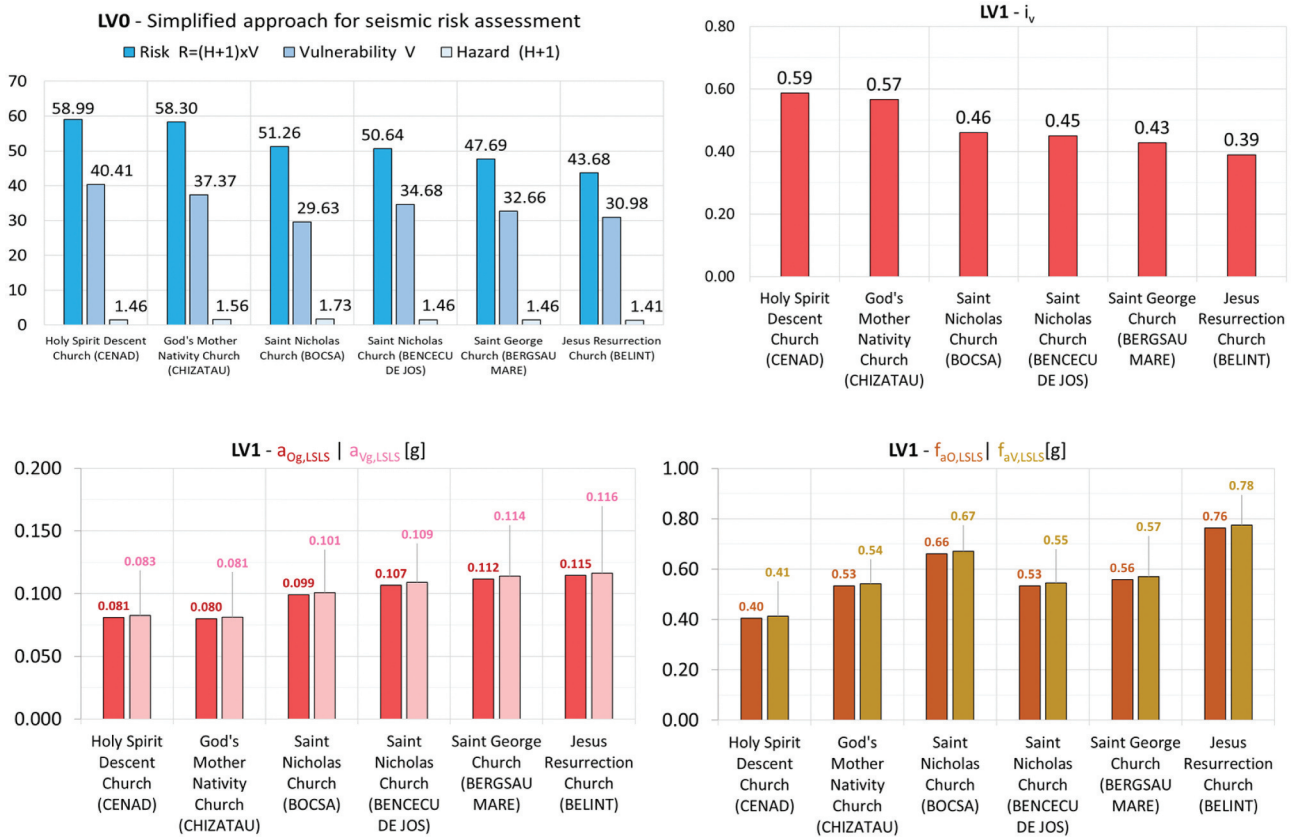
Figure 9. The results following LV0 and LV1 methodology.

In Figure 9, there are presented the results obtained following both LV0 and LV1 analysis. There can be noticed a good correlation between those two different valuation levels, as both methodologies indicate the church of Cenad as the most vulnerable, while the least vulnerable seems to be the church in Belint in both cases. The obtained horizontal acceleration at LSLS is $a_{Og,LSLS} = 0.080 \text{ g} \div 0.115 \text{ g}$, and the obtained vertical acceleration at LSLS is $a_{Vg,LSLS} = 0.081 \text{ g} \div 0.116 \text{ g}$. The expected ag on rock soil ($TR = 225$ years) is 0.15 g for the churches in Chizatau, Belint, and Bocsa and 0.20 g for the churches in Cenad, Bencecu de Jos and Beregsau Mare.

less vulnerable is the Church in Belint. The Romanian empiric vulnerability assessment methodology that takes into consideration also the cultural value proposed tends to underestimate 10–15% the seismic vulnerability of the investigated churches in terms of vulnerability indexes but estimates correctly the expected damage state (Figure 9). None of the investigated churches satisfies the LSLS verification.

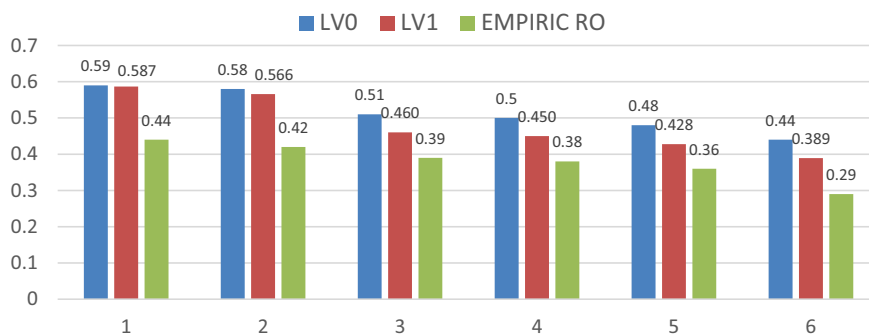
Figure 10. Comparison between the different methodologies results.

The Romanian procedure tends to underestimate the expected damage in comparison with the Italian procedure. These results are expected, as the Romanian methodology is more simplified than the Italian one and considered fewer possible failure mechanism regarding the structural vulnerability of the investigated church. Despite this slight difference, the expected mean damage following the Romanian methodology also indicates a medium vulnerability, which is consistent with the damage state of the existing investigated masonry churches that was observed after on-site investigation. A comparison between the vulnerability indexes is presented in Figure 10.

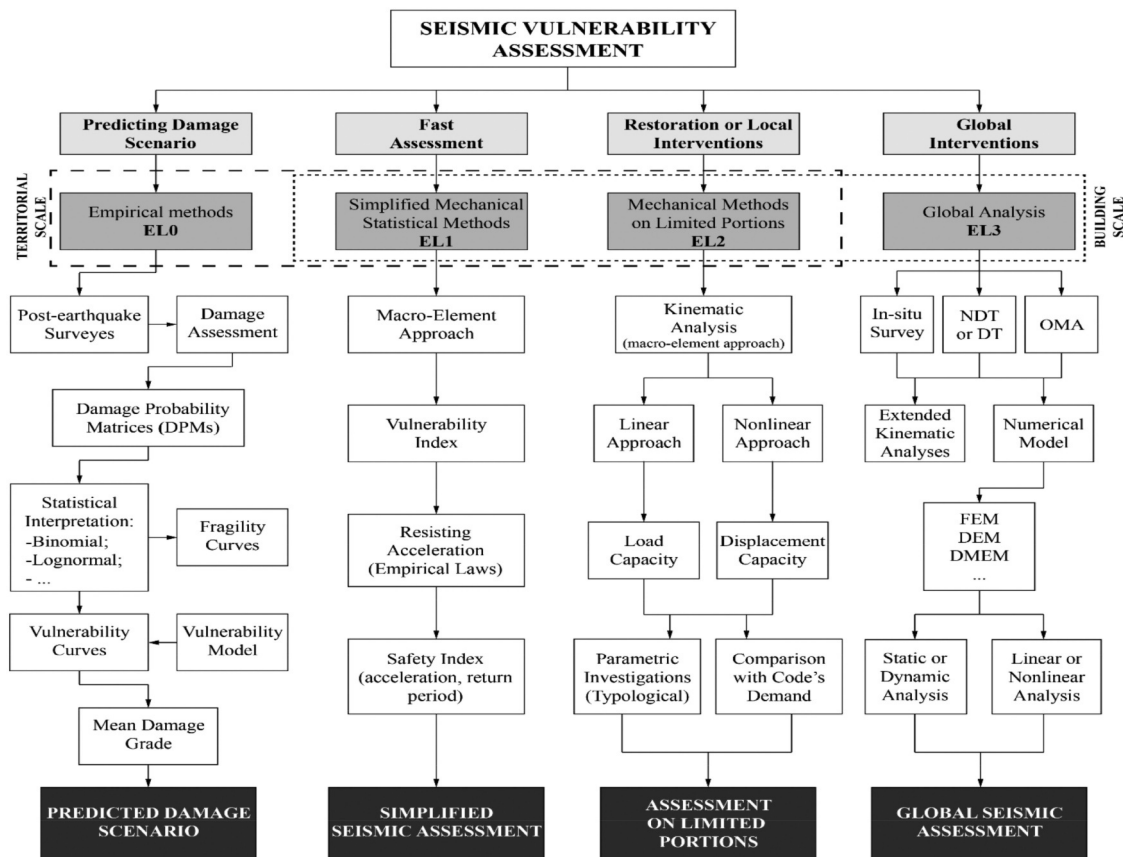
Figure 12. Approaches in the seismic vulnerability assessment process [15].

The surveys that were conducted after past earthquakes, especially in Italy, showed considerable damage to masonry churches, highlighting the necessity of increasing the knowledge level and of improving the existing assessment methodologies for preserving the valuable cultural heritage by means of risk mitigation. The first step in the risk mitigation process is the proper seismic vulnerability assessment of the vulnerable churches, which is a complex process that can be achieved following a large number of approaches, each one corresponding to a different level of accuracy, as presented in Figure 12 (Zizi et al. 2021).
