Double-leaf masonry walls under in-plane loading strengthened with GFRP/SRG strips

Double-leaf masonry walls under in-plane loading strengthened with GFRP/SRG strips / Capozucca, Roberto. - In: ENGINEERING STRUCTURES. - ISSN 0141-0296. - STAMPA. - 128C:(2016), pp. 453-473. [10.1016/j.engstruct.2016.09.042]

**Double-leaf masonry walls under in-plane loading
strengthened with GFRP/SRG strips**

ABSTRACT

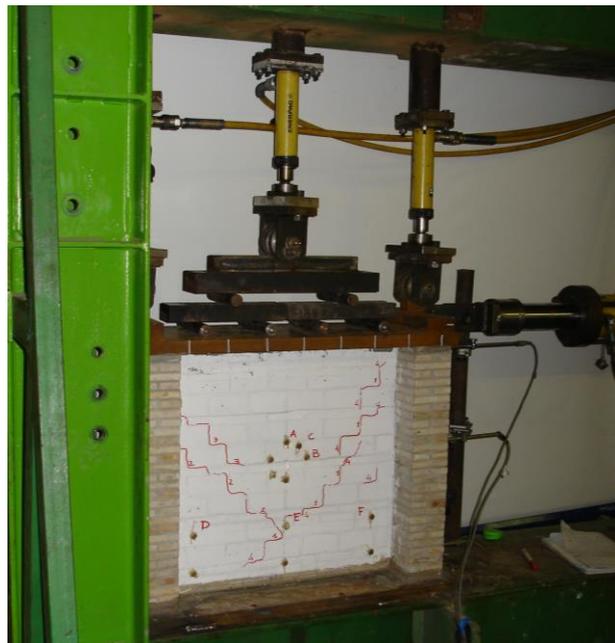
Figure 4 – Exp. cracking view of damaged model M-LW1.

In Figure 3 the experimental diagrams of cyclic load, $\pm F$, vs deflection, $\pm \delta$, at the top of the model wall (transducer no.1) is shown for M-LW1. The diagonal cracking distribution at the failure of both wall models M-LW1 is shown in Figure 4.

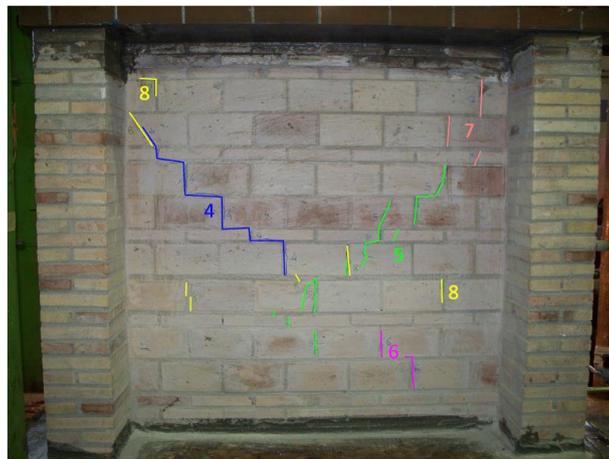
Figure 10 – Exp. cracking of tested model M-LW4: (a) first side and (b) second side of web.

In model M-LW3 the first cracks appeared when it was subjected to a horizontal load value equal to $F=+10\text{kN}$ (Fig. 8). In model M-LW4 initial load cracking appeared at a value equal to $F=-15\text{kN}$ marked number 1 (Fig. 10 (a)); the cracks appeared between the vertical mortar joints (Figs. 8 and 10) in both models.

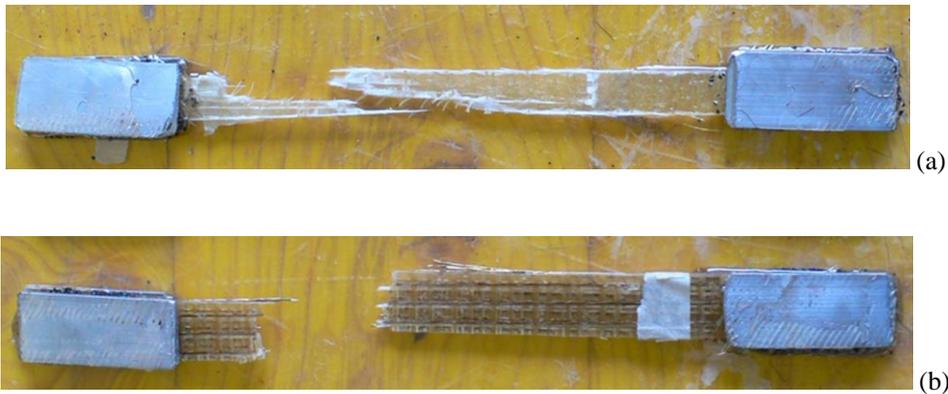
Figure 13- View of experimental failure by tensile tests: (a) GFRP specimen – failure type AGM (Angled, Gage, Middle); (b) SRP specimen – failure type LGM (Lateral, Gage, Middle).

Similar experimental tests were carried out on damaged models after strengthening with external bonded CFRP and SRG strips. Previously, tensile tests were carried out on specimens of GFRP strips and steel reinforced polymer (SRP) strips [29]. Although SRG strips were adopted in the strengthening of the masonry wall model, tensile strength on SRP specimens permitted to control the strength capacity of this type of composite material with steel fiber. Both the glass and the steel fibers were soaked with epoxy resin as a polymer matrix offering high adhesion (such as Kimitech EP-IN), with a density of $\rho=1,08\text{g/cm}^3$. The main mechanical characteristics of epoxy resin are: maximum traction strength $f_t > 30\text{N/mm}^2$ and tensile Young's modulus equal to 1760N/mm^2 . Tables 4 and 5 contain the experimental geometric data relative to the samples investigated and the experimental results obtained from traction tests according to ASTM D 3039 [29]. For the steel wires, the equivalent area was calculated considering the area and the number of wires in the specimens. Figure 13 shows the experimental failure of specimens by tensile tests with failure types.

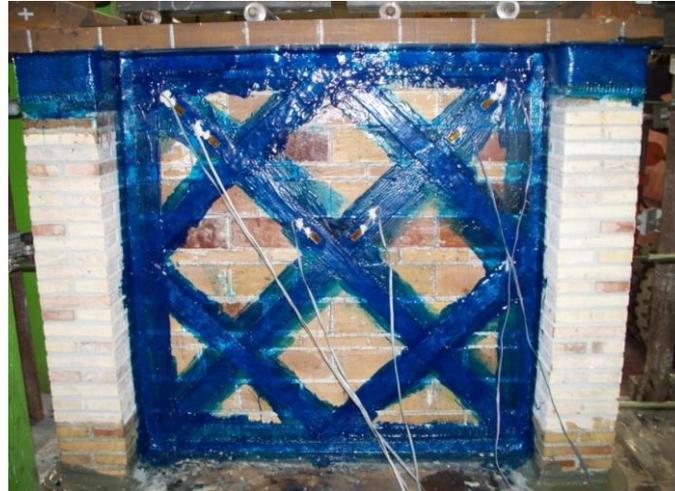
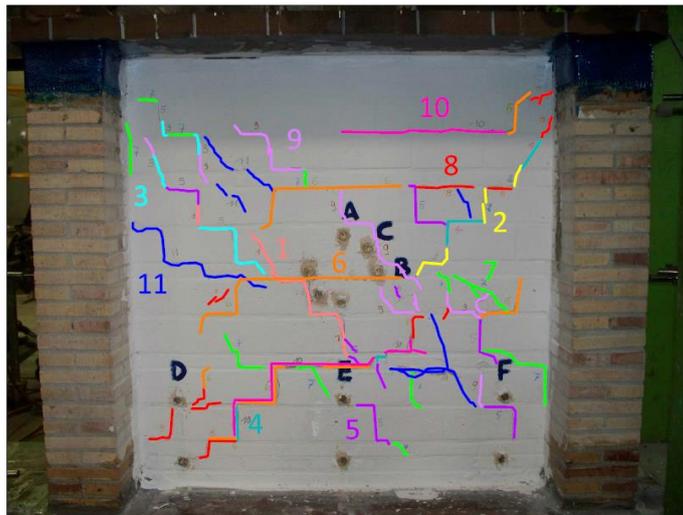
Figure 14 – (a) Reinforced model M-LW4 by GFRP strips with 6 strain gauges on central diagonal strips; (b) view of cracking distribution on one side without strengthening.

Three diagonal GFRP strips with an inclination of $\pm\pi/4$ were adopted as strengthening in M-LW1 and M-LW4, with a width value equal to 30mm (Fig. 14). Applying the strengthening entailed a series of operations: preparing the support by eliminating any surface impurity in the masonry; applying a *primer* obtained by mixing two components; applying a layer of adhesive and, finally, a GFRP composite. The thickness of the GFRP strips was equal about to 1.5mm.

In addition to all the instruments used for the test on the unreinforced models, two strain gauges on M-LW1 and six strain gauges on M-LW4 (Fig. 14 (a)) were also used in order to measure strain

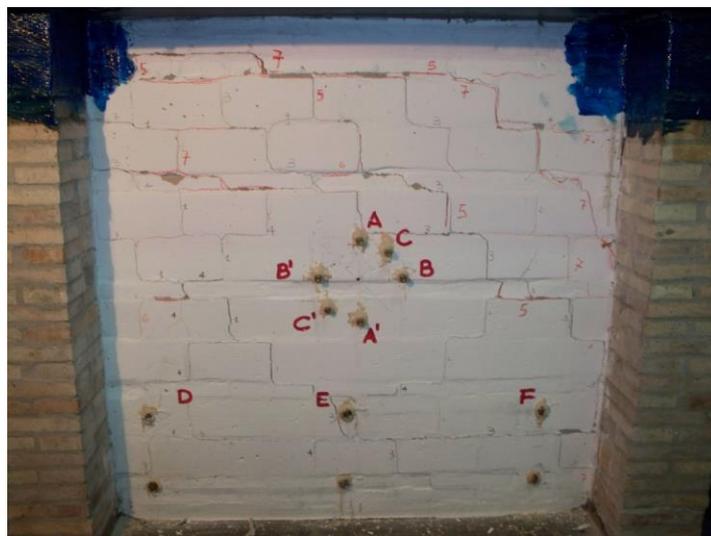
Figure 16 – Side view of cracking of reinforced model M-LW1 at horizontal load $F \approx \pm 21$ kN.

The evolution of the cracking trend for M-LW1 observed during the test is contained in Figure 16 for the side without strengthening. Cracking begins at horizontal force approximately $F=-10\text{kN}$; for $F=-20\text{kN}$, cracks numbered 5 are highlighted and the onset of the strengthening debonding is also

highlighted. Subsequently for horizontal force, $F=+20$ kN, cracks 6 and 7 formed. The cracks occurred at the mortar-brick interface and showed a prevalently diagonal trend which indicates that the crisis occurred because the shear resistance of the masonry wall was exceeded. Sliding of the joints was also recorded. In this case, the ultimate strength of L-MW1 is not increased compared to unreinforced model L-MW1, although relevant differences between experimental diagrams horizontal load versus deflection are recorded.

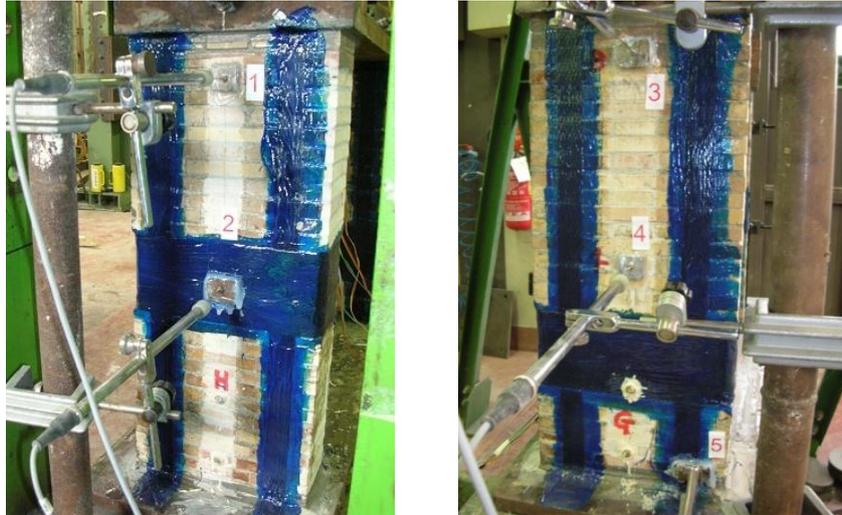
Figure 21 – Exp. reinforced model M-LW3 and position of transd. 1,...,6.

The instruments used for tests on model M-LW3 were the same as those used in the previous shear tests on the reinforced panels: five LVTDs no. 1,...4, 5 placed on the flange (Fig. 21) allowed registering the lateral deflection values; six strain gauges applied (Fig. 20(b)) along the two principal diagonals of the strengthening to measure deformation on the strengthening. The panel was subjected to a vertical precompression load equal to $\sigma_v = 1.15 \text{ N/mm}^2$.

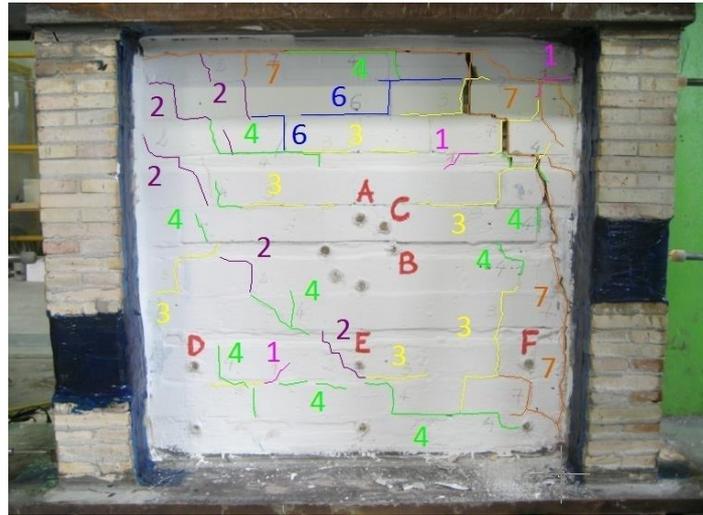
Figure 23 -View of cracking on one side of exp. reinforced model M-LW3 at failure.

The experimental diagrams for cyclic horizontal load, F , versus deflection, δ , recorded for M-LW3 model are shown in Figure 22(a) and (b), respectively, for transducer no. 1 and 3 at the top of model. Figure 23 contains a view of cracking for one side of M-LW3 without strengthening.

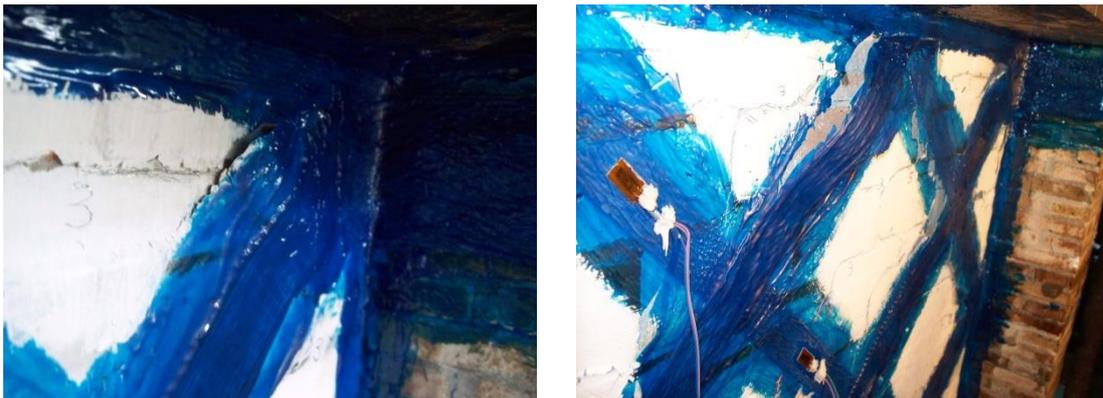
Figure 28 - View of failure of GFRP strips on strengthened M-LW1 and M-LW4: (a) debonding of strips; (b) tensile failure of strips.

Failure of the three strengthened models manifested with cracking of the masonry and with different debonding mechanisms for the two types of GFRP/SRG strengthening adopted. In the case of strengthening with GFRP strips, debonding of the diagonal strips occurs due to traction equal to $\varepsilon = 2500 \div 3000 \cdot 10^{-6}$ (Fig. 28).
