Use of acoustic techniques to analyse interlayer shear-torque fatigue test in asphalt mixtures

Use of acoustic techniques to analyse interlayer shear-torque fatigue test in asphalt mixtures / Ragni, D.; Takarli, M.; Petit, C.; Graziani, A.; Canestrari, F.. - In: INTERNATIONAL JOURNAL OF FATIGUE. - ISSN 0142-1123. - ELETTRONICO. - 131:(2020). [10.1016/j.ijfatigue.2019.105356]

# Use of acoustic techniques to analyse interlayer shear-torque fatigue test in asphalt mixtures

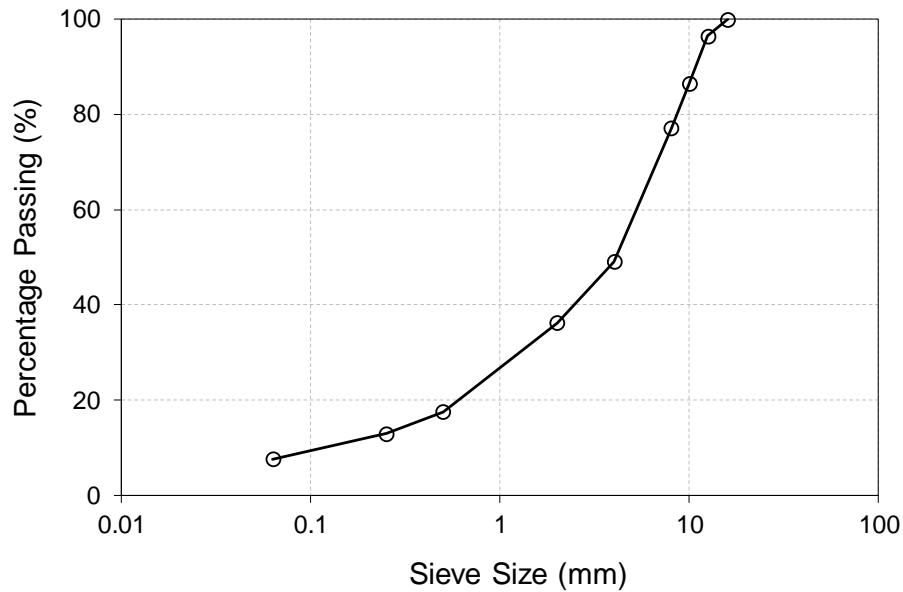
Fig. 1. Grading curve of aggregates.

An asphalt concrete (AC) for surface course with 12.5 mm maximum aggregate size (AC 12.5) was employed in this study. The mixture was prepared with the aggregate gradation shown in Fig. 1 containing basalt coarse aggregate, limestone fine aggregate and filler. The binder was a Styrene-Butadiene-Styrene polymer modified bitumen classified as PMB 45/80-65 [29] and dosed at 5.5% by aggregate mass.

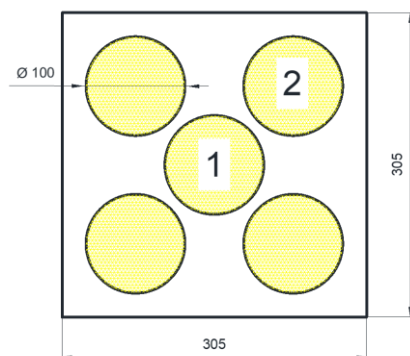
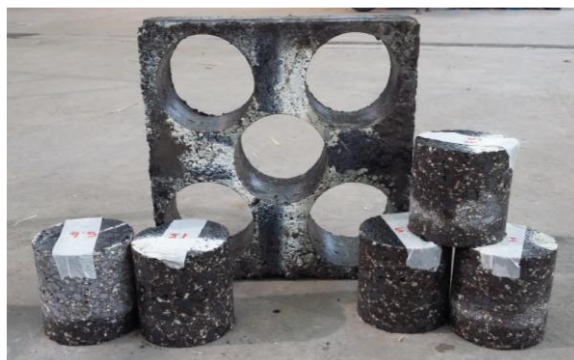
Fig. 2. Slab coring procedure: (a) specimen identification and (b) cored cylindrical specimens.

A double-layered square slab ( $305 \times 305 \text{ mm}^2$ ) was compacted in the laboratory in a stainless-steel mould by means of a roller compactor [30]. The lower layer was compacted at the temperature of  $150 \text{ }^\circ\text{C}$  until reaching a target thickness of 60 mm. Then, after cooling at room temperature for 3 hours, the upper layer was compacted at the same temperature reaching a target thickness of 40 mm. A tack coat or reinforcement was not applied at the interface in order to study the failure mechanism in the simplest condition [8]. The slab was demoulded after cooling at room temperature for one day, and five cylindrical specimens, with a nominal diameter of 100 mm, were cored, as shown in Fig. 2. Specimens 1 and 2 were used for this investigation. The upper and lower parts of the specimens were sawed (about 1 cm) and rectified. The final properties of the specimens are summarised in Table 1.

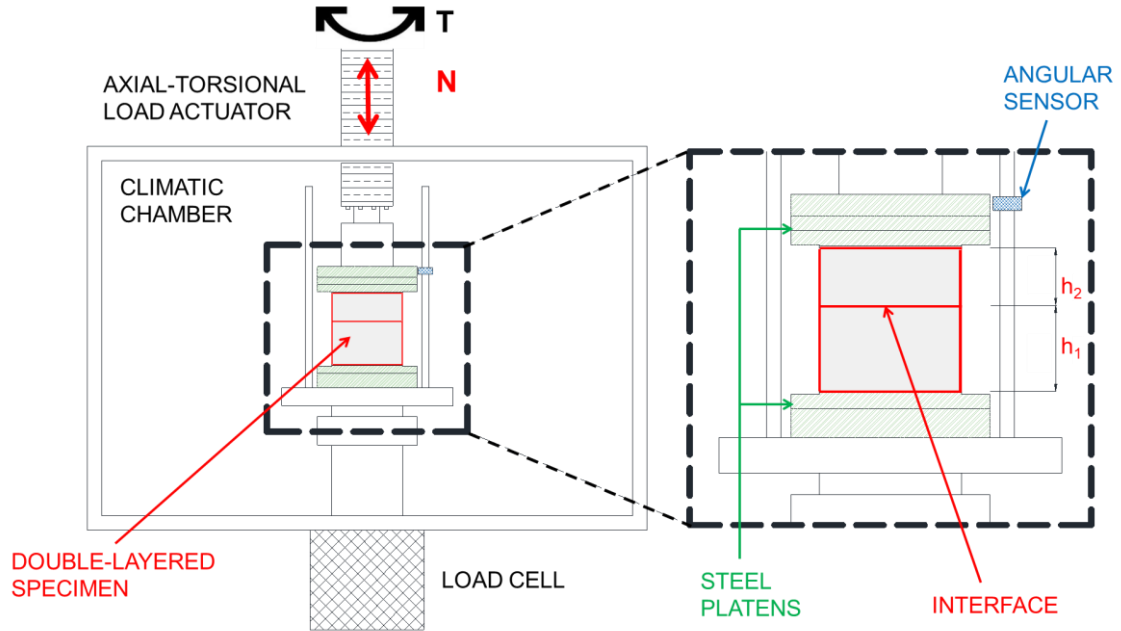
Fig. 3. Working scheme of shear-torque fatigue test.

Shear-torque fatigue tests were carried out on two double-layered specimens by means of a material testing system (MTS) device equipped with a temperature-controlled chamber. The MTS device is able to apply a torque of 1000 Nm and an axial load of 100 kN. The fatigue tests were performed at a temperature of 20 °C as normally suggested for static tests [4]. A sinusoidal torque with a frequency of 10 Hz and an amplitude  $T_0$  of 85 Nm and 95 Nm was applied on specimens 1 and 2, respectively. An axial compression load  $N$  of 0.05 kN was also applied and kept constant during the whole test. The torsional rotation angle was measured using a non-contact angular sensor with an accuracy of  $0.001^\circ$ , located on the upper steel platen as shown by the working scheme in Fig. 3.

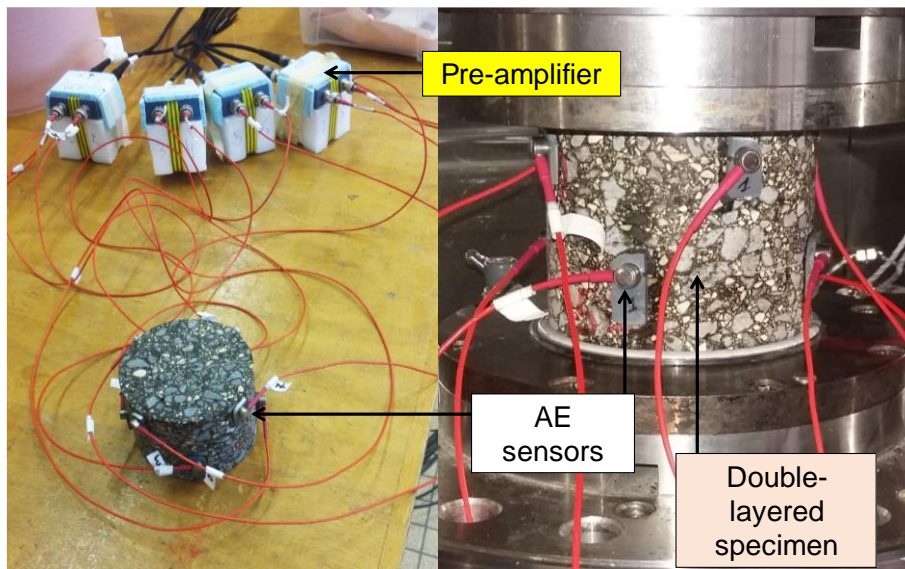
Fig. 6. AC specimen instrumented with acoustic emission sensors and pre-amplifiers.

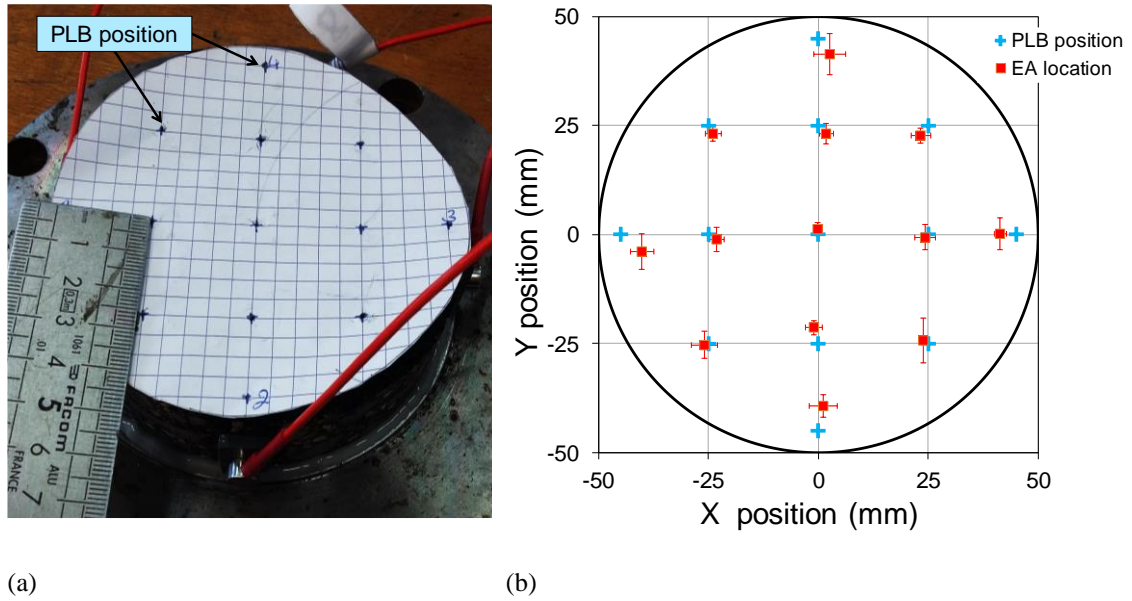
Fig. 7. Calibration of the AE-location with the PLB test: (a) square mesh of 25 mm overlaid on the fractured surface and (b) PLB test results.

In this study, the 3D localisation of the AE sources was improved by performing a calibration protocol called pencil lead break (PLB) test. This test consists in simulating an AE event using the fracture of a brittle graphite lead in a prefixed PLB position. This fracture generates an intense acoustic signal, quite similar to a natural AE source that the sensors detect as a strong burst. The PLB test was performed at the end of the shear-torque fatigue test on the

fractured surfaces of each specimen considering 13 points as shown in Fig. 7. Six pencil lead break repetitions were performed in each position.

The calibration results are shown in Fig. 7b and the data are summarised in Table 2. Dispersion in acoustic location was less significant in the centre of the fracture surface ( $x = 0$  mm;  $y = 0$  mm), and more significant closer the transducers.

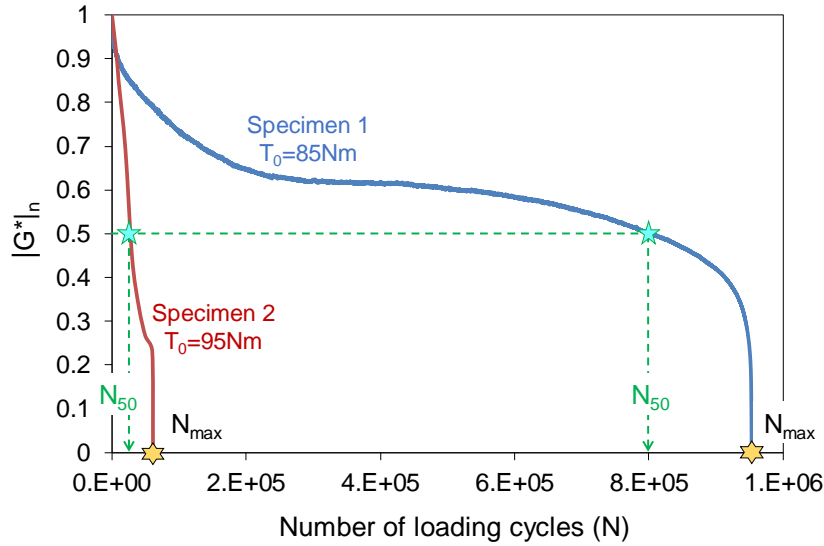
Fig. 8. Evolution of  $|G^*|_n$  in shear-torque fatigue test at 10 Hz and 20 °C and classical fatigue failure criterion.

Fig. 8 shows  $|G^*|_n$  as a function of the number of loading cycles for the two tested specimens. As expected,  $|G^*|_n$  decreases with the number of loading cycles and the number of loading cycles required to completely fracture the specimen ( $N_{\max}$ ) increases with decreasing applied torque. Specimen 1 failed after 953,263 cycles and the evolution of  $|G^*|_n$  was similar to that observed for asphalt concrete subjected to cyclic testing, where three typical stages can be normally observed [13, 32]. In the first stage, the complex modulus decreases rapidly, whereas, in the second stage, the complex modulus decreases quasi-linearly. Finally, the third stage is characterised by a quick decrease of complex modulus until the complete failure of the specimen. Specimen 2 failed after 61,150 cycles and different stages cannot be distinguished. This behaviour can be due to the higher applied torque. However, it is highlighted that specimen 2 was cored close to the corner of the slab. In this area, the presence of the rigid mould restricts

the movement of the aggregates close to the border (boundary effect) during the compaction. This generally results in differences in the internal aggregate structure of the material between the corners and the centre of the slab, and for this reason, the material could present lower mechanical performance [33, 34].

The fatigue life may be estimated by considering various failure criteria, and it is generally defined as the number of loading cycles to failure ( $N_f$ ). The value  $N_f$  is lower than  $N_{max}$  and is usually associated with the number of loading cycles at which the initial modulus is reduced by a prefixed percentage (e.g. 50%  $\rightarrow N_f = N_{50}$ ). As shown in Fig. 8, by referring to the classical fatigue failure criterion ( $N_{50}$ ), the fatigue life for specimens 1 and 2 are of 800,000 and

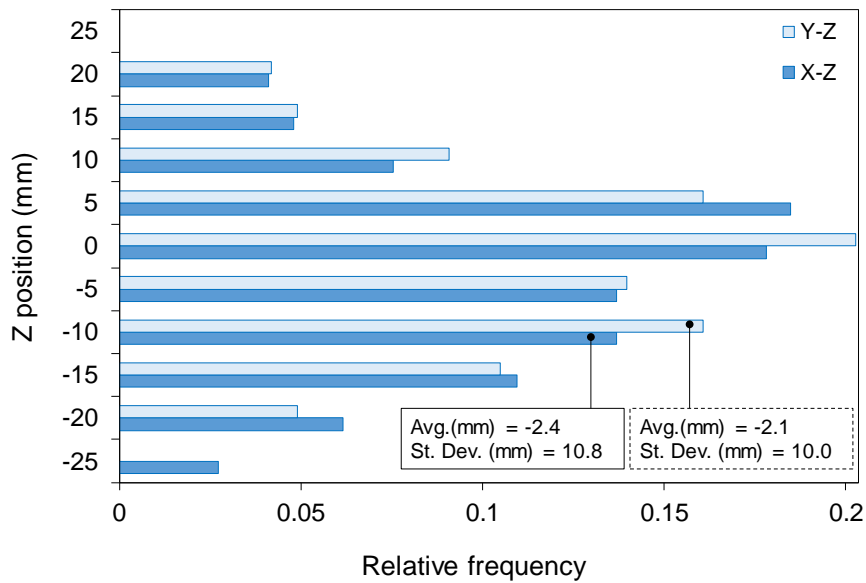
Fig. 11. EA events frequency distribution along Z position for specimen 1.

In order to better understand the results obtained from the acoustic analysis, a statistical analysis was carried out. Figs. 11 and 12 show the frequency distribution along Z position of the EA events reported in Figs. 9 and 10, respectively. For both specimens, it can be observed that the EA events are mostly concentrated within the range -7.5 and +7.5 mm.

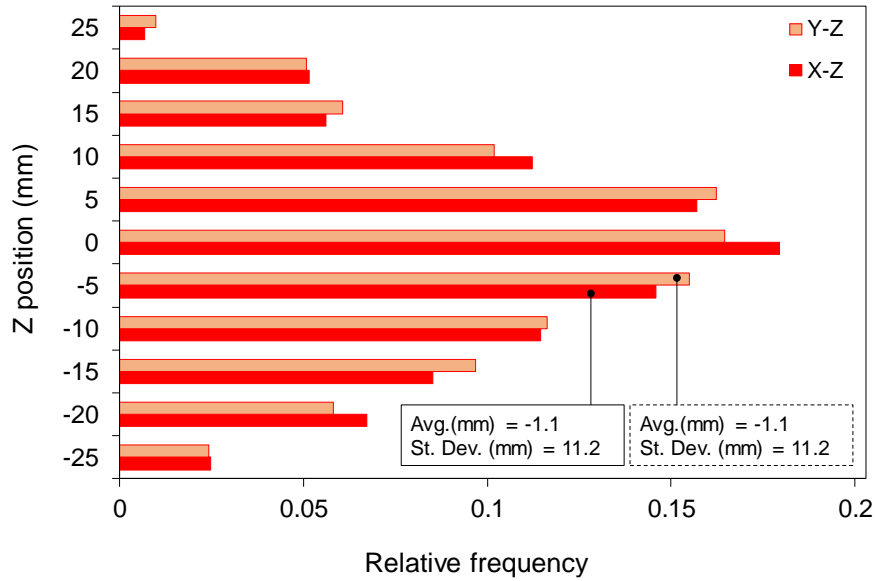
Fig. 12. EA events frequency distribution along Z position for specimen 2.

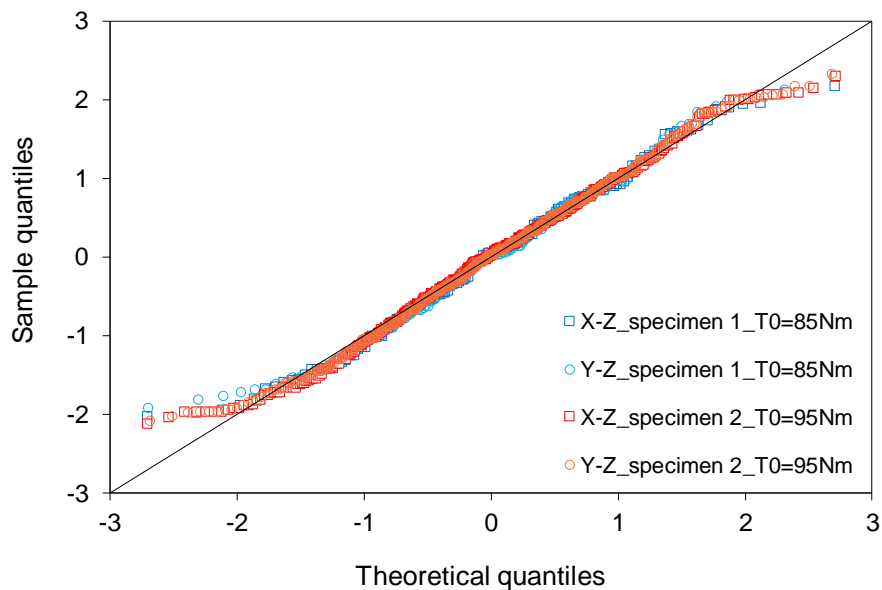
Fig. 13. Normal QQ plot of AE events along Z position for specimen 1 and specimen 2.

The statistical distribution of the measurements along the Z position was checked using a normal Quantile-Quantile (QQ) plot. Fig. 13 reports the data for both specimens in the X-Z and Y-Z planes. The points plotted along the equality line, confirming that most of the AE events may be considered normally distributed around the interface. The two tails outside the range -2 and +2 show a possible deviation from normality. These points can be related to the AE events located close to the steel platens which are not part of the same normal distribution. Thus, it is possible to affirm that the damage tends to localise in the interlayer zone, confirming that this is the weakest part of the specimen.

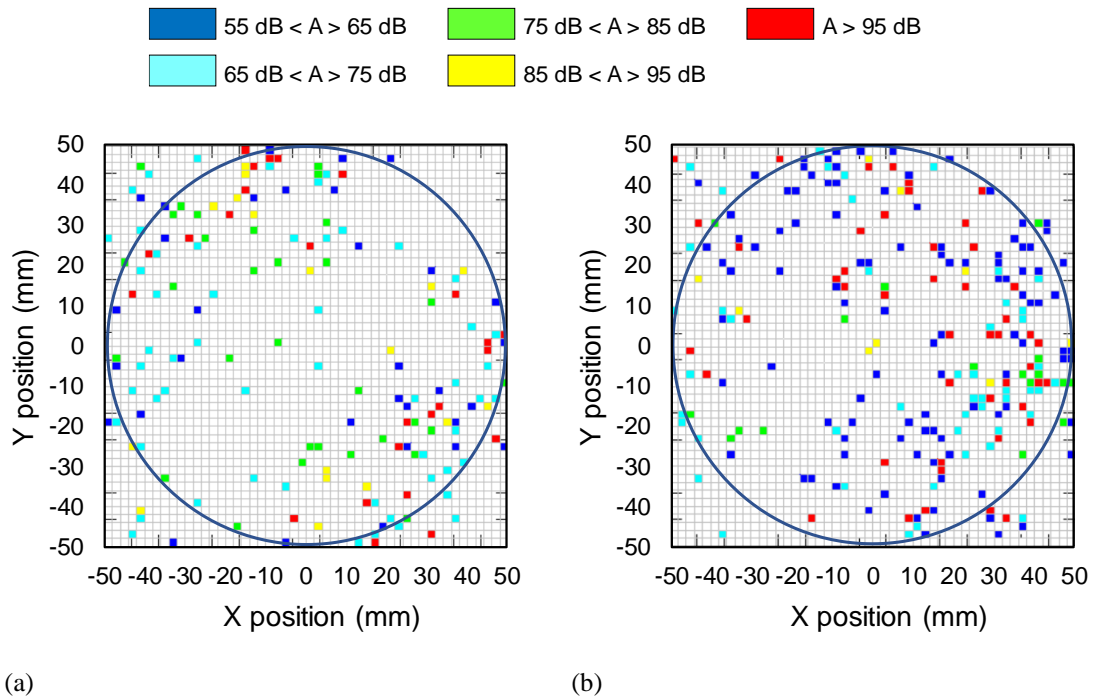
Fig. 14: Location of AE events on the X-Y plane: (a) specimen 1 and (b) specimen 2.

Fig. 14 presents the AE events on the X-Y plane for specimens 1 and 2 at the end of the test. The events are classified with the scale of the peak amplitude. It was observed during the tests that only AE events with small amplitudes occurred at the initial stage, and the events with large amplitudes began gradually to occur until reaching the peak at the end of the test. In Fig. 14, for both specimens, it can be observed that AE events were distributed mostly around the border of the specimen. A certain number of points were also identified outside the specimen. These events could be generated by uncertainties of the localisation method and/or because of echo events as already observed in Figs. 9 and 10.

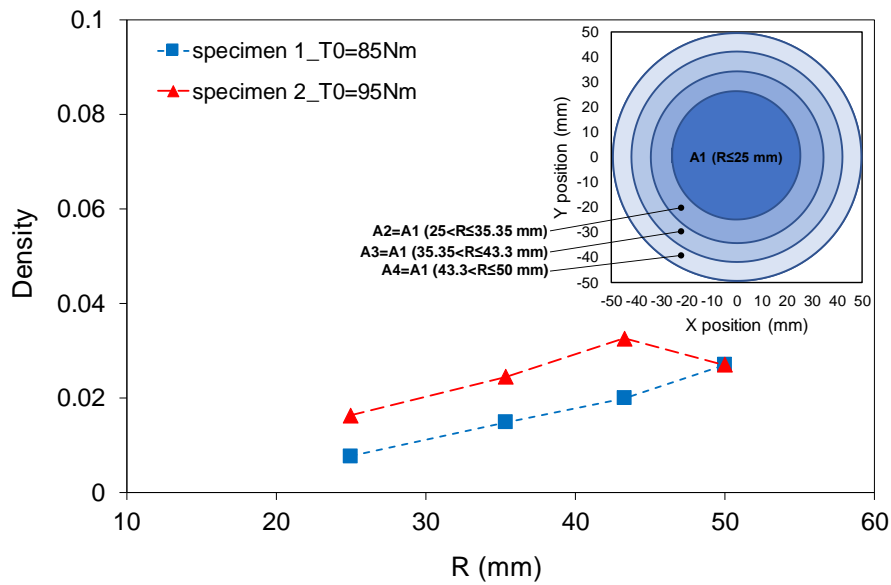
Fig. 15. EA events density on the X-Y plane as a function of the distance from the centre of the specimen (R) for specimen 1 and specimen 2.

A statistical analysis of the distribution of AE events on the X-Y plane was also carried out. The cross-section of each specimen was divided into four annuluses with the same area and with an outer radius equal to 25, 35.35, 43.3 and 50 mm, respectively. Fig. 15 shows the density of the EA events (number of events per unit area) reported in Fig. 14 as a function of the distance from the centre of the specimen ( $R = \sqrt{X^2 + Y^2}$ ). The density was higher close to the circumference of the specimen, i.e. where the maximum shear stress occurs. Moreover, the cross-section of each specimen was also divided into eight sectors formed by angles of 45 degrees each. Fig. 16 shows the polar frequency distribution of the AE events reported in Fig. 14. The frequency of the events is not homogeneously distributed on the X-Y plane. These results agree with the previous observations and indicate that the AE events were mostly concentrated in certain areas.

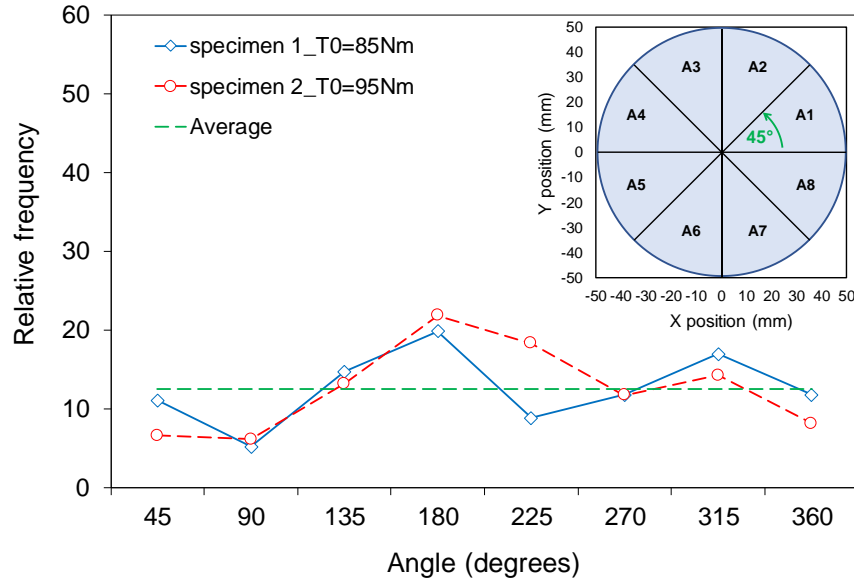
Fig. 16. EA events polar frequency distribution on the X-Y plane for specimen 1 and specimen 2.

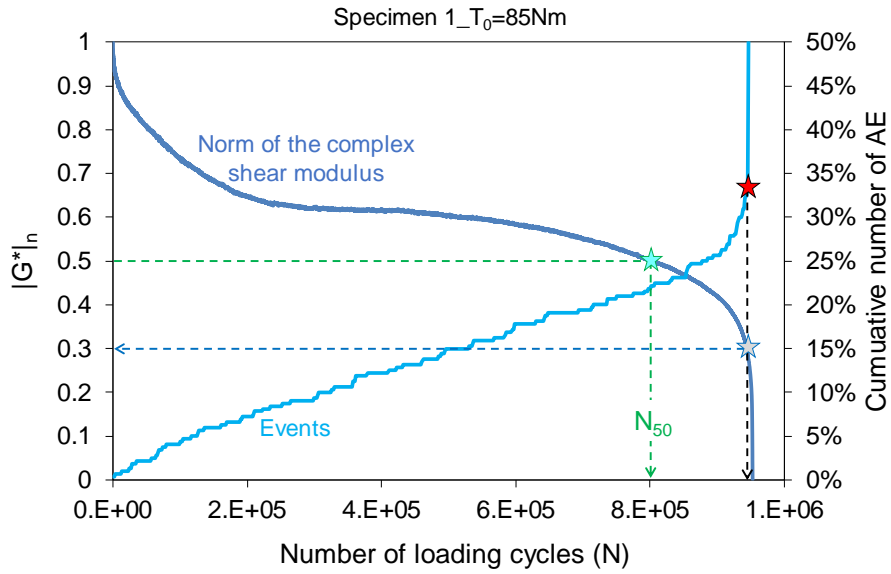
Fig. 17. Evolution of the cumulative number of AE events and of  $|G^*|_n$  during shear-torque fatigue test for specimen 1.

Figs. 17 and 18 show the evolution of the cumulative number of AE events as a function of the number of loading cycles superposed to parameter  $|G^*|_n$  for specimen 1 and specimen 2, respectively. Focusing on the evolution of the cumulative number of AE events, it is possible to identify two phases during the shear-torque fatigue test. A first phase during which the number of AE events increases almost linearly as the number of loading cycles increases. Subsequently, it can be observed a second phase during which the cumulative number rapidly increases as approaching the end of the test. Indeed, it is generally accepted that when the material is undamaged, the acoustic emission activity is almost negligible [15, 22]. The subsequent abrupt rise of AE activity indicates the formation of micro-cracks at the interlayer, as observed before, and occurs after 945,000 and 59,340 cycles for specimen 1 and 2, respectively, as shown in Figs. 17 and 18. This sharp increase of AE events, that corresponds to a rapid acceleration to failure, occurs when  $|G^*|_n$  reaches approximately 30% for specimen 1 and 25% for specimen 2, i.e., when the complex shear modulus decreases by about 70%. Since acoustic activity is generally a sensitive precursor to the failure process [16, 18, 22, 37, 38], these results indicate that a huge part of the decrease is not accompanied by the formation of micro-cracks. These observations appear to be in strict agreement with those presented in a previous study [27].

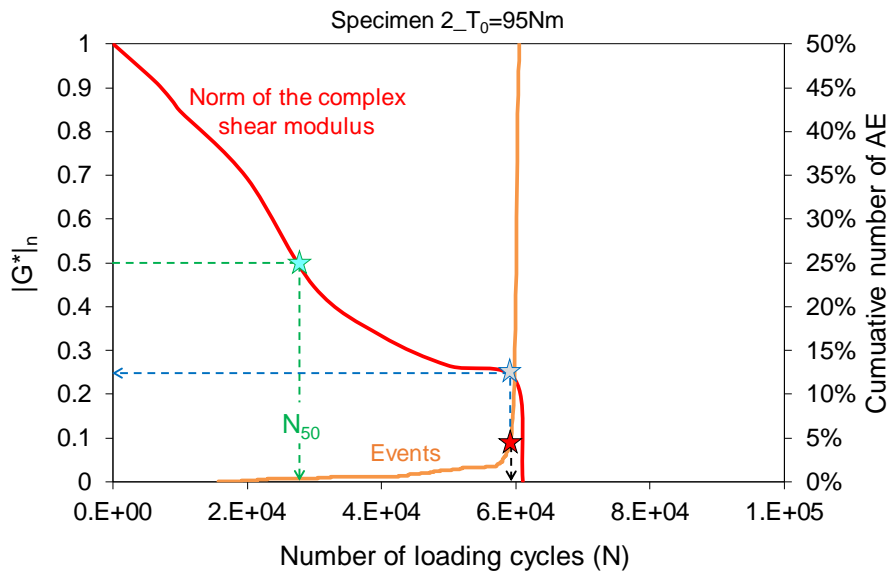
Fig. 18. Evolution of the cumulative number of AE events and of  $|G^*|_n$  during shear-torque fatigue test for specimen 2.
