Experimental static and dynamic response of RC beams damaged and strengthened with NSM GFRP rod

Experimental static and dynamic response of RC beams damaged and strengthened with NSM GFRP rod / Capozucca, R.; Magagnini, E.; Vecchiotti, M. V.. - In: COMPOSITE STRUCTURES. - ISSN 0263-8223. - STAMPA. - 241:(2020). [10.1016/j.compstruct.2020.112100]

# Experimental static and dynamic response of RC beams damaged and strengthened with NSM GFRP rod

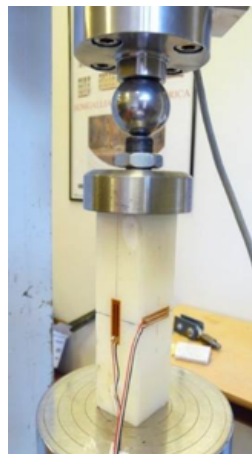
Figure 2 – Compression test of prismatic specimen of adhesive material.

The GFRP rods used on are of Company *MAPEI*. The mechanical and geometrical parameters of the GFRP rods were experimentally derived by tensile tests carried out on 2 specimens (Tab. 1); failure of specimens was of the XGM type - *Explosive, Gage, Middle* – as indicated in ASTM D-3039 Standard [32]. The adhesive used to glue reinforcement of GFRP rod was a two-component epoxy structural adhesive with high capacity to adhere to concrete surfaces. Three specimens of 40mm·40mm·160mm size were tested and subjected to compression tests to determine the mechanical characteristics of adhesive (Fig. 2). Each

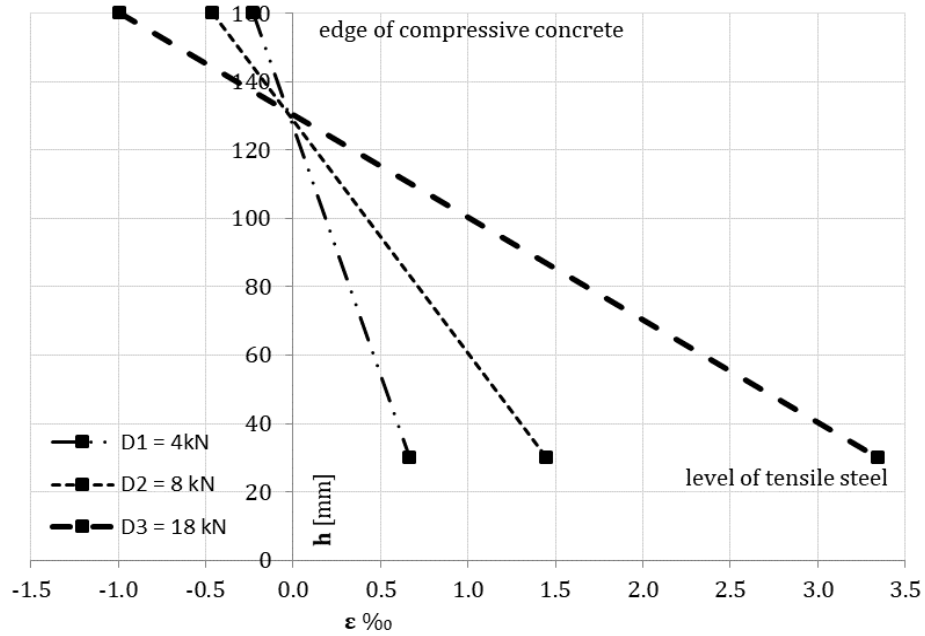
Figure 6 – Exp. strain values vs height of midspan section at different cycles of loading ( $D_i$  with  $i=1, \dots, 3$ ) for un-strengthened beam B1.

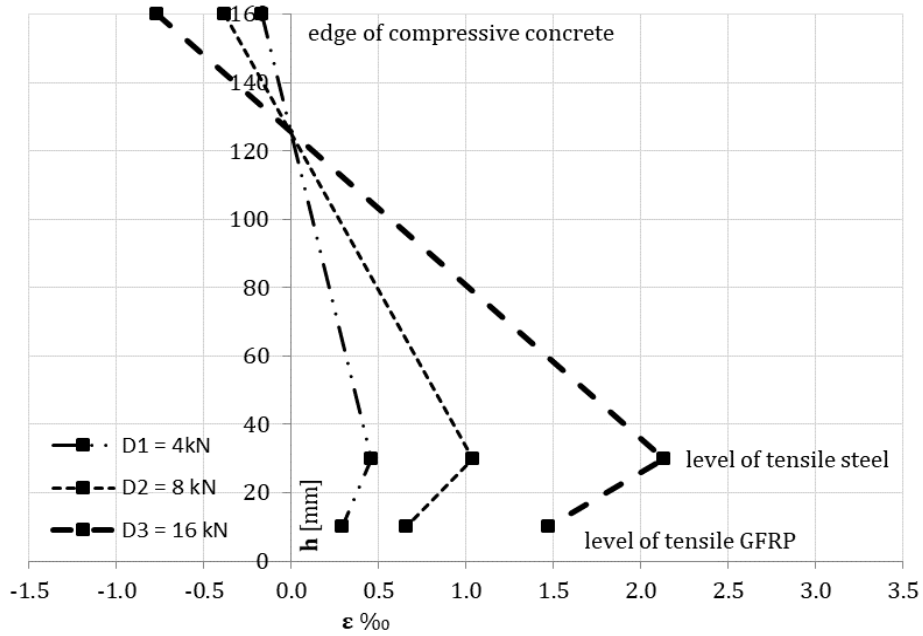
Figure 10 – Exp. strain values vs height of midspan section at different cycles of loading ( $D_i$  with  $i=1, \dots, 3$ ) for strengthened beam B1.

The distribution of the experimental strain values recorded at damage degree  $D_i$  at the midspan section is represented in Figure 10 considering the points of compressive edge of concrete, tensile steel and tensile GFRP rod. In this case the section's real behaviour is not plane because the strains on the GFRP rod aren't linearly congruent with the strains of steel and of the compressed concrete fiber and are conditioned by a *stress-strain lag*.

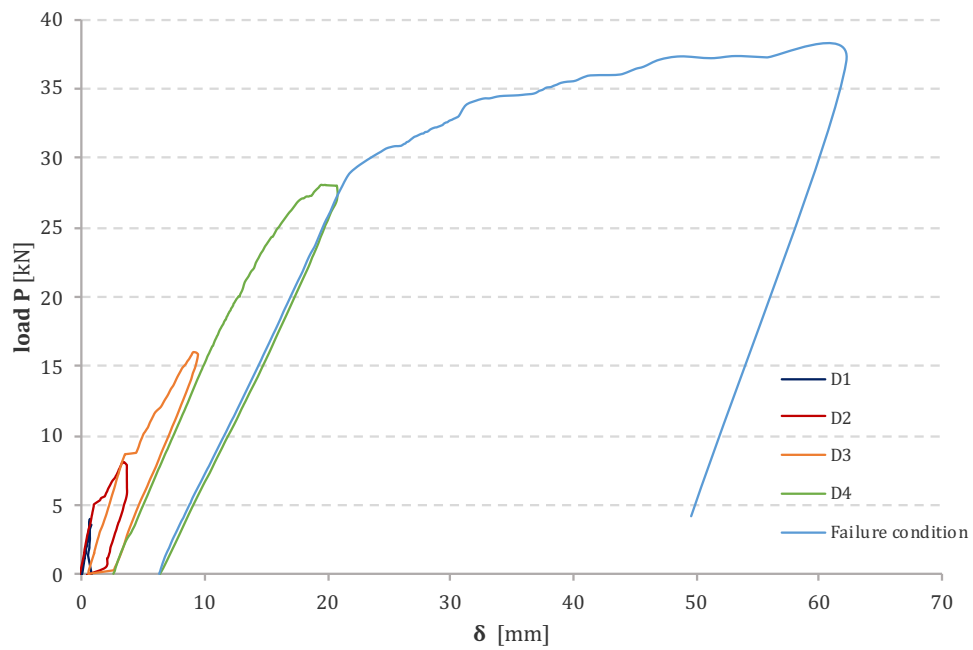
Figure 13 – (a) Exp. diagram load,  $P$ , vs deflection,  $\delta$ , at the midspan section of strengthened beam B2; (b) exp. diagram load,  $P$ , vs strain of concrete,  $\epsilon_c$ , at the edge of compressive concrete.

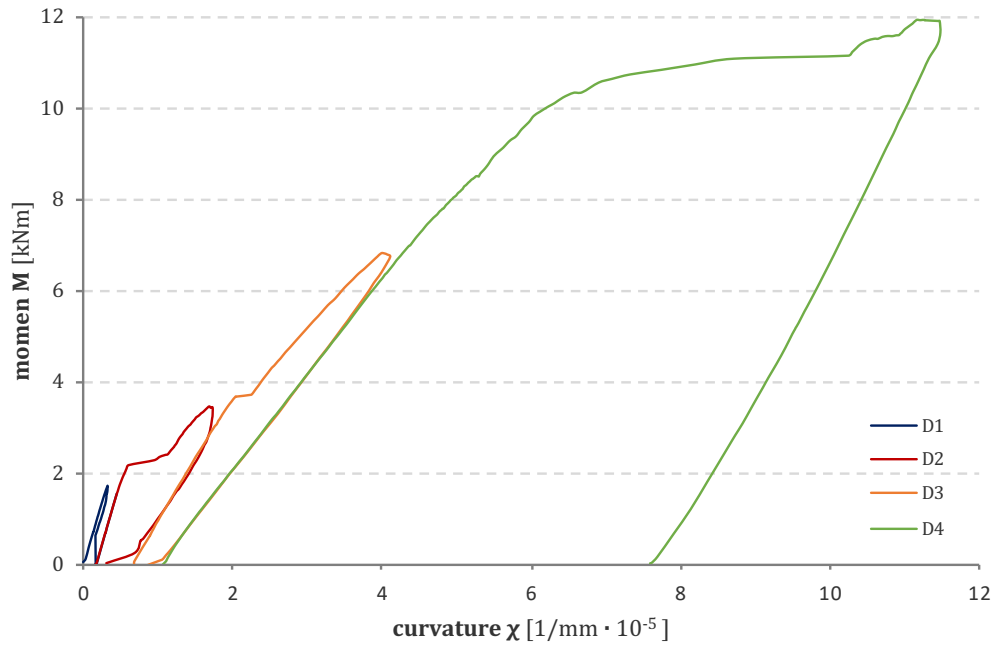
Figure 15 – Exp. diagram moment,  $M$ , vs curvature,  $\chi$ , at the midspan section of strengthened beam B2.

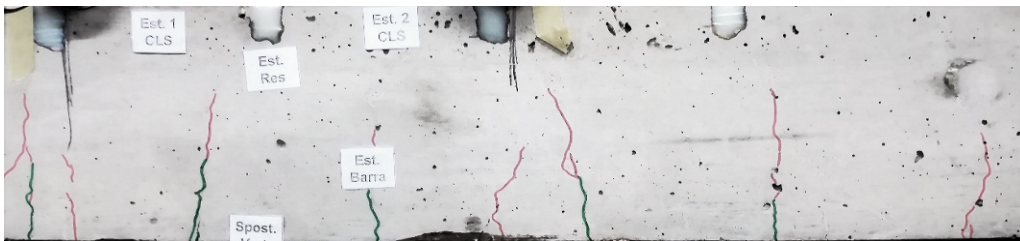
Figure 16 – Cracking damage development due to bending test at different damage degrees  $D_i$ ,  $i=2,3$  for strengthened RC beam B2.

The cracking caused by load level  $P=8.0 \text{ kN}$  ( $D2$ ) and  $P=16.0 \text{ kN}$  ( $D3$ ), is shown in Figure 16.

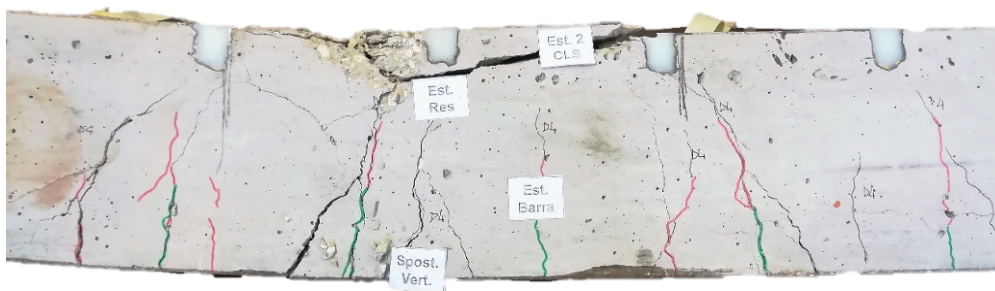
Figure 17 – View of failure of strengthened beam B2.

The failure occurs by the crash at the extrados of compression concrete cover containing the notches filled with resin (Fig. 17).

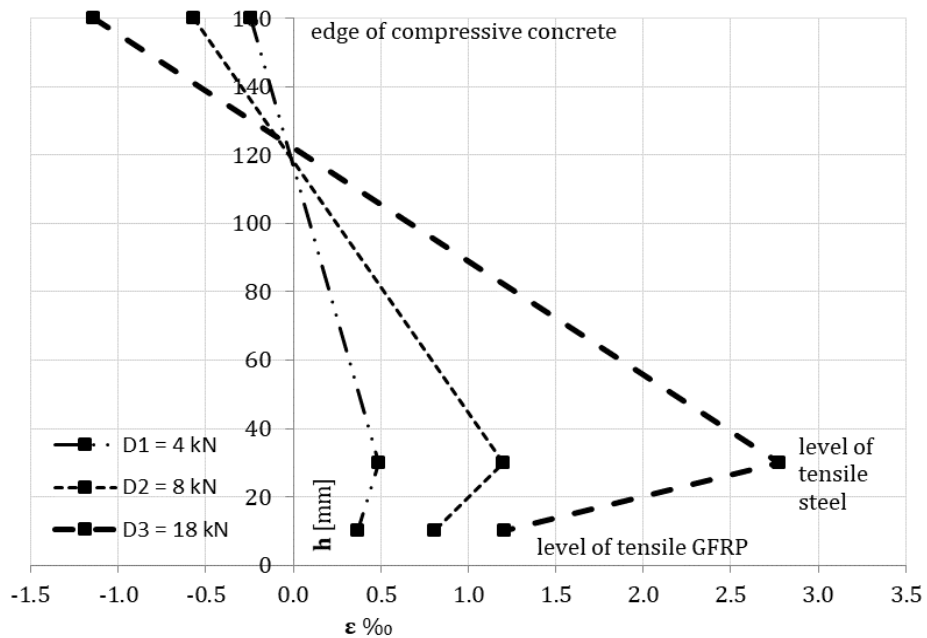
Figure 21 – Exp. strain values vs height of midspan section at different cycles of loading ( $D_i$  with  $i=1, \dots, 3$ ) for strengthened beam B3.

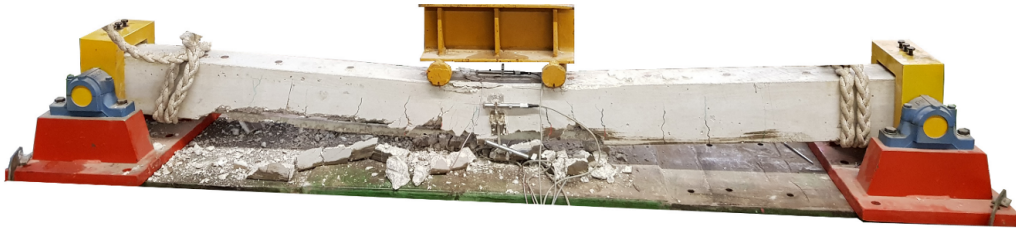
Figure 22 – Collapse view of strengthened beam B3 ( $P \cong 33$  kN).

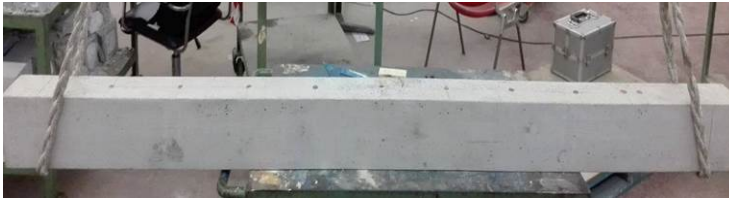
1. beam 2. accelerometer 3. impact hammer 4. analyzer FFT 5. PC

Figure 23 – (a) Set up of vibration tests on undamaged RC beams with hinge-hinge condition and instrumentation for dynamic tests; (b) beam hung to elastic springs and (c) accelerometer.

Experimental vibration tests were carried out considering two constraints conditions: free-free ends and hinges at the ends. In the case of free ends an elastic spring has been adopted to simulate this condition (Fig. 23(b)) and in the case of hinged ends the beam was located on metal hinge devise.

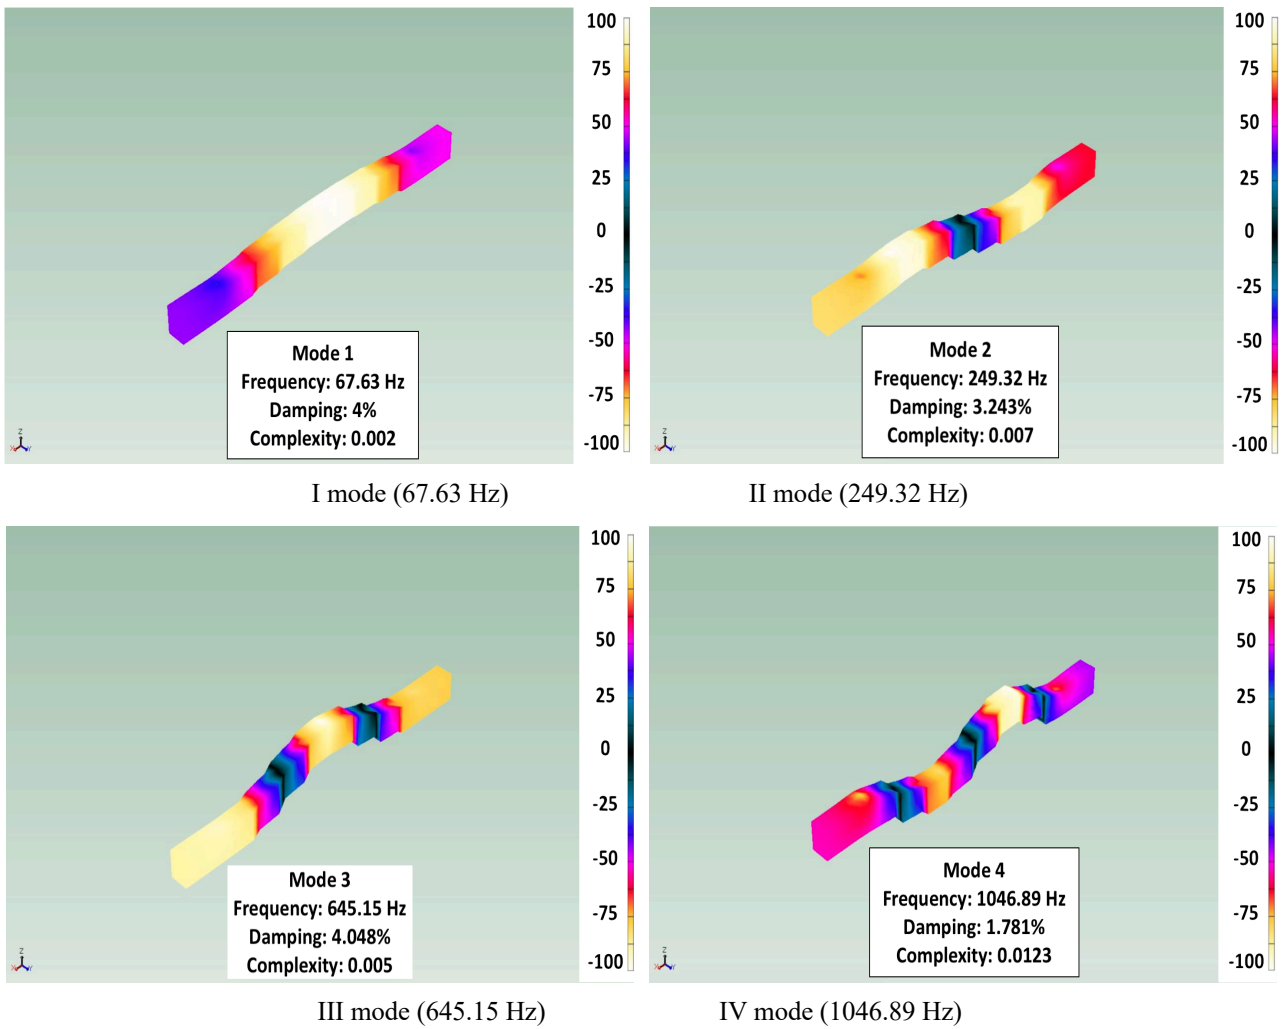
Figure 24 – Modal shapes of free vibration of undamaged RC beam B3.

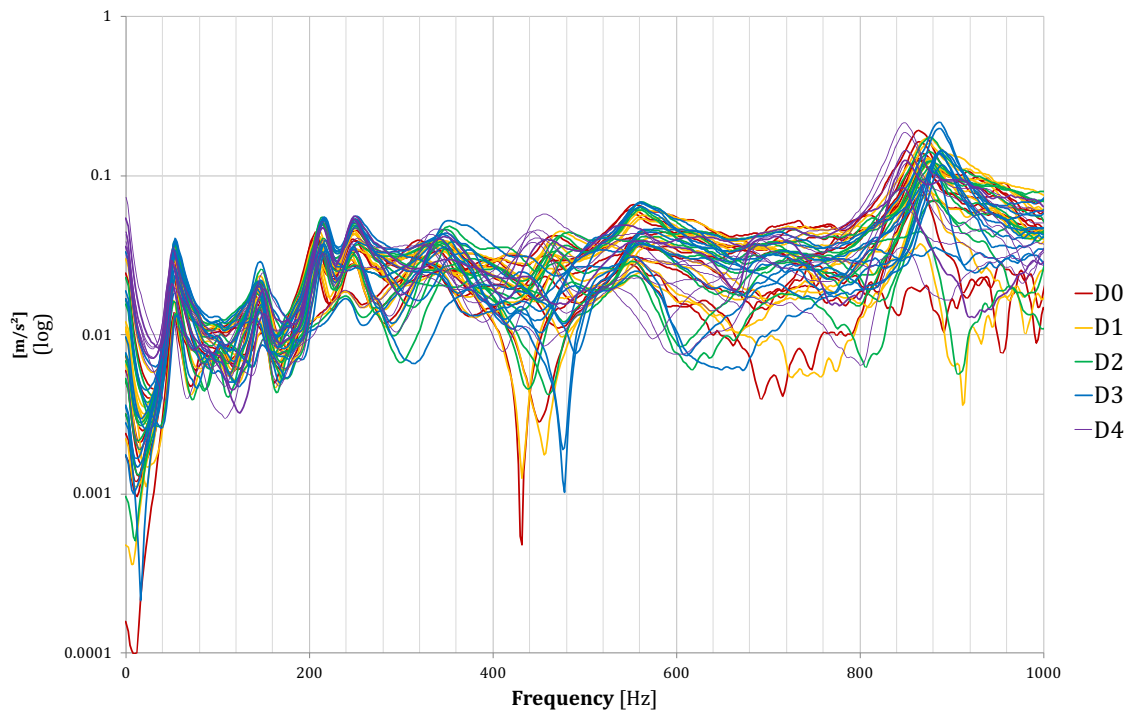
Figure 26 – Envelope of FRFs for strengthened beam B1 with hinge-hinge ends at different damage degrees  $D_i=0, 1, \dots, 3$ .

The beam B1 subjected to bending tests and therefore damaged by cracking of concrete by bending was subjected to free vibration in the condition of hinge-hinge constraint. The main experimental frequency values data obtained from the analysis of free vibration for RC beam B1, without and with GFRP NSM strengthening, at the various damage steps  $D_i$ , are contained in the Tables 9 and 10. Average frequency values were recorded experimentally at each of the accelerometer positions and contained in Tables 9 and 10 are also the frequency variations in percent with reference to the different damage degree. In Figures 25 and 26 the FRF envelope diagrams for the different damage degree  $D_i=1, \dots, 4$  of RC B1 beam with hinged ends, respectively, without and with strengthening are shown.

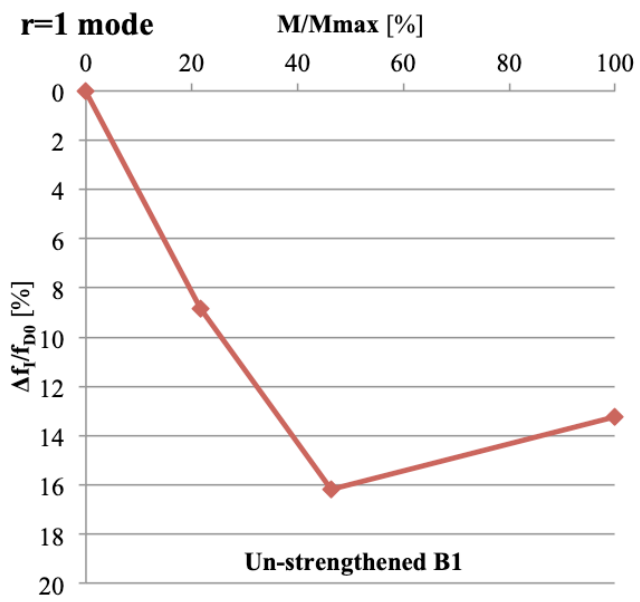
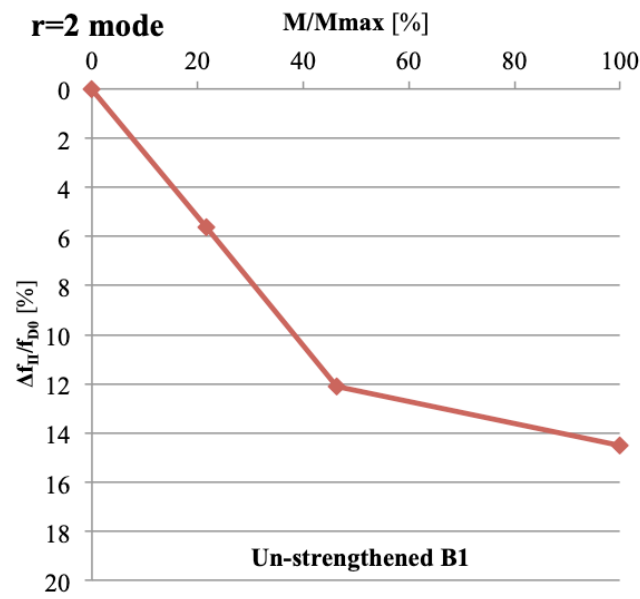
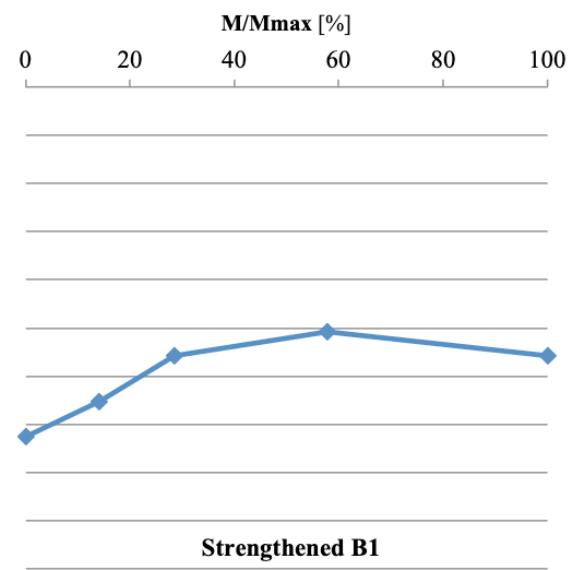
Figure 33 –Exp. diagrams of variation of frequency values (%) for the first two modes  $r = 1,2$  vs moment ratio  $M/M_{max}$  (%) for beams (a) B1 and (b) B3.

loading conditions expressed by bending moment  $M/M_{max}$  ratios (Figure 33(a) and (b)).

The comparison of frequency variations for the response for first two modes  $i=1,2$  versus the ratio of bending moment  $M/M_{max}$  when the beams B1 and B3 are strengthened, shows that the variations of frequency values is rather small. In fact, the strengthening by NSM GFRP rod contributes to reducing the width of the cracks undergoing even heavy loads. These diagrams confirm that the decrease of frequency values correlated to increase of bending moment is relevant for a non-strengthened beam while the diagrams in Figures 33 are substantially constant in the case of RC beams strengthened by NSM GFRP rod.
