Numerical model upgrading of a historical masonry building damaged during the 2016 Italian earthquakes: the case study of the Podestà palace in Montelupone (Italy)

NUMERICAL MODEL UPGRADING OF A HISTORICAL MASONRY BUILDING DAMAGED DURING THE 2016 ITALIAN EARTHQUAKES: THE CASE STUDY OF THE PODESTÀ PALACE IN MONTELUPONE (ITALY)

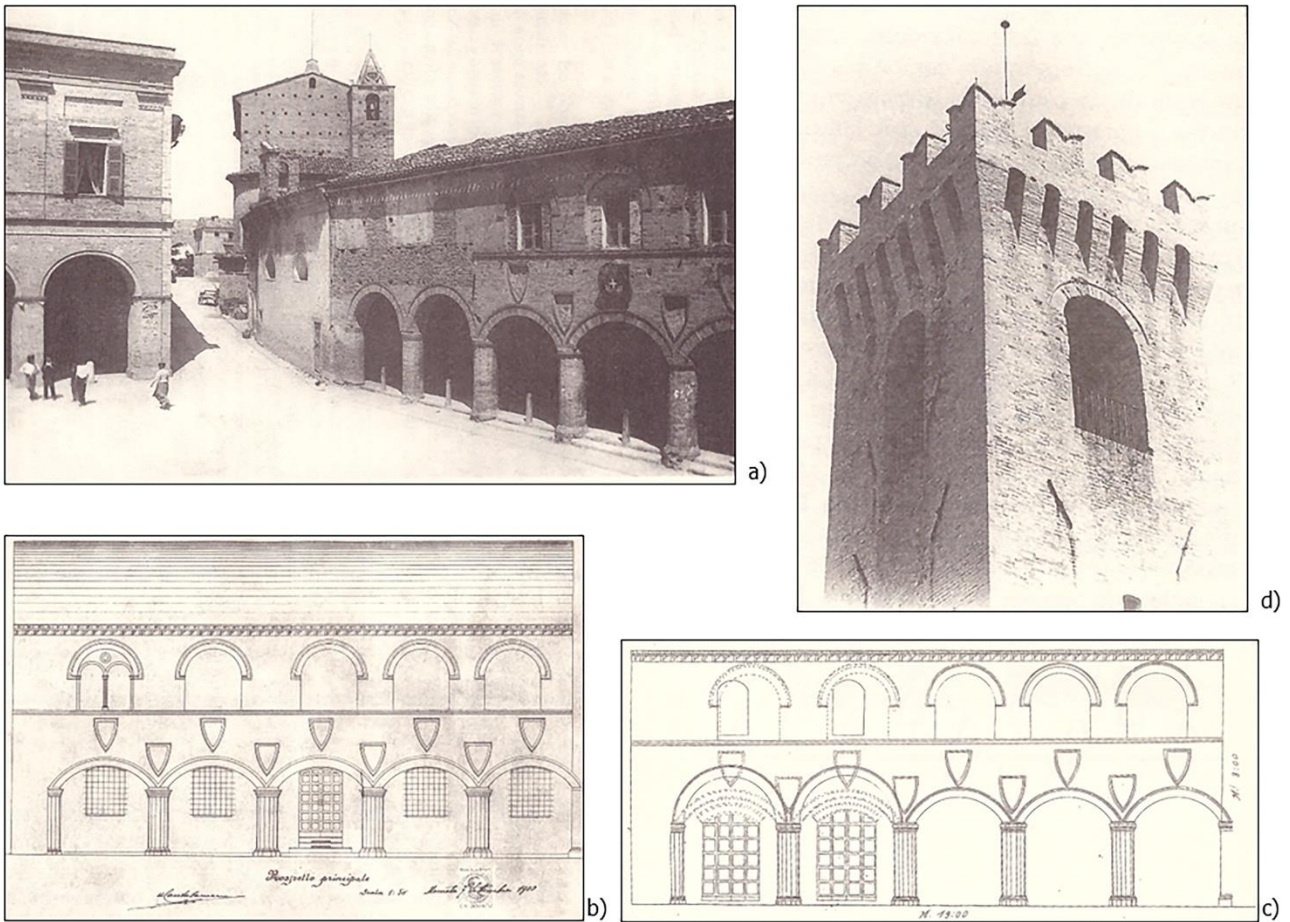
**Figure 1**. Picture of the palace during the AVS in 2016 November 25th.

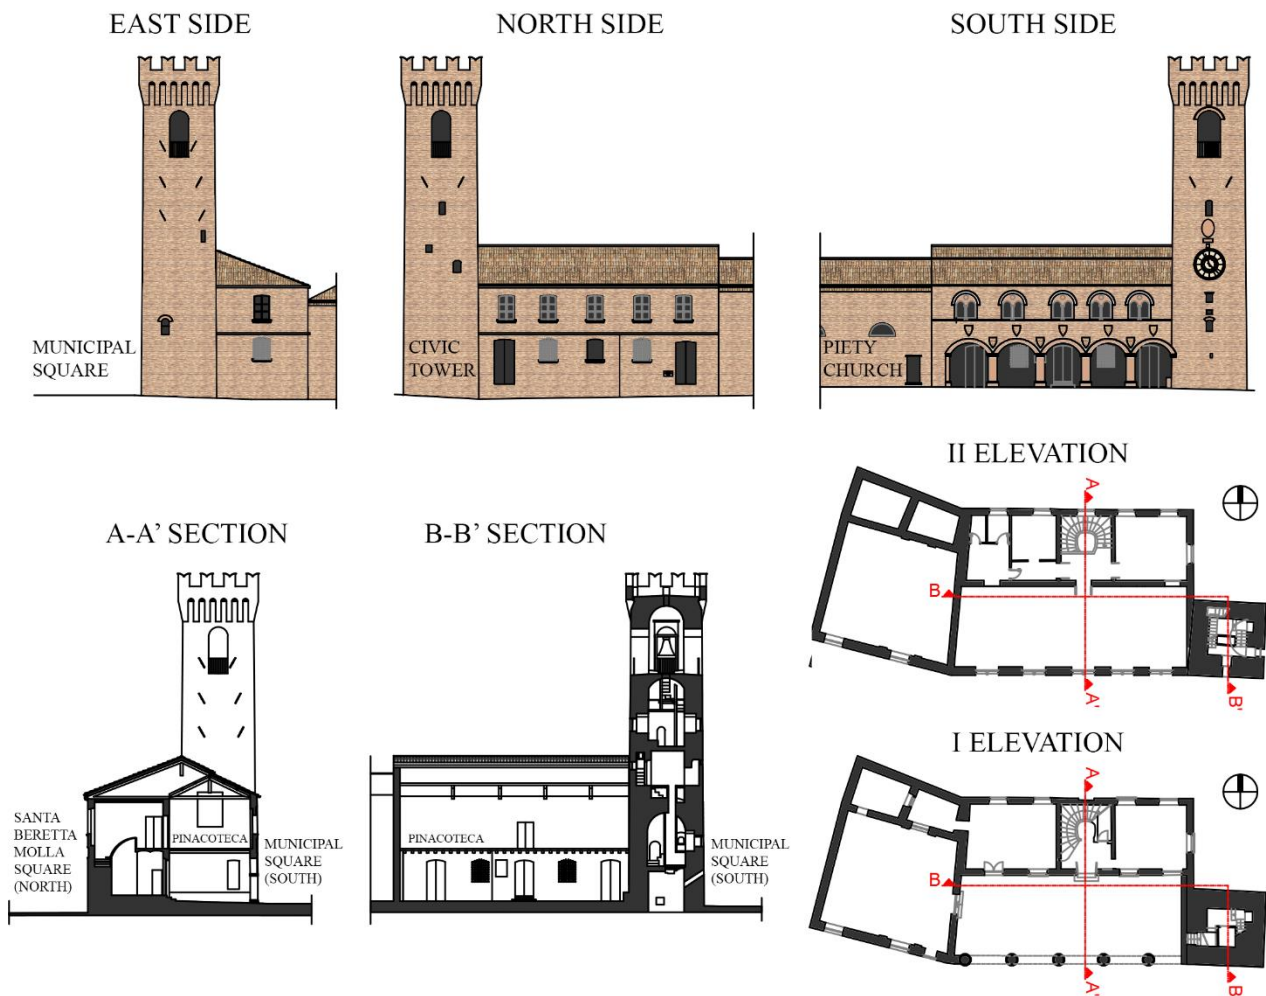
Figure 3. Architectural fronts, transversal sections and plants of the palace, tower and Piety church.

The building occupies an area of about 35 x 16 m, with a height of about 11.8 m for the Podestà Palace and an average height of 26 m for the tower (**Figure 3**). The structures are mainly made of masonry walls composed by solid bricks and lime mortar; the first and the roof levels of the church and palace are characterized by timber elements and arches. The walls thickness varies between 0.5 m and 0.6 m passing from the palace to the church.

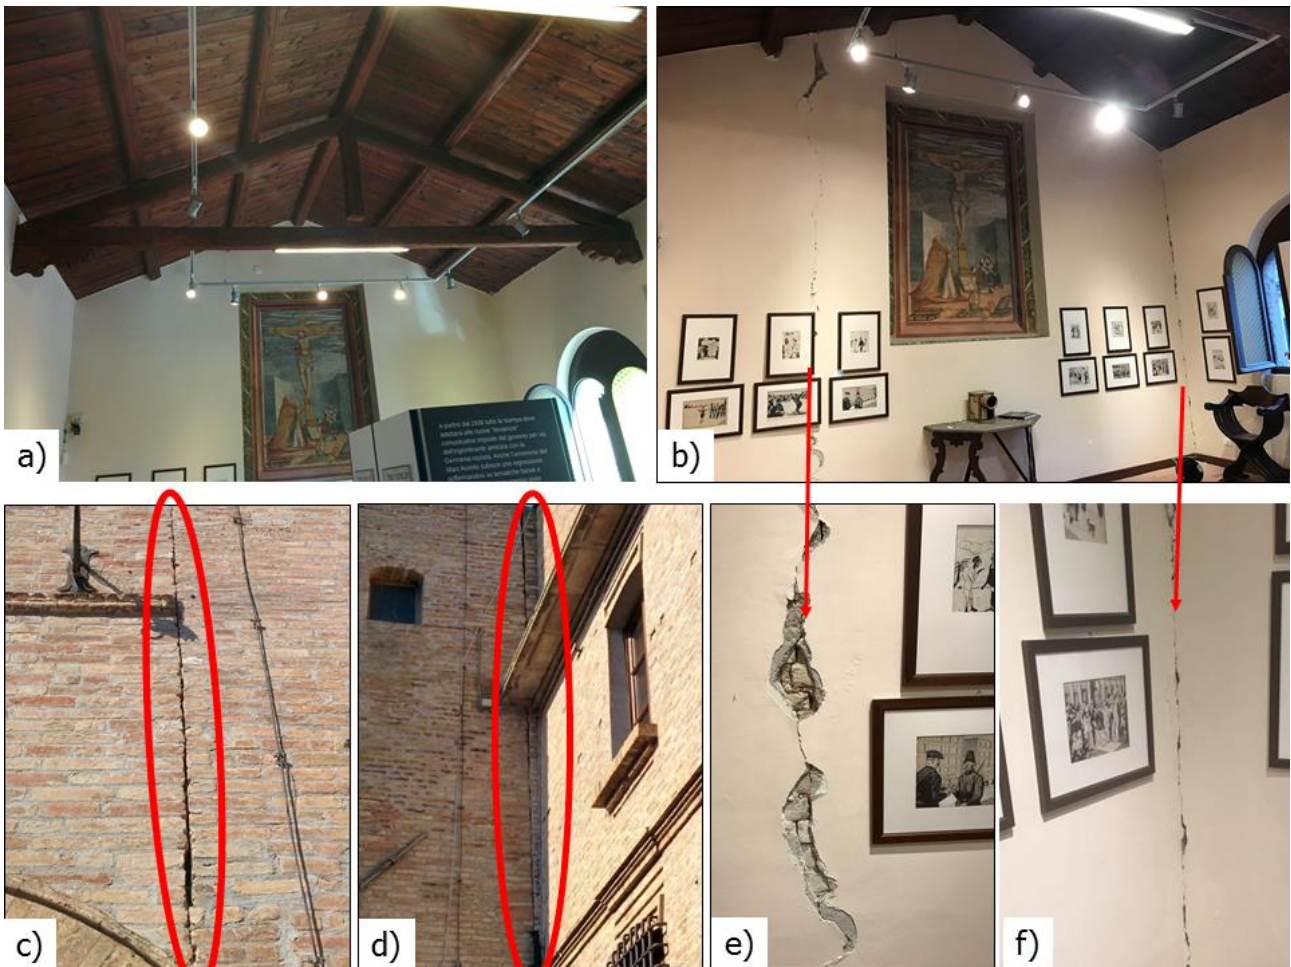
Figure 4. Some damages in the *camorcanna* and in the connection between transversal walls (a), only in the *camorcanna* (b) and in the connection between wooden beams and walls of the facades (c).

Figure 5. Comparison of the main wall between the "Pinacoteca" and the tower before (a) and after (b) October 30th, where a clear disconnection is present in the north (c) and south (d) parts between the facades and the tower. Some enlargements of the interior cracks are reported in the middle of the wall (e) and in the south façade (f).

The most evident damages are focused on the first floor of the palace, in the contact area between the tower and the palace, were a normal-quality masonry and not good connections are observed. In particular, the tower pounded the walls of the "Pinacoteca" of the palace and a clear disconnection between the wall of the façades and the tower appeared (**Figures 5b-f**) in the interior and in the exterior facades, which actually are clearly visible.

At a first sight, the palace and the tower look simply close to each other, even if the detachment is visible only from a height of about 4 meters (**Figure 5c**). In fact, the palace and the tower are well connected up to the level of the arches at the base of the palace, meanwhile the wall above seems to be of a normal-quality and leaned on the tower.

Sliding between wooden roof beams and housing in the main walls have also appeared after the main shock (**Figure 4c**). Further enlargements of the previous damages in stuccos and in *camorcanna* were observed. Actually, the Podestà Palace is closed and some retrofitting interventions should be addressed in order to reopen the building.

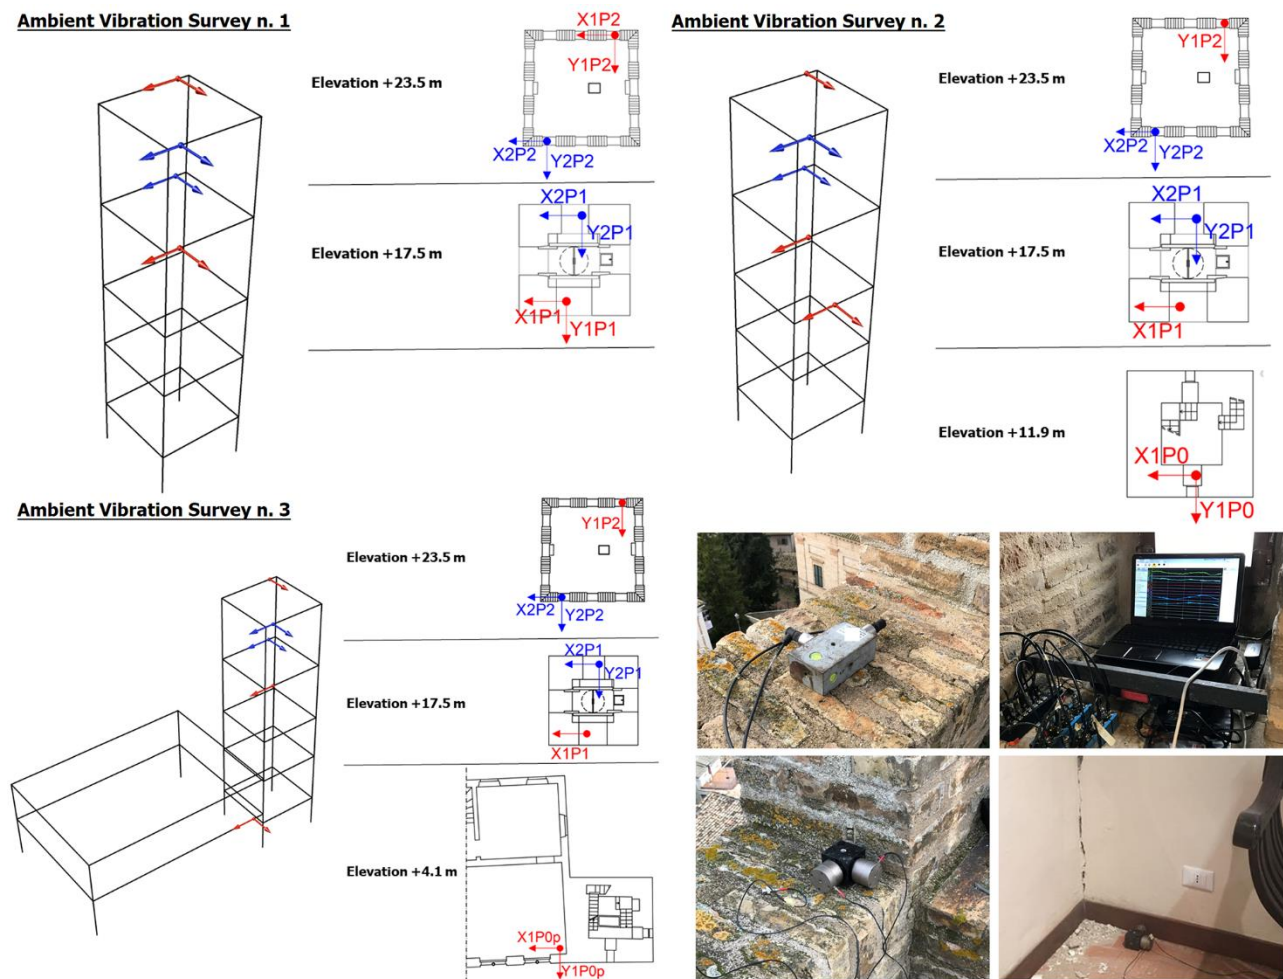
Figure 6. Layout of the accelerometers at each floor (see online version for colours) for different Ambient Vibration Surveys.

- KS48C-MMF with voltage sensitivity of 1V/g and measurement range of ±6g (in blue in **Figure 6**);
- KB12VD-MMF with voltage sensitivity if 10V/g and measurement range of ±0.6g (in red in **Figure 6**).

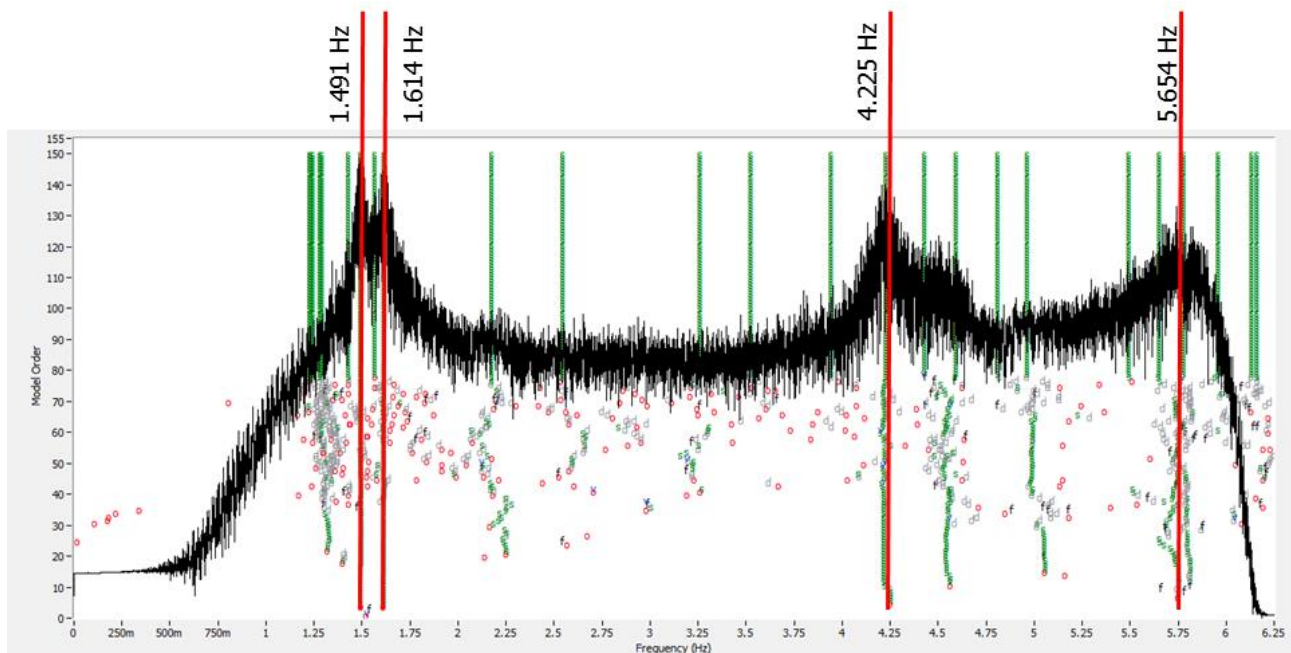
Figure 7. Stabilisation diagram (Cov-SSI) (see online version for colours).

The stabilization diagram obtained from the analysis of the collected data through Cov-SSI is reported in **Figure 7**. It shows the alignments of stable poles, for increasing order models, and allows the determination of the "n" eigenvectors of dynamic matrix [A] which are representative of structural modes, and how many are instead purely numeric (due to their redundancy of calculation or noise). Red points indicate negative results of the stability test, while green points represent the positive ones: considering that natural modes show intrinsic characteristics of the structure, they are invariant to the process and the order of the NM [37]. Then, it is possible to isolate the natural modes from the numerical ones by increasing the order of the model and checking the stability of the results.

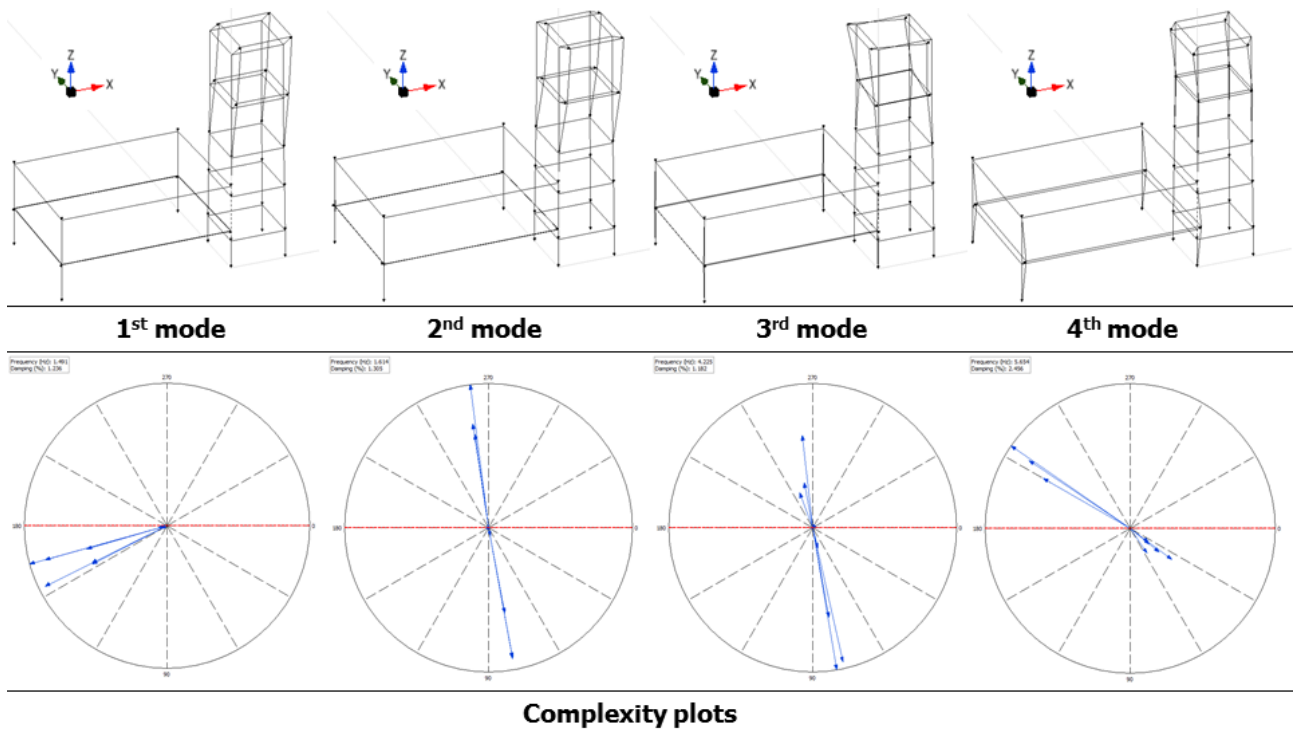
Figure 8. Modal shapes identified with SSI technique (see online version for colours) and relative complexity plots.

The identified frequencies appear rather spaced, the relative mode shapes mainly involve the tower and global modes appear only for values upper to the third (**Figure 7**). In fact, the first three modes involve only the tower in particular: the 1st and 2nd modes are mixed translational modes involving the tower - at the same time - in X- and Y-directions. The torsional component is visible with the 3rd mode, that always involves the tower in the

Complexity plots may also be very useful in order to check if the shapes are normal or not [38]. A shape is called a "normal" shape if all of its shape components have 0 or 180 degrees of phase relative to one another. In other words, all of the shape components lie along a straight line in the Complexity Plot. A "complex" shape can have arbitrary phases in its shape components, so they will not lie along a straight line. **Figure 8** shows the complexity plots from the measurement data: all modes are normal or nearly normal (see, for instance, the third and fourth modes, which are weakly excited).

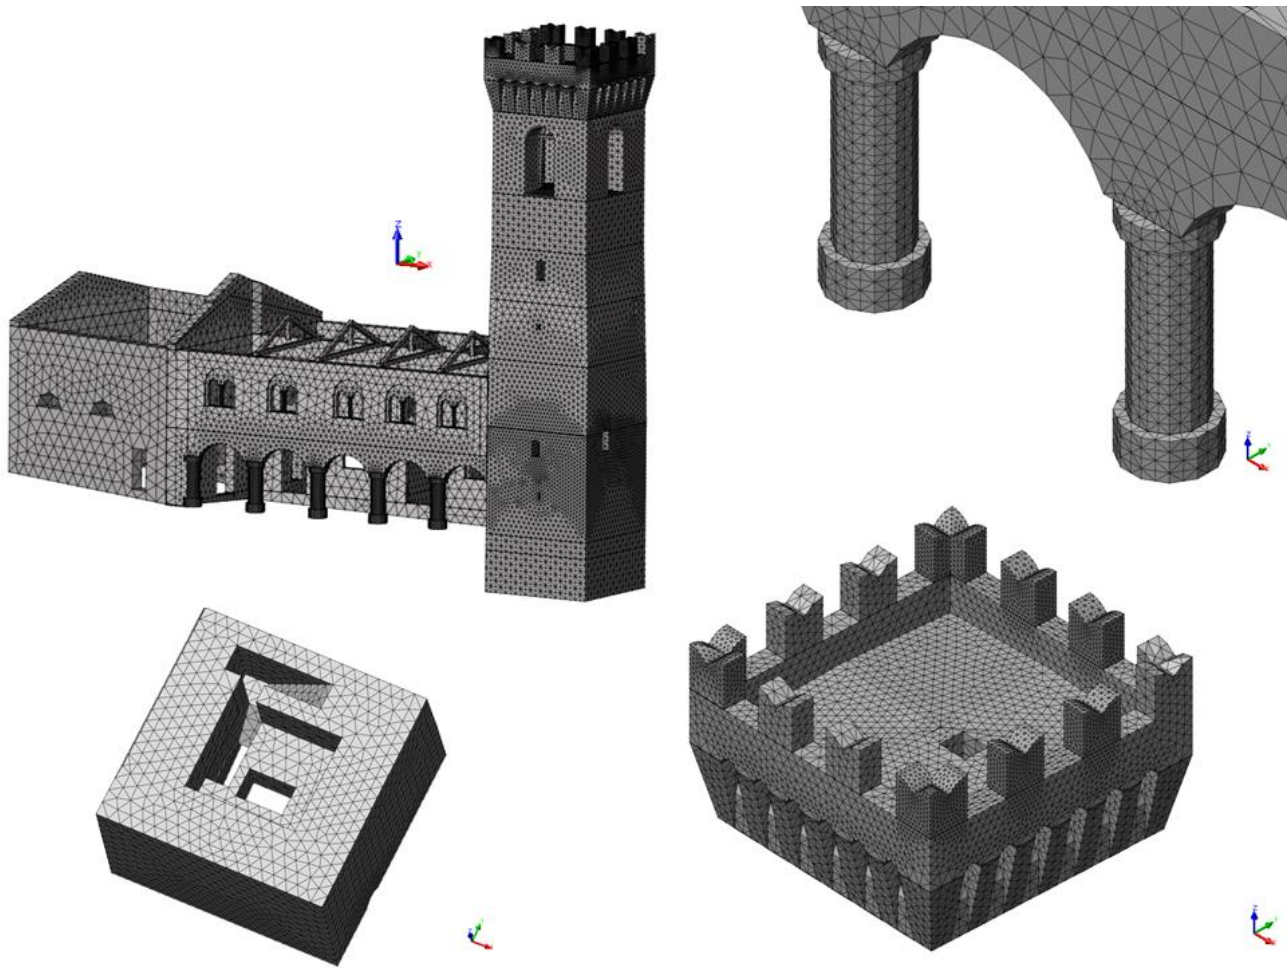
Figure 9. View of the FE model of the structure and some structural details.

A relatively large number of finite elements were used in the model, which was formed by quadrilateral and tetrahedral elements with a maximum side equal to 0.30 m. Therefore, the model results in a total of 80349 nodes and 346806 elements with 235929 active degrees of freedom. A 3D view of the model is shown in **Figure 9**.

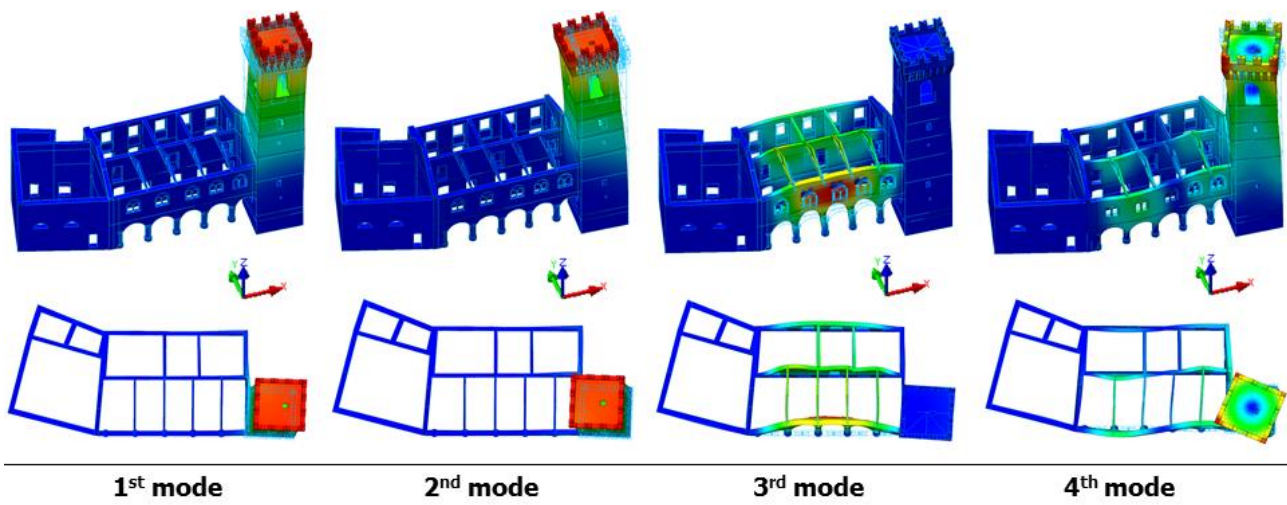
Figure 10. The first four modes of the NM: starting point for the calibration.

The dynamic properties and mode shapes of the structure, reported in **Table 3** and illustrated in **Figure 10**, have revealed important characteristics of the structural behaviour. The first three modes reach about 30% of the mass participation ratio in X-direction and about 45% in Y-Direction, involving separately the tower (the first two modes) and the Palace (the third mode). Differently, the fourth is the first mode that involves contemporary the palace and the tower. The subsequent modes, not reported in **Table 3**, are always local and involve the elements in out-of-plane deformations.

The main consideration, comparing the results of AVS in **Figure 8** and those of NM reported in **Figure 10**, is that the structure has a clear decoupled dynamical behaviour between tower and palace. The main difference is that the third mode of AVS involves only the tower, while that of NM involves only the second level of the "Pinacoteca". On the other hand, the frequencies are not scattered. In order to have a better understanding of this situation, a correlation analysis could be made in terms of scattering between analytical and experimental values of natural frequencies:

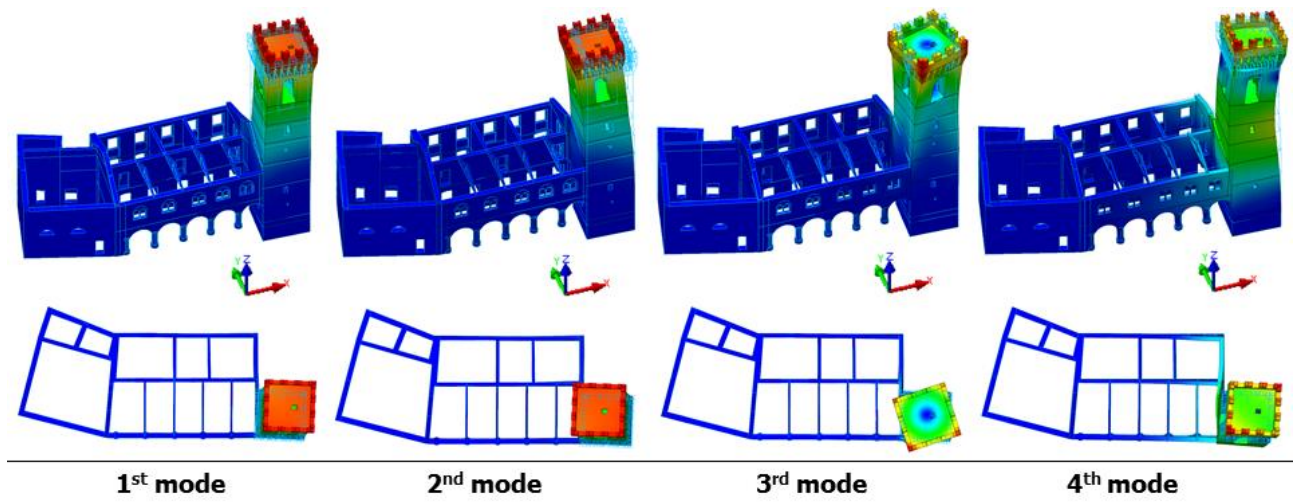
Figure 12. The first four modes of the NM after the second calibration.

At this step of calibration, it is possible to observe that there are quite small differences between the four main frequencies values as reported in **Table 5** (last column): of about +3.49% for the first mode, and +2.99% for the second mode and -0.27% for the third mode. The main difference is again on the fourth mode, where a +6.4% is noticeable comparing the experimental and the numerical frequency. In terms of modal shapes good matches are observable comparing **Figures 8 and 12**.
