Upgrading of quay walls at the Ravenna port, Italy: evaluation of the steel piles degradation after a long working life

# Upgrading of quay walls at the Ravenna port, Italy: evaluation of the steel piles degradation after a long working life

Paolo Ruggeri<sup>1</sup>, Vivienne Marianne Esther Fruzzetti<sup>1</sup>, Giuseppe Scarpelli<sup>1</sup>

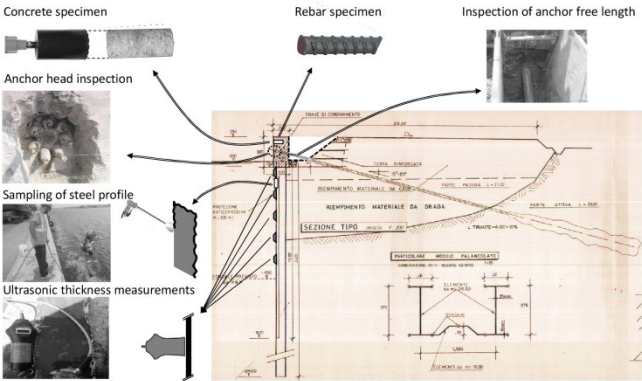
In Figure 3 the cross section of a considered quay with indication of the investigations carried out to verify the degradation of the structure are shown. In particular, the aspects of major relevance being addressed are:

Figure 3. Typical investigations carried out on each quay  
209x297mm (300 x 300 DPI)

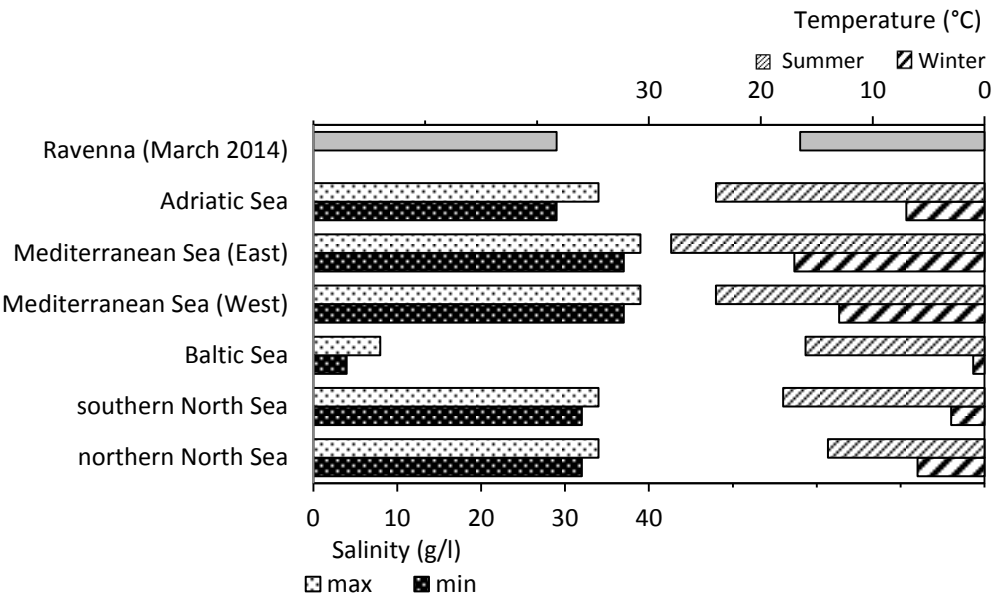
FIGURE 4

along the coast of Germany and Denmark; Mediterranean Sea – salinity of 37-39 g/l and a temperature ranging from 13 to 24°C (winter/summer) in the West side and from 17 to 28°C (winter/summer) in the East side. Figure 4 presents all the collected data: it results that salinity is very similar for all the considered seas (with the well-known exception of the Baltic Sea in which values are extremely low), whereas the temperature varies more significantly both in the seasonal and extreme values. Taking into account the dependence of the corrosion rate from environmental parameters, as clearly pointed out by Nevshupa et al. (2018), it is confirmed the importance of providing corrosion data for different environments of exposure.

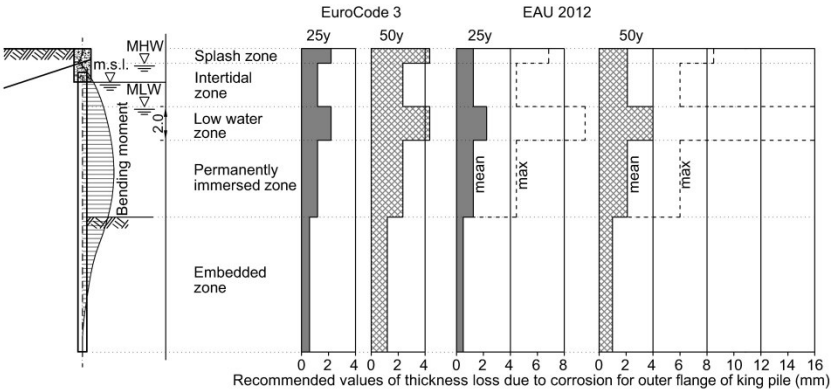
Figure 5 compares the thickness of metal loss after 25 and 50 years of exposure according to EAU2012 and to Eurocode 3 for the previously defined zones. The given thickness losses refer to the outer flange of the king pile and include both the corrosion on the sea side and on the ground side, the latter refers to undisturbed deposits of natural soil. It should be noted that EAU 2012 provides a mean value and a maximum value of the thickness losses due to the corrosion process. It is evident that the values proposed by the Eurocode 3 match the corresponding mean values of EAU 2012. It is worth noting that the maximum

Figure 5. Vertical zoning of sea water on a sheet pile wall and recommended values for thickness loss due to corrosion according to Eurocode 3 and EAU 2012. Given values refer to 25 and 50 years of exposure for the outer flange of H-type pile
