Upgrading of quay walls at the Ravenna port, Italy: evaluation of the steel piles degradation after a long working life

Paolo Ruggeri¹, Viviene Marianne Esther Fruzzetti¹, Giuseppe Scarpelli¹

ABSTRACT

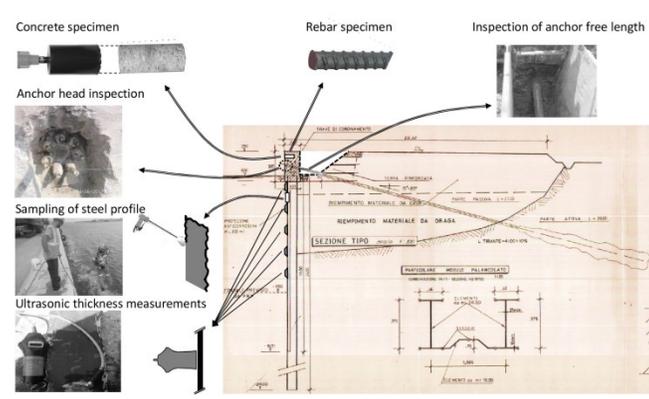
Figure 3. Typical investigations carried out on each quay
209x297mm (300 x 300 DPI)

In Figure 3 the cross section of a considered quay with indication of the investigations carried out to verify the degradation of the structure are shown. In particular, the aspects of major relevance being addressed are:

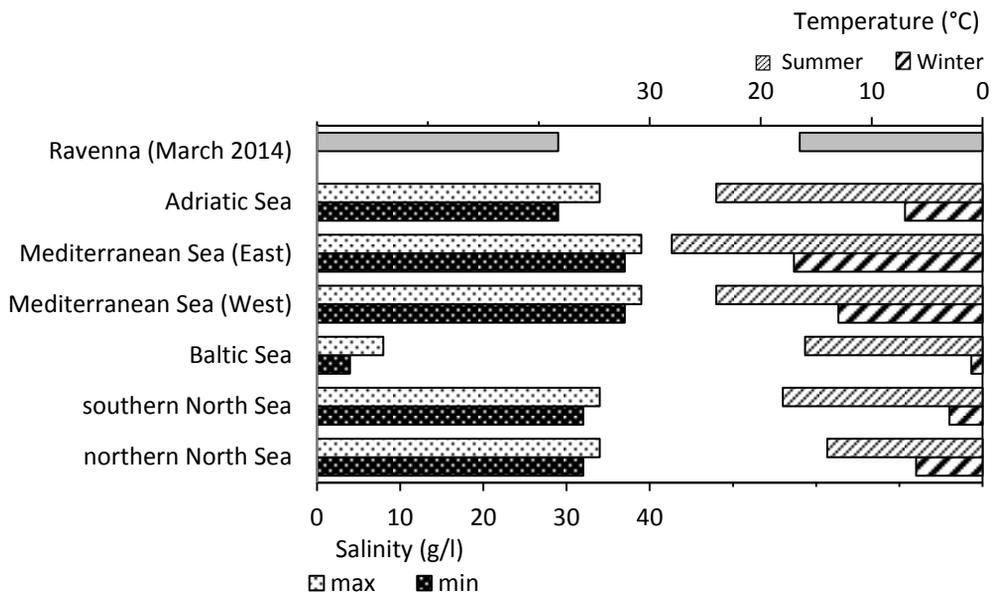
FIGURE 4

1
2
3 along the coast of Germany and Denmark; Mediterranean Sea – salinity of 37-39 g/l and a temperature
4 ranging from 13 to 24°C (winter/summer) in the West side and from 17 to 28°C (winter/summer) in the East
5 side. Figure 4 presents all the collected data: it results that salinity is very similar for all the considered seas
6 (with the well-known exception of the Baltic Sea in which values are extremely low), whereas the
7 temperature varies more significantly both in the seasonal and extreme values. Taking into account the
8 dependence of the corrosion rate from environmental parameters, as clearly pointed out by Nevshupa et al.
9 (2018), it is confirmed the importance of providing corrosion data for different environments of exposure.
10
11

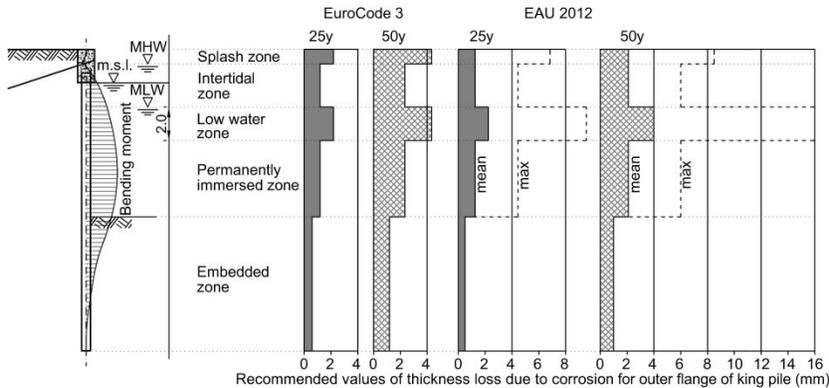
54
55 Figure 5 compares the thickness of metal loss after 25 and 50 years of exposure according to EAU2012 and
56 to Eurocode 3 for the previously defined zones. The given thickness losses refer to the outer flange of the
57 king pile and include both the corrosion on the sea side and on the ground side, the latter refers to
58 undisturbed deposits of natural soil. It should be noted that EAU 2012 provides a mean value and a
59 maximum value of the thickness losses due to the corrosion process. It is evident that the values proposed by
60 the Eurocode 3 match the corresponding mean values of EAU 2012. It is worth noting that the maximum

Figure 5. Vertical zoning of sea water on a sheet pile wall and recommended values for thickness loss due to corrosion according to Eurocode 3 and EAU 2012. Given values refer to 25 and 50 years of exposure for the outer flange of H-type pile
