Renovation of quay walls to meet more demanding requirements: Italian Experiences

Paolo Ruggeri, Vivienne Marianne Esther Fruzzetti, Giuseppe Scarpelli

To appear in: *Coastal Engineering*

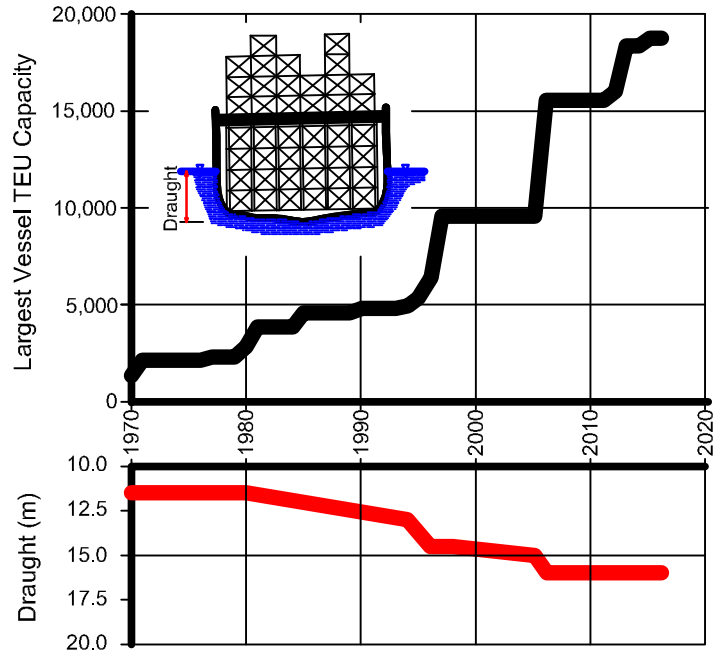
37 The evolution of port infrastructure has been always linked to the characteristics of the ships, as is clearly
38 shown by Figure 1, in which historical development of the container capacity of vessels is compared with
39 their draught.

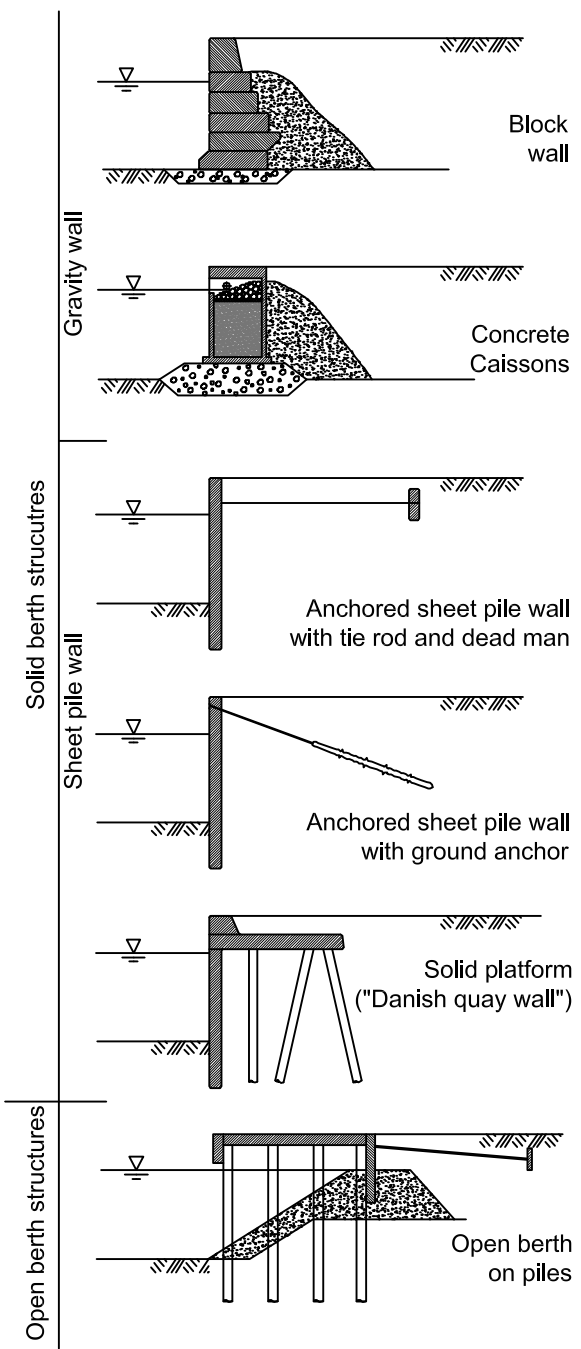
133 [Figure 2](#) illustrates some examples of the structural solutions described.

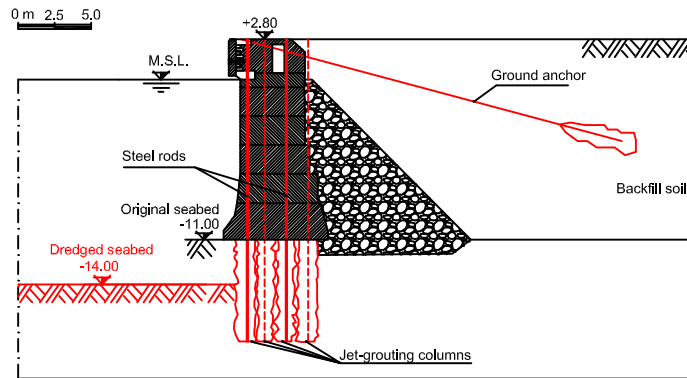
213 To enhance the existing structures, a structural intervention had to be carried out in 1998. As showed in
214 [Figure 4](#), the blocks were given an underpinning of jet-grouting columns down to a depth of 18 m, reinforced
215 by steel rods. These rods extend into the blocks, linking the blocks to one another. Moreover, to improve the
216 stability of the geotechnical system, active ground anchors were installed along the entire length of the pier.
217 Details of the intervention, and of the innovative monitoring of structural movements over an extended
218 period of time, based on fibre-optic linear deformation sensors, can be found in [Del Grosso et al. \(2007\)](#).

219 The solution adopted is designed to convert the gravity wall in place at the head into a massive embedded
220 wall. It presents some potential weaknesses, in particular the effective size of injected columns beneath the

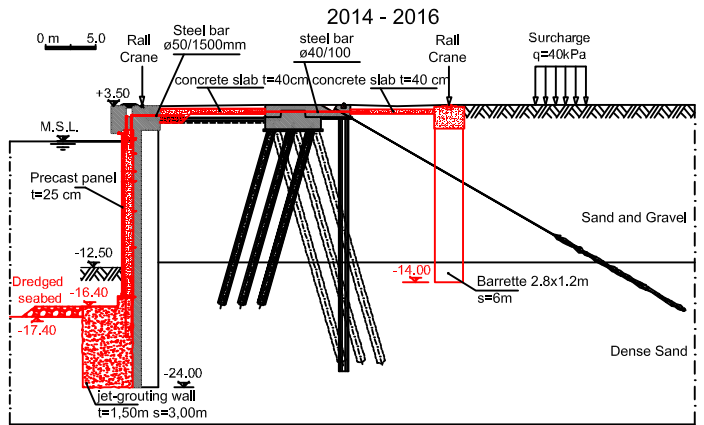
618 Figure 10. Eastern quay – sector D (port of Gioia Tauro): cross section of the original quay and
619 representation of the renovation works carried out in 1994-1996 (left) and 2014-2016 (right)

- 492 - a massive beam to hold the new landside rails, resting on a foundation of concrete rectangular
493 diaphragms placed every 6 m and measuring 1.20 m x 2.80 m (W x L), extending down to 14 m
494 below sea level;
- 495 - a concrete slab, 0.40 m thick, to replace the old steel frame between the retaining wall and the raked
496 piles;
- 497 - horizontal steel rods to join the structures behind the head of the wall.

498 The recent works were complex and expensive, but it should be noted that the performance of the original
499 quay wall was greatly improved. The works both enhanced the passive resistance of the soil and strengthened
500 the structures, especially the head restraints of the wall.
