## **Renovation of quay walls to meet more demanding requirements: Italian Experiences**

To appear in: *Coastal Engineering*

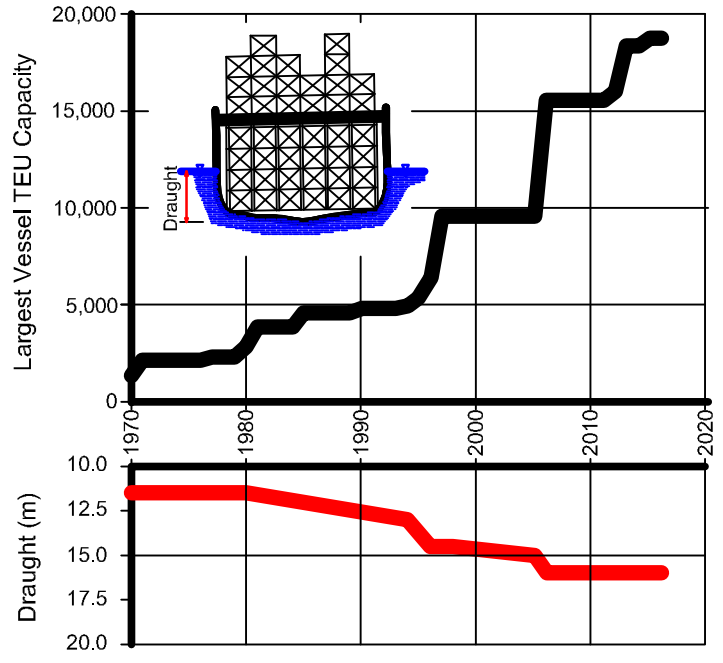
37 The evolution of port infrastructure has been always linked to the characteristics of the ships, as is clearly  
38 shown by Figure 1, in which historical development of the container capacity of vessels is compared with  
39 their draught.

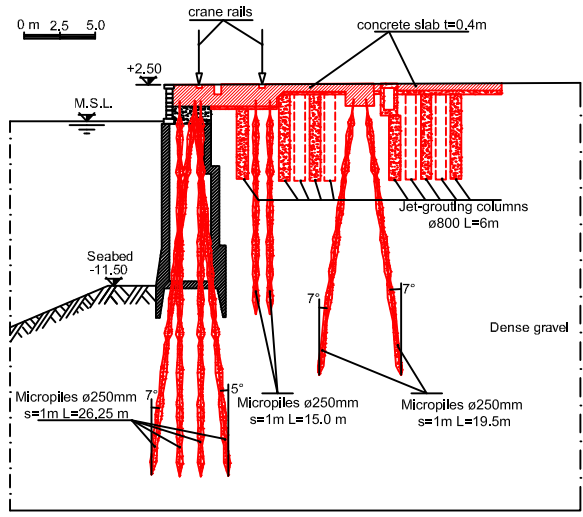
237 Peloro quay consists of a precast concrete caisson 13 m high and 6 m long, with a width that ranges from 3.6  
238 m at its head to 6.0 m at its base. The base has two prominent shear keys, one in the front and one on the  
239 rear, to connect the structure with the subsoil. A massive concrete beam, 2.5 m in height, was cast on-site on  
240 the heads of the caisson. [Figure 5](#) shows a schematic cross section of the Peloro quay, with the reinforcement  
241 works highlighted.

252 The reinforcement measures consisted of:

- 253 - underpinning the caisson with a set of micro-piles 26 m in length, arrayed in 4 lines with spacing of  
254 1 m along the line, 2 positioned vertically and 2 inclined; each micro-pile was reinforced with a  
255 steel pipe with a diameter of 139.7 mm and a thickness of 14.2 mm;

- 256 - two lines of vertical micro-piles, positioned about 5 m far from the caissons, with spacing of 1 m  
257 along the line, reinforced with steel pipe with a diameter of 88 mm and a thickness of 8 mm, able to  
258 sustain the crane rail and to enhance resistance to horizontal actions;

- 259 - a pair of micro-piles, inclined at  $7^\circ$  from the vertical, positioned at a distance of approximately 10  
260 m from the caissons, with spacing of 1 m spaced along the line and reinforcement in the form of a  
261 steel pipe with a diameter of 139.7 mm and a thickness of 10.0 mm;

- 262 - jet-grouting treatment of the backfill, with columns 800 mm in diameter and 6 m in length, arrayed  
263 in a quincunx pattern with spacing of 2.15 m;

- 264 - a concrete slab 500-600 mm thick, to create a new deck able to join the caissons and the micro-  
265 piles, set on a foundation of jet-grouting columns.

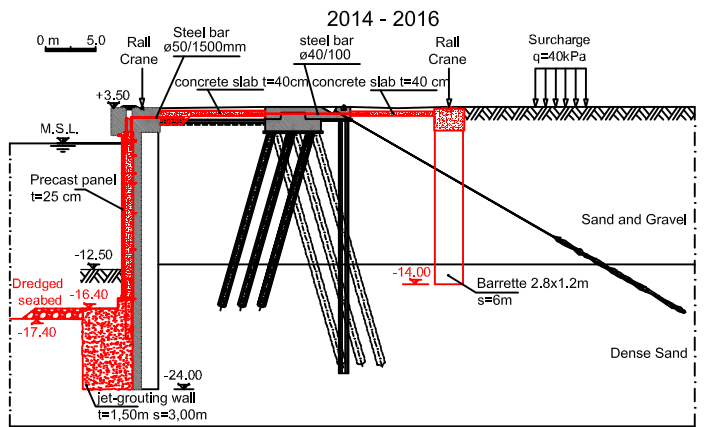
618 Figure 10. Eastern quay – sector D (port of Gioia Tauro): cross section of the original quay and  
619 representation of the renovation works carried out in 1994-1996 (left) and 2014-2016 (right)

- 478 - a sturdy steel frame made from HEB320 beams, to connect the wall and the rear portions of the  
479 piles in order to prevent differential horizontal displacements between the rails of the crane;
- 480 - new crane rails with a span of 20 m, resting on a foundation of piles with a diameter of 1000 mm, a  
481 length of 25 m and an interval along the line of 6 m;
- 482 - pre-stressed ground anchors reinforced with 8 strands of 0.6'', 25 m of free length and 15 m of  
483 foundation, inclined at 30° to the horizontal, fixed to the beam holding the new crane rails;

- 492 - a massive beam to hold the new landside rails, resting on a foundation of concrete rectangular  
493 diaphragms placed every 6 m and measuring 1.20 m x 2.80 m (W x L), extending down to 14 m  
494 below sea level;
- 495 - a concrete slab, 0.40 m thick, to replace the old steel frame between the retaining wall and the raked  
496 piles;
- 497 - horizontal steel rods to join the structures behind the head of the wall.

498 The recent works were complex and expensive, but it should be noted that the performance of the original  
499 quay wall was greatly improved. The works both enhanced the passive resistance of the soil and strengthened  
500 the structures, especially the head restraints of the wall.
